<div>Behan House, 10 Lower Mount Street, Dublin 2. D02 HT71 Tel: +353 (0)1 661 1100 e-mail: info@cora.ie web: www.cora.ie</div></div>							
Project Details:						Project Name: <b>Glaspistol Castle</b>			Scale:	Project Number:							
Site Address: Clogherhead						<b>Clogherhead - Phase 3</b>			NTS	21718							
Client:	Charles Markey	I1	Issued for Information.	04/06/2025	RK	Drawing Title: <b>Proposed Repairs</b>			Project:	Originator:	Zone:	Level:	Type:	Discipline:	Drawing No.:	Stage:	Revision:
Architect:	7L Architects	REV. No.	REVISION DESCRIPTION	DATE	ISSUED BY	<b>to the Internal North Wall</b>				CORA					SK300		I1

</div><div>Behan House, 10 Lower Mount Street, Dublin 2. D02 HT71 Tel: +353 (0)1 661 1100 e-mail: info@cora.ie web: www.cora.ie</div></div>						
Project Details:						Project Name: <b>Glaspistol Castle</b>		Scale:	Project Number:							
Site Address: Clogherhead						<b>Clogherhead - Phase 3</b>		NTS	21718							
Client:	Charles Markey	I1	Issued for Information.	04/06/2025	RK	Drawing Title: <b>Proposed Repairs</b> <b>To the West External Elevation</b>		Project:	Originator:	Zone:	Level:	Type:	Discipline:	Drawing No.:	Stage:	Revision:
Architect:	7L Architects	REV. No.

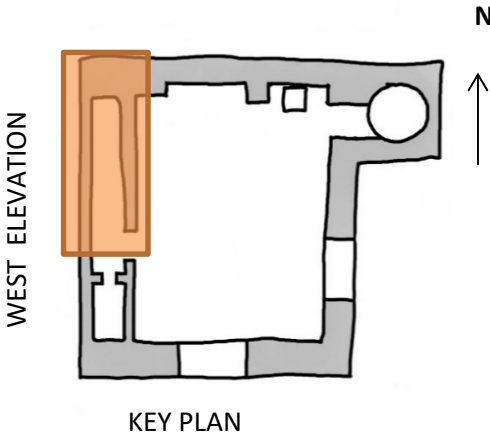
Stone lintel over the timber beam opening has no bearing on the right hand side.

End of the existing wall is unravelling and there are unsupported stones over.

Existing stone wall unsupported at the base due to missing lintel / corbel stones.

Existing stone lintel / corbel stones of the internal room are missing.

Fully record all stones in the top 200-300mm of the wall.  
Carefully rake out any loose mortar.  
Arrange for inspection.  
Allow for any loose stone to bedded in lime mortar.

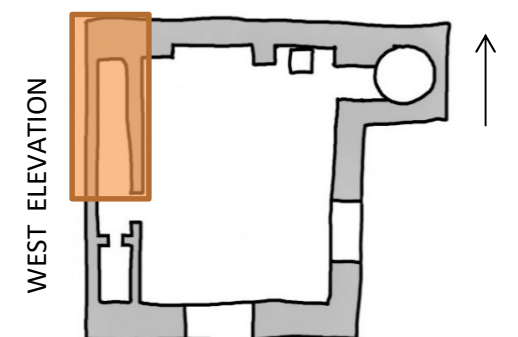
## INTERNAL IMAGE OF THE WEST WALL

Assumed  
- second floor  
level.

Assumed sequence of repair works for the repairs to the internal section of the west wall:

- i) Erect a safe working platform.
- ii) Inspect the wall over and temporary prop any loose stones or fully record and carefully remove any loose stone. Deep repointing maybe required in some areas to stabilise loose stone before the works commences.
- iii) Remove the vegetation from the base of the wall.
- iv) Construct the internal leaf of the wall with new or salvaged stone to match the existing.
- v) Install the lintels over the internal room.
- vi) Deep repoint the exposed core of the wall.
- vii) Locally rebuild with new or salvaged stone to support any overhanging stone above.
- viii) Consolidate the cantilever stones.
- ix) Infill the opening with new or salvaged stone to match the existing.
- x) Repair the wall top.
