| Project Details: Menlough Castle | | | | | | Project Name: <b>Menlough</b> | | | Scale: | Project Number: | | | | | | | |
| Site Address: | Menlough Castle, Galway | | | | | <b>Castle Galway Phases 5 &amp; 6</b> | | | NTS | 20612 | | | | | | | |
| Architect: | 7L Architects | REV. No. | REVISION DESCRIPTION | DATE | ISSUED BY | <b>Proposed Phasing</b> | | | | CORA | | | | | SK5001 | | I1 |

| Architect: | 7L Architects | REV. No. | REVISION DESCRIPTION | | DATE | ISSUED BY | <b>Internal Wall - Sheet 1</b> | | | | CORA | | | | | SK5020 | | I1 |

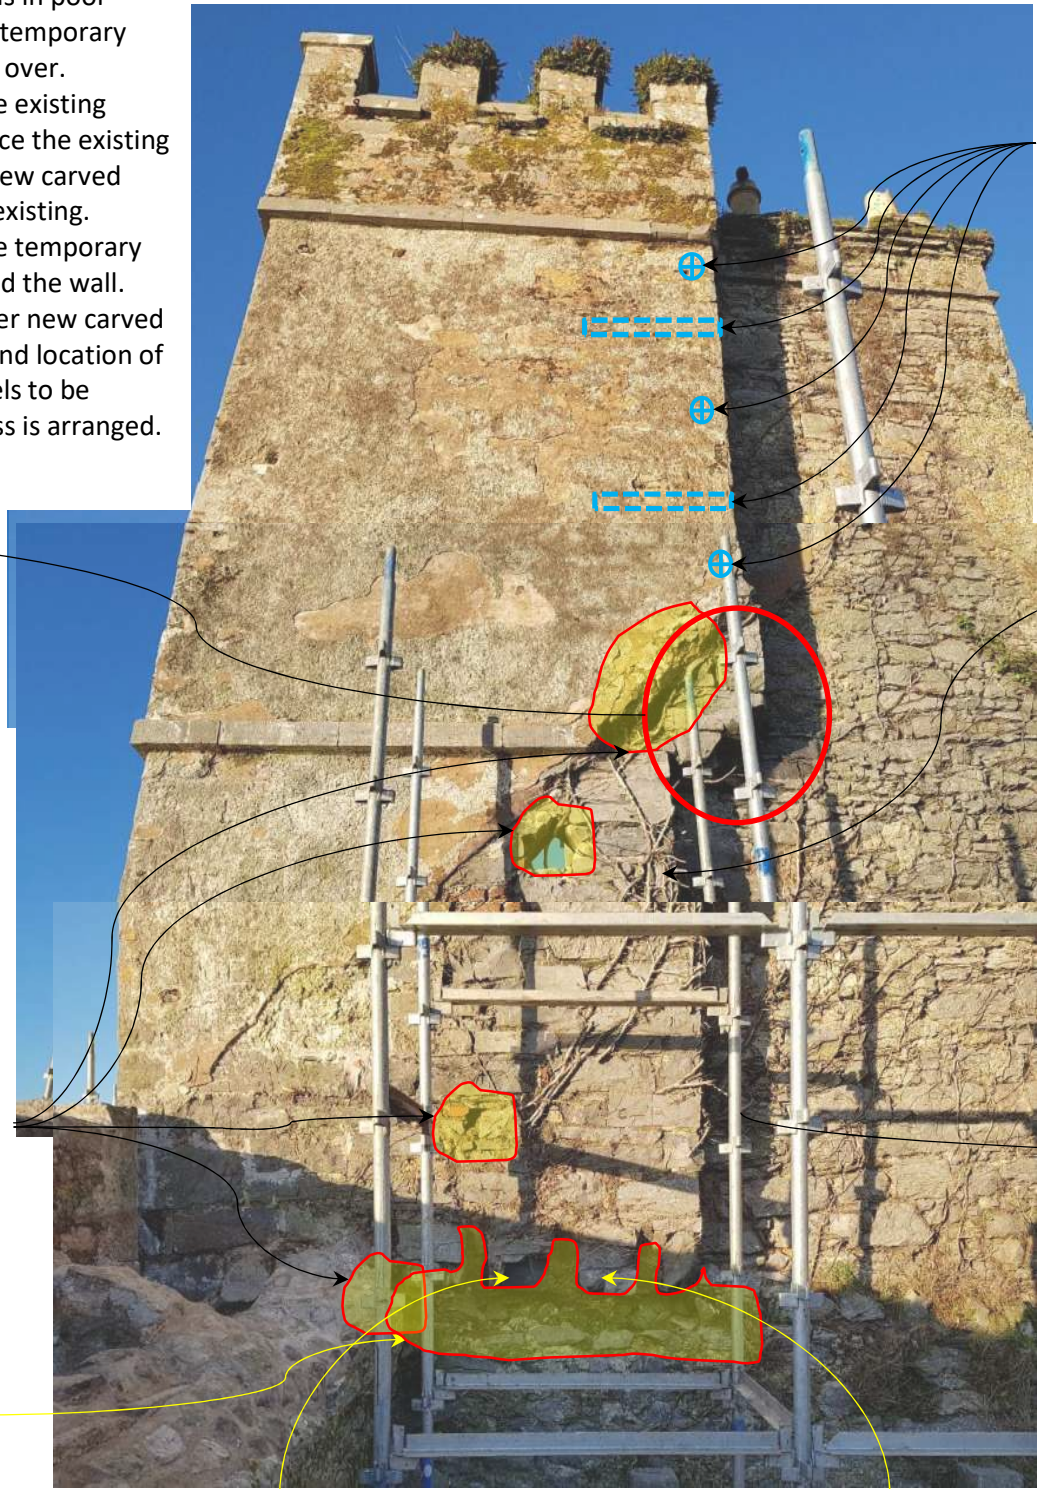
Existing stone corbels in poor condition. Allow for temporary propping of the wall over. Carefully remove the existing stone corbels. Replace the existing stone corbels with new carved stone to match the existing. Carefully remove the temporary props and make good the wall. Allow for two number new carved corbel stones. Size and location of the new stone corbels to be reviewed once access is arranged.

M8 sock fix anchors installed at an angle to support the corner of the tower. Allow for 5 number sock anchors to be installed. Sock fix anchors approximately 600mm long. Location and size of the sock fix anchors to be reviewed when access is arranged.

Spray and remove the vegetation growing from the wall.

Allow for 2 new stone indent where the existing stone corbels have cracked and are missing stone sections. Stone indents to be dowelled to the existing stone with 2 No. M8 grade 316L stainless steel dowels in chemical resin compatible with the stone.

Allow for 2 number cracks in the existing stone corbels to be stitched across with 2 No. M8 grade 316L stainless steel dowels in chemical resin compatible with the stone.

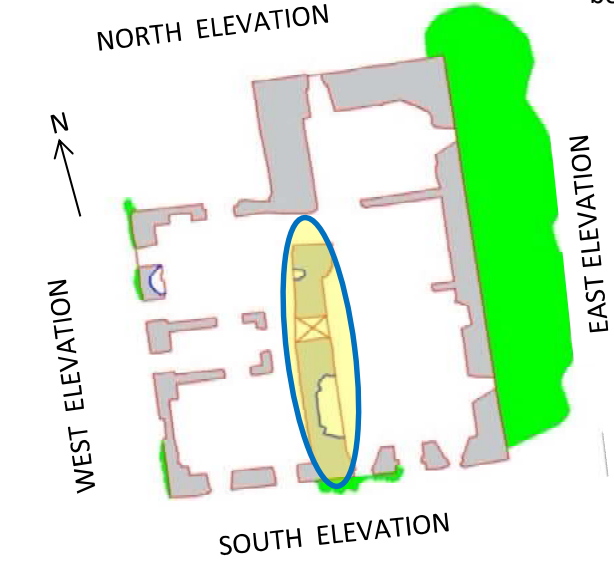
Existing stone corbels in poor condition. Allow for building of new masonry with salvaged stone to match the existing in lime mortar to support the corbel stones and the wall over. New masonry section to be keyed into the existing wall.
