ECOLOGICAL SURVEY

GRAND CANAL

Part 2 Conservation Management Plan 1991

**Prepared for
The Wildlife Service and Waterways Section,
Office of Public Works. 1992.**

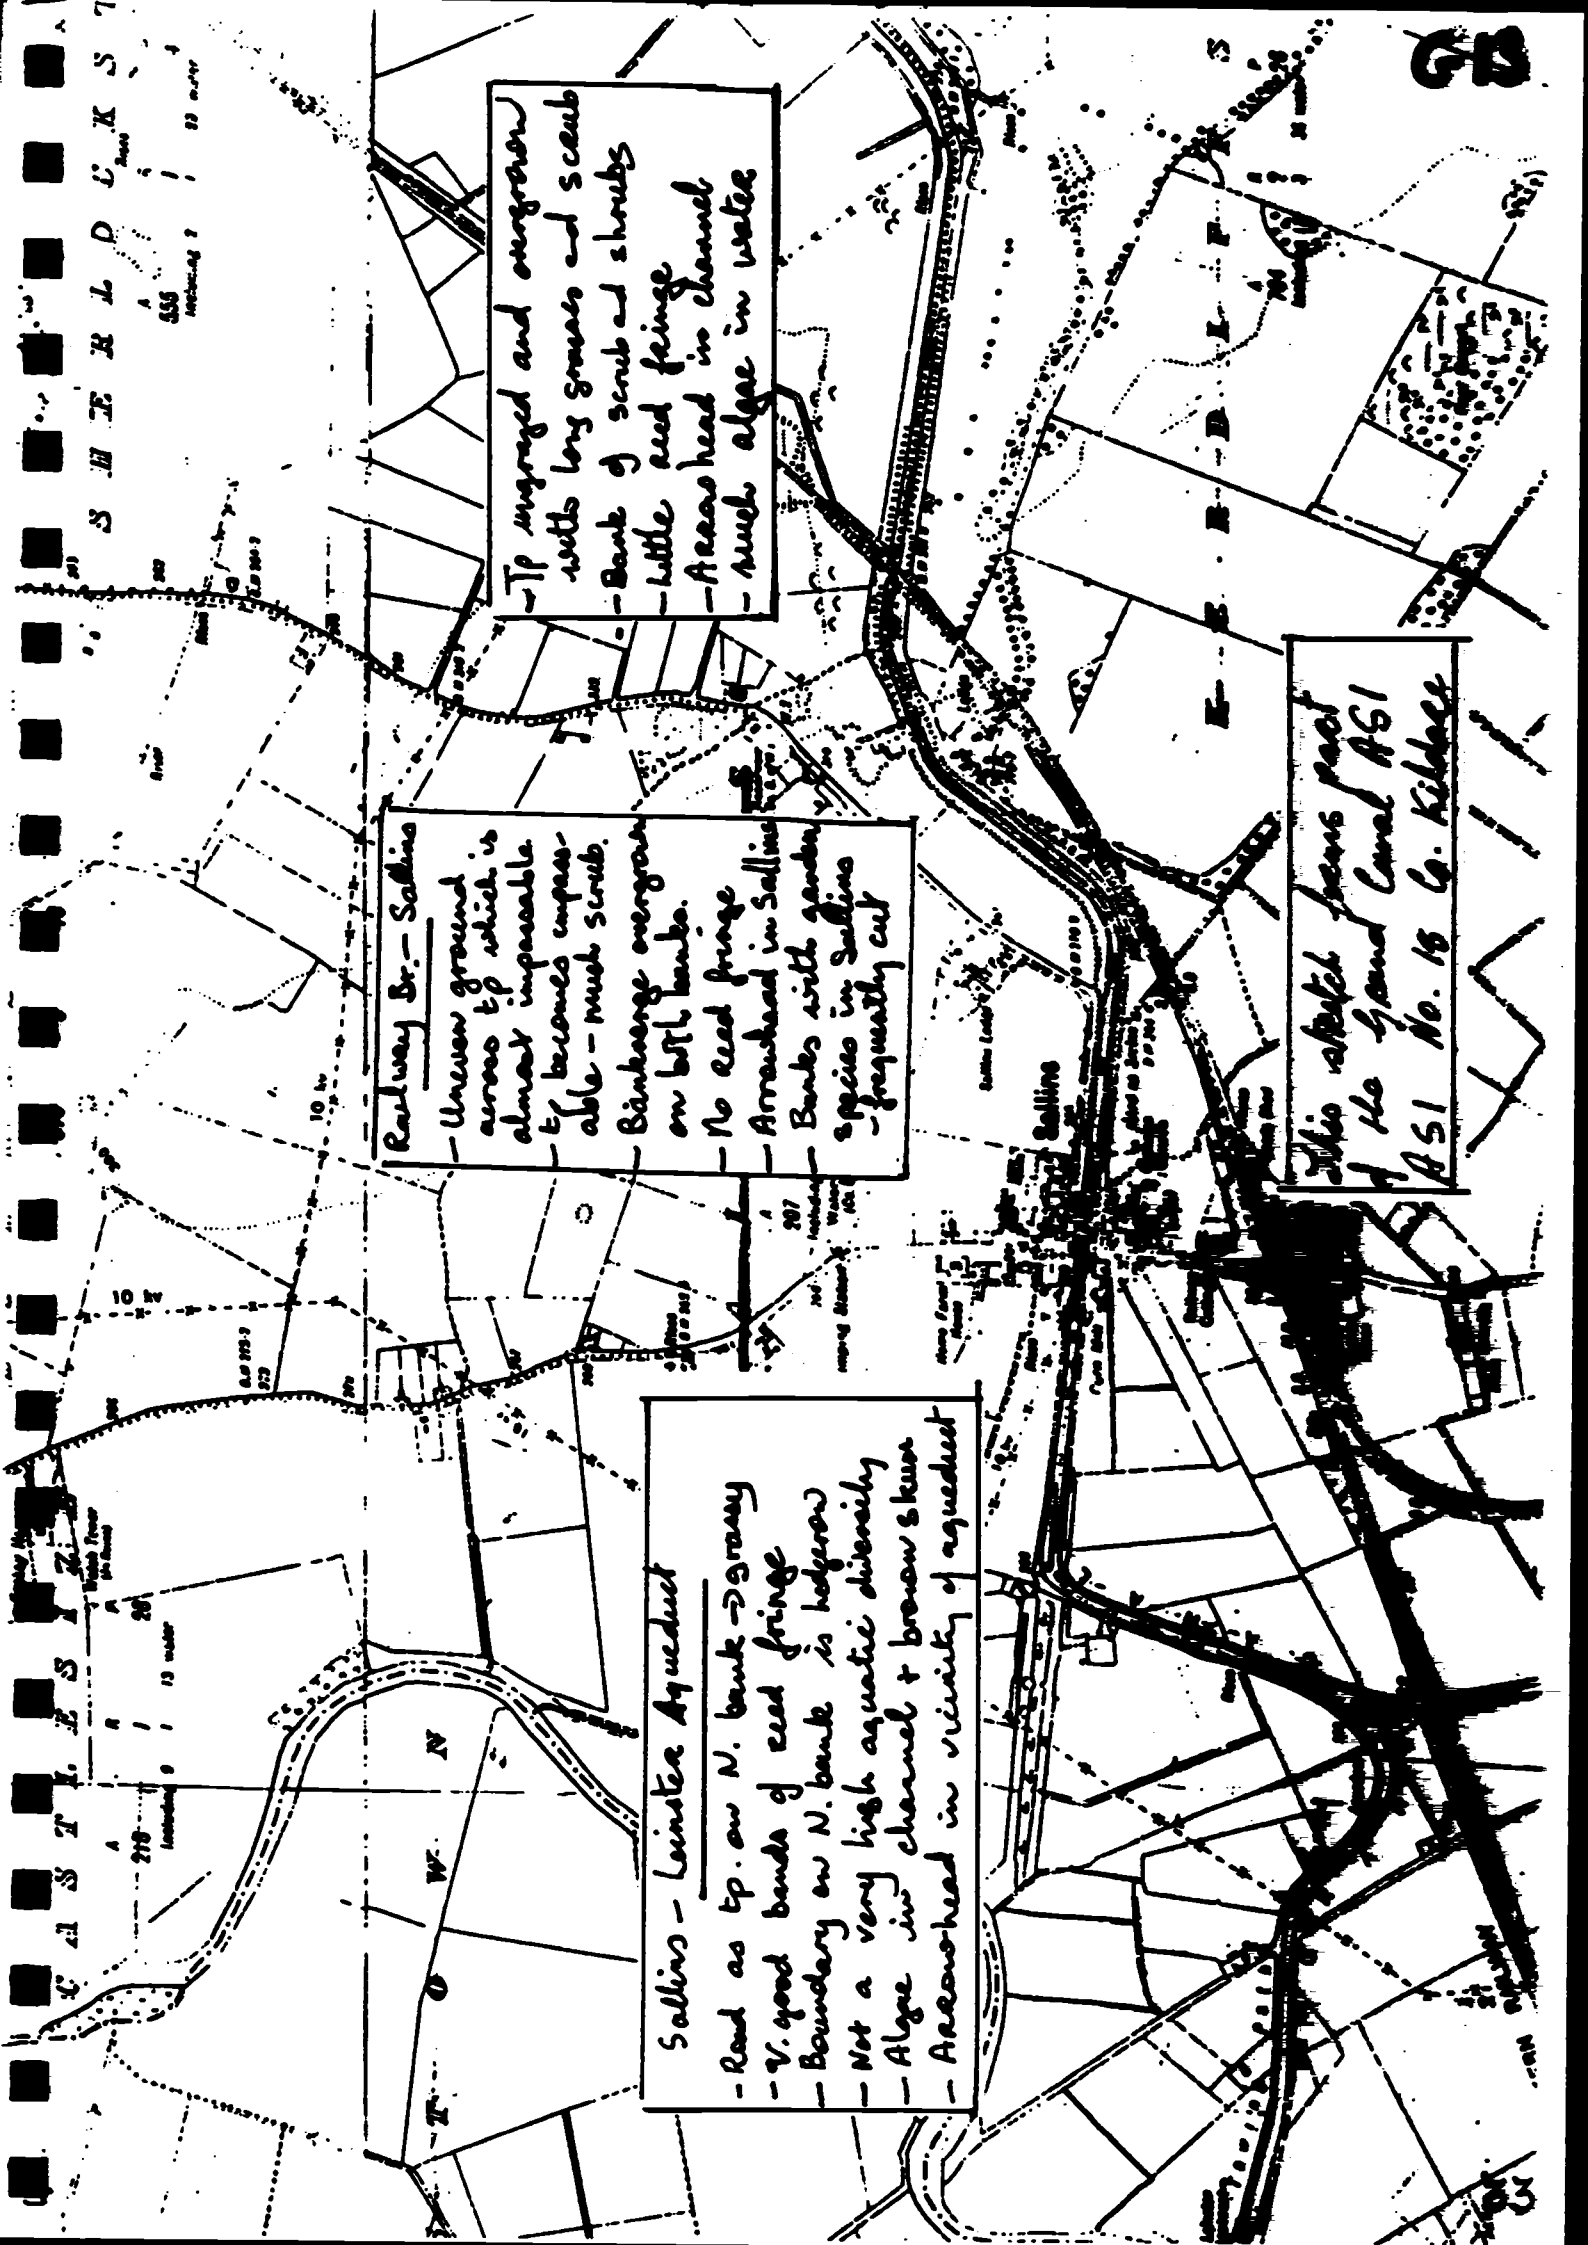
Railway Dr. - Salinas

- Unweeded ground across tp which is almost impassable - becomes impassable - much scrub.
- Bantarge overgrown on both banks.
- No weed fringe
- Arrowshead in Salinas
- Banks with garden species in Salinas frequently cut

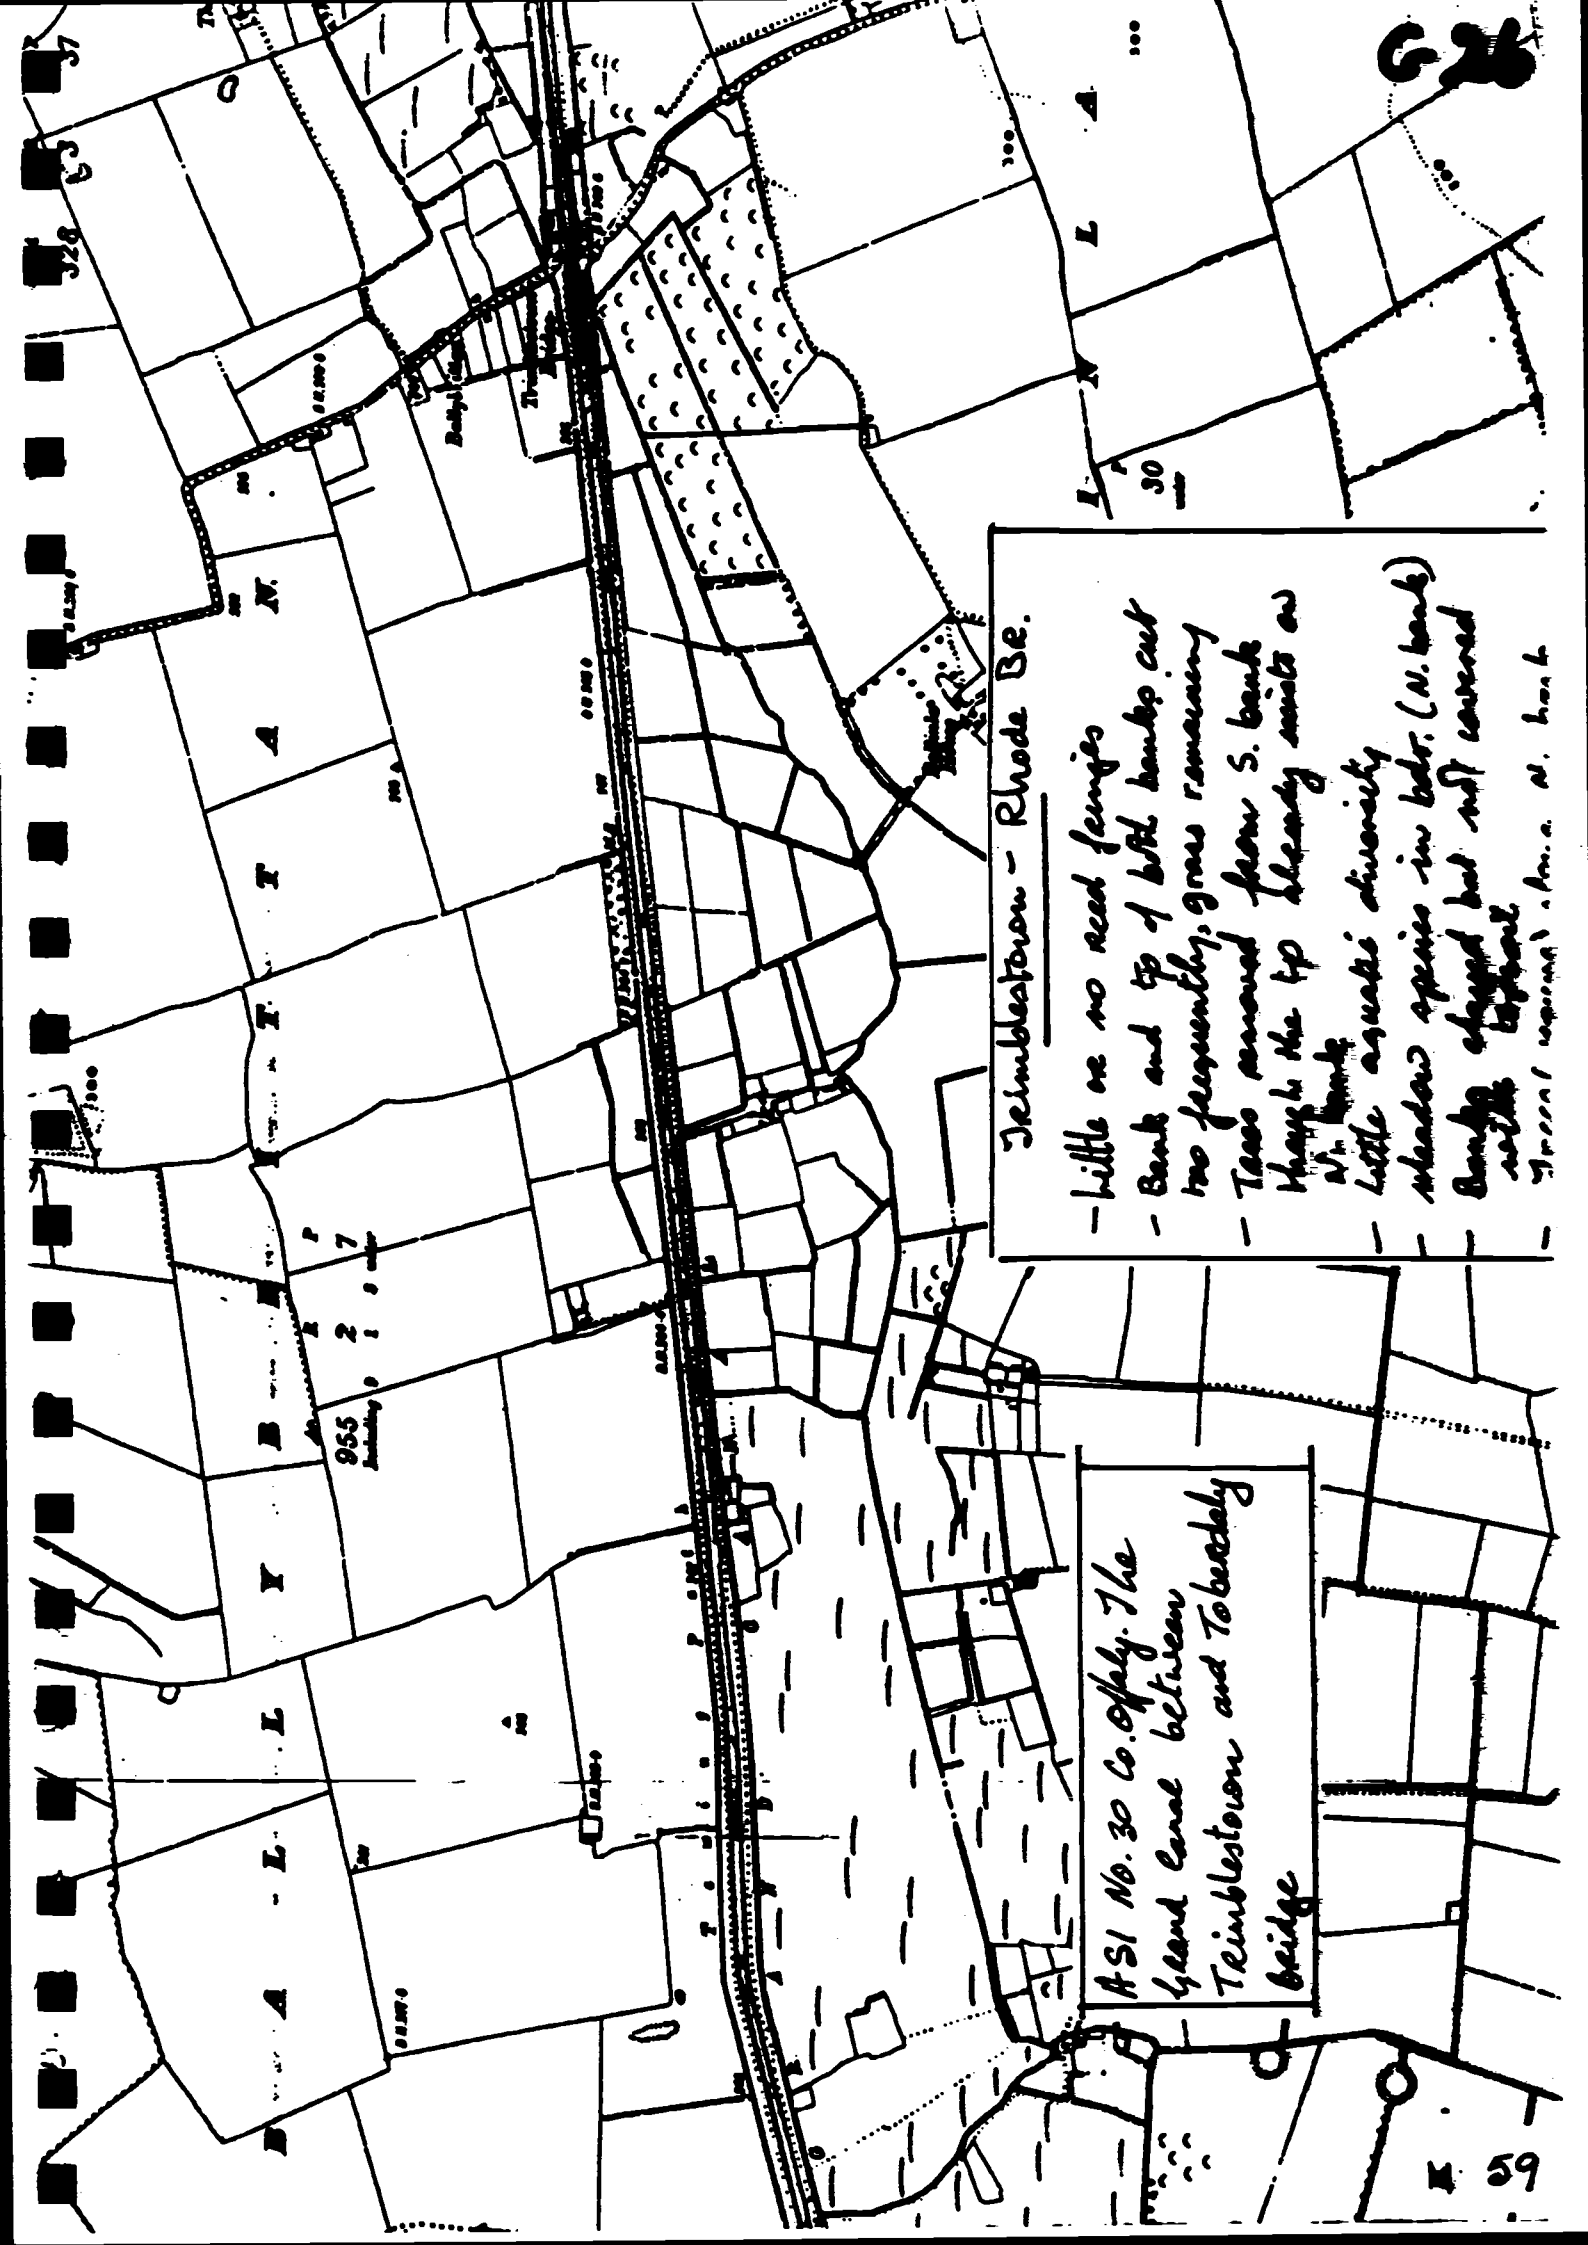
Teinbleston - Rhode Be.

- little or no seed fairs
- Banks and top of both banks cut too frequently, grass remaining
- Tassos removed from S. bank though the top already mints as N. bank
- Little aquatic diversity
- Meadow species in bdr. (N. bank)
- Banks changed but not covered with topsoil
- Grassland vegetation, some N. bank

- Allow reed fringe and aquatic species to recover. It is proposed to leave this stretch free from herbicide and manual cutting in 1992 (Caffrey, 1991).
- Protect the boundary verges by cutting once a year. Cutting will prevent the scrub species dominating.
- Cutting of such a wide path along both banks is not necessary. The path width and cutting frequency can both be reduced. Cutting so frequently does not allow plants to fruit and produce seed, reducing the ecological diversity so that in time the towpath will resemble "green concrete."
- Cut bank verge and part of towpath just once a year, collecting all cuttings and leaving some saplings on each bank after the cut.
- Put topsoil on the clayed banks to encourage plants to take root and so stabilize the banks further.
- Investigate the source of nutrients in the water.

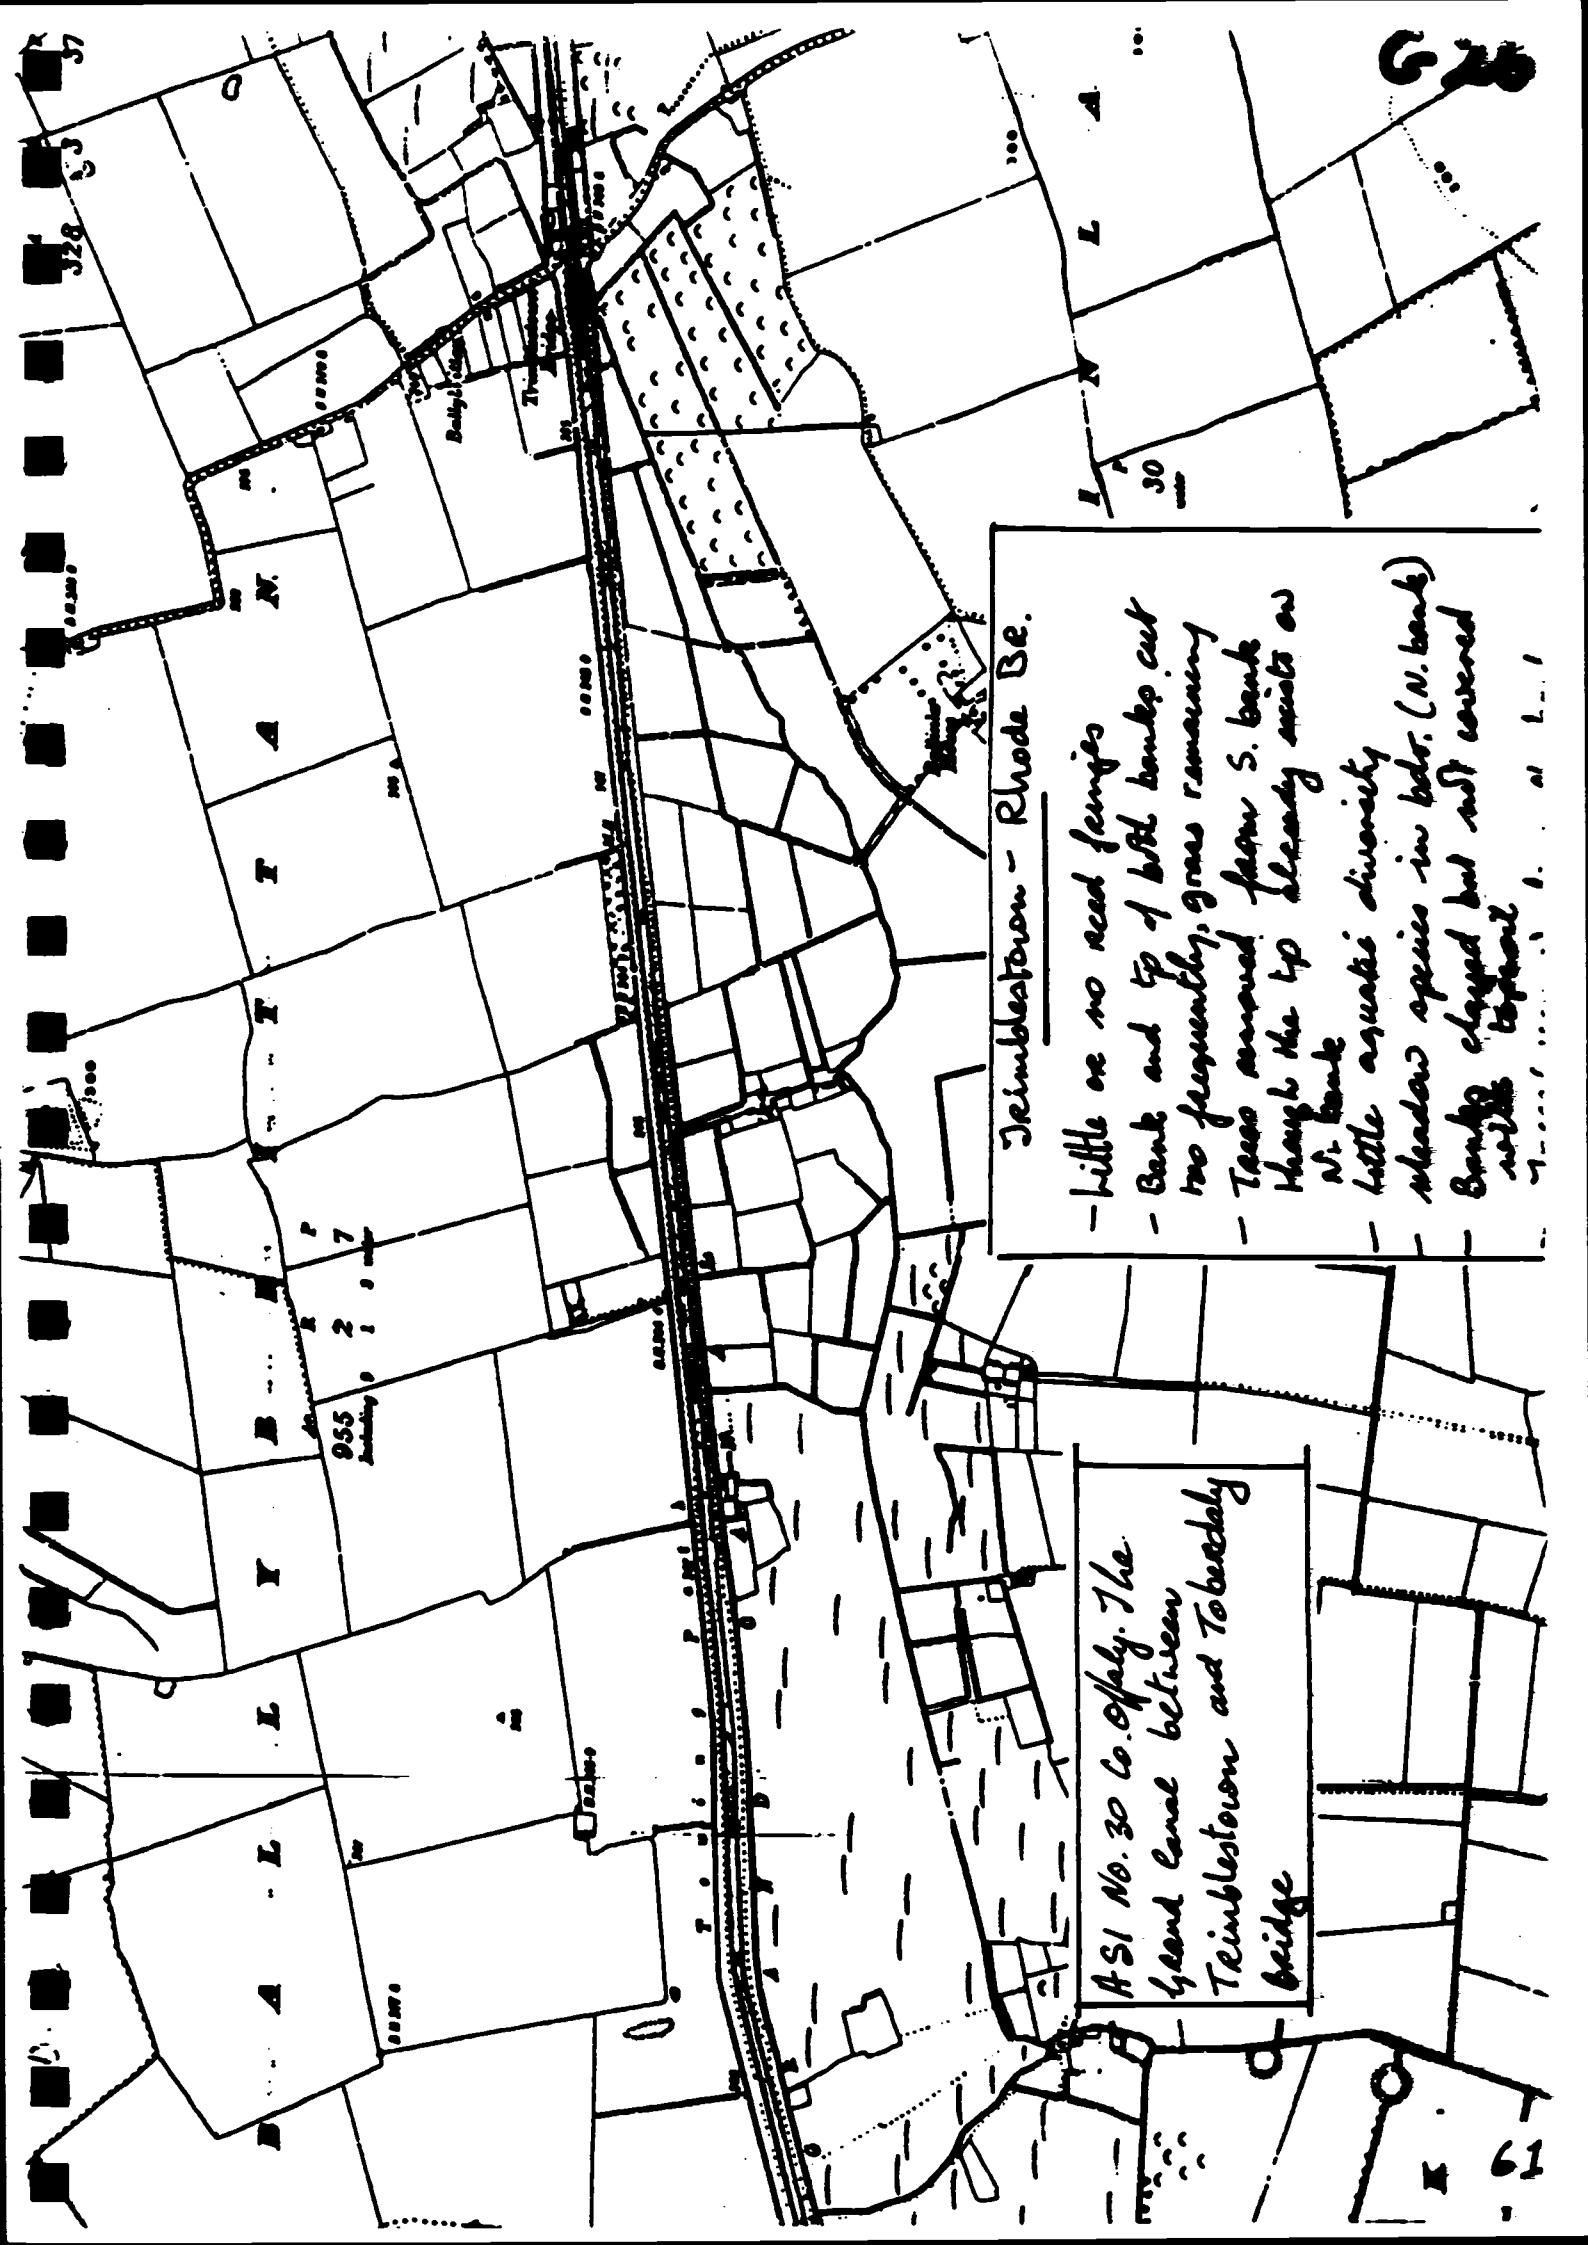
Trimbleston - Rhode Be.

- Little or no seed fairs
- Bank and top of both banks cut
- too frequently, grass remaining
- Tress around from S. bank
- though the top already exists on N. bank
- little aquatic diversity
- meadow species in bdr. (N. bank)
- Banks clayed but not covered with topsoil

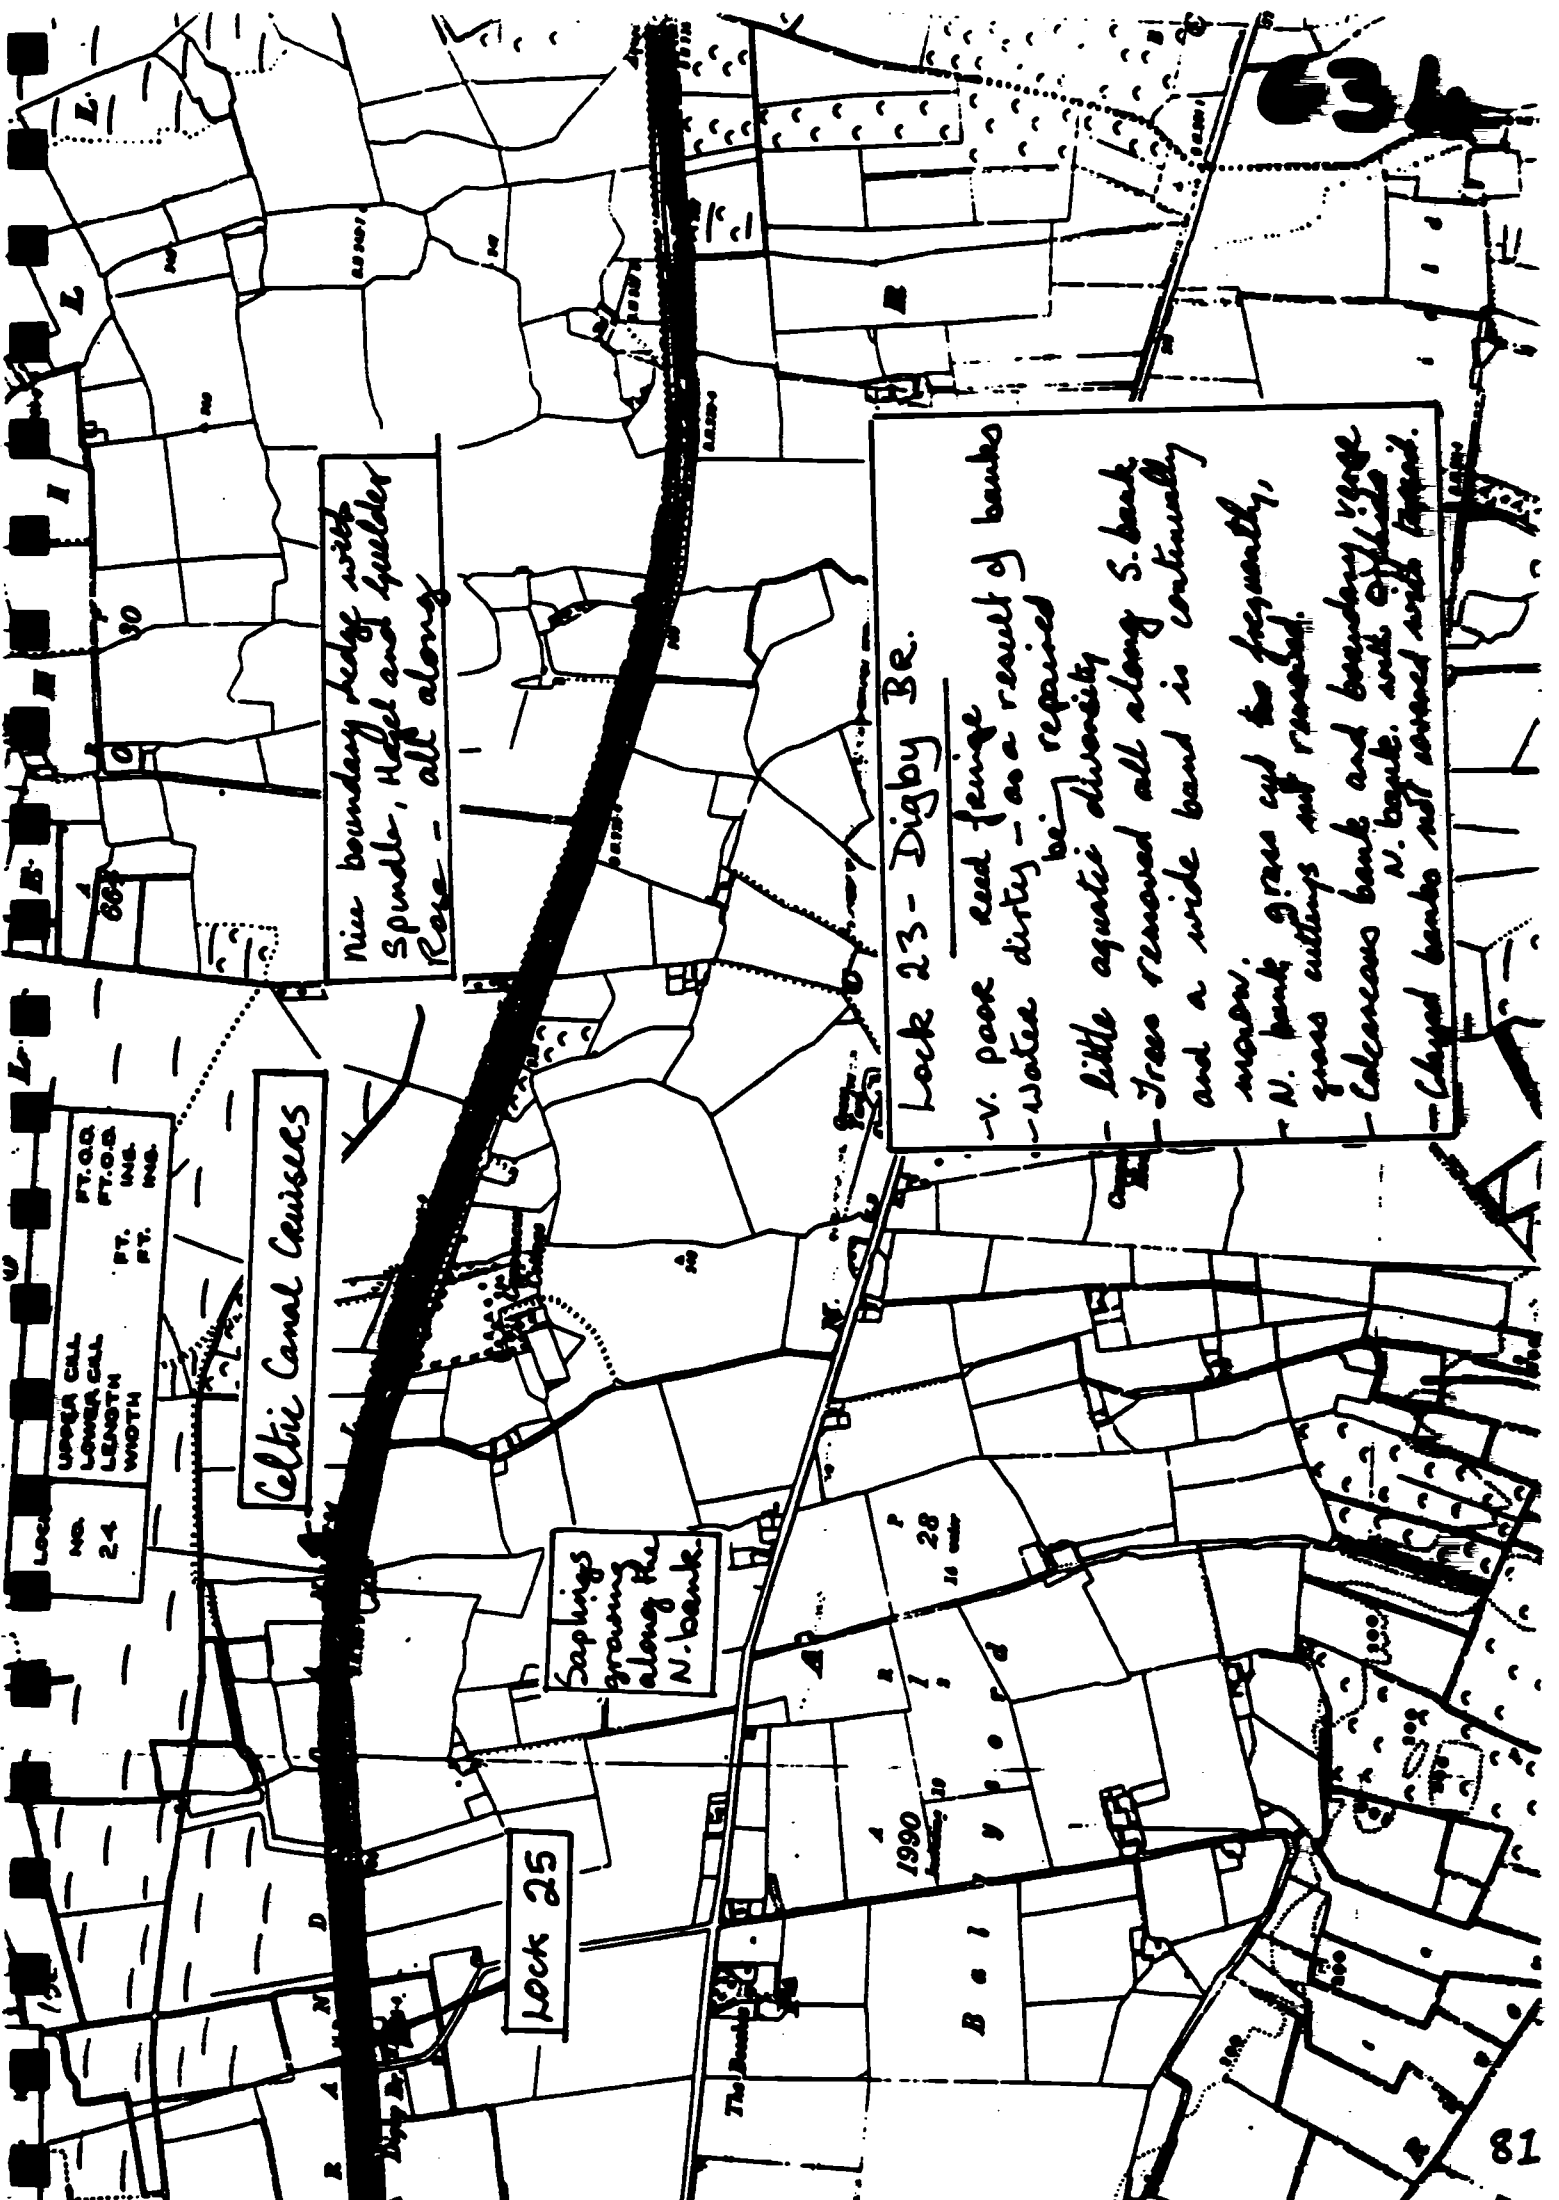
Lock 23 - Digby BR.

- V. poor seed fence
- water dirty - as a result of banks
being repaired
- little aquatic diversity
- Trees removed all along S. bank
and a wide band is continually
mown.
- N. bank grass cut too frequently,
grass cuttings not removed.
- Calcareous bank and boundary hedge
N. bank, with *Opuntia*
- Clayed banks not covered with *Lythrum*.

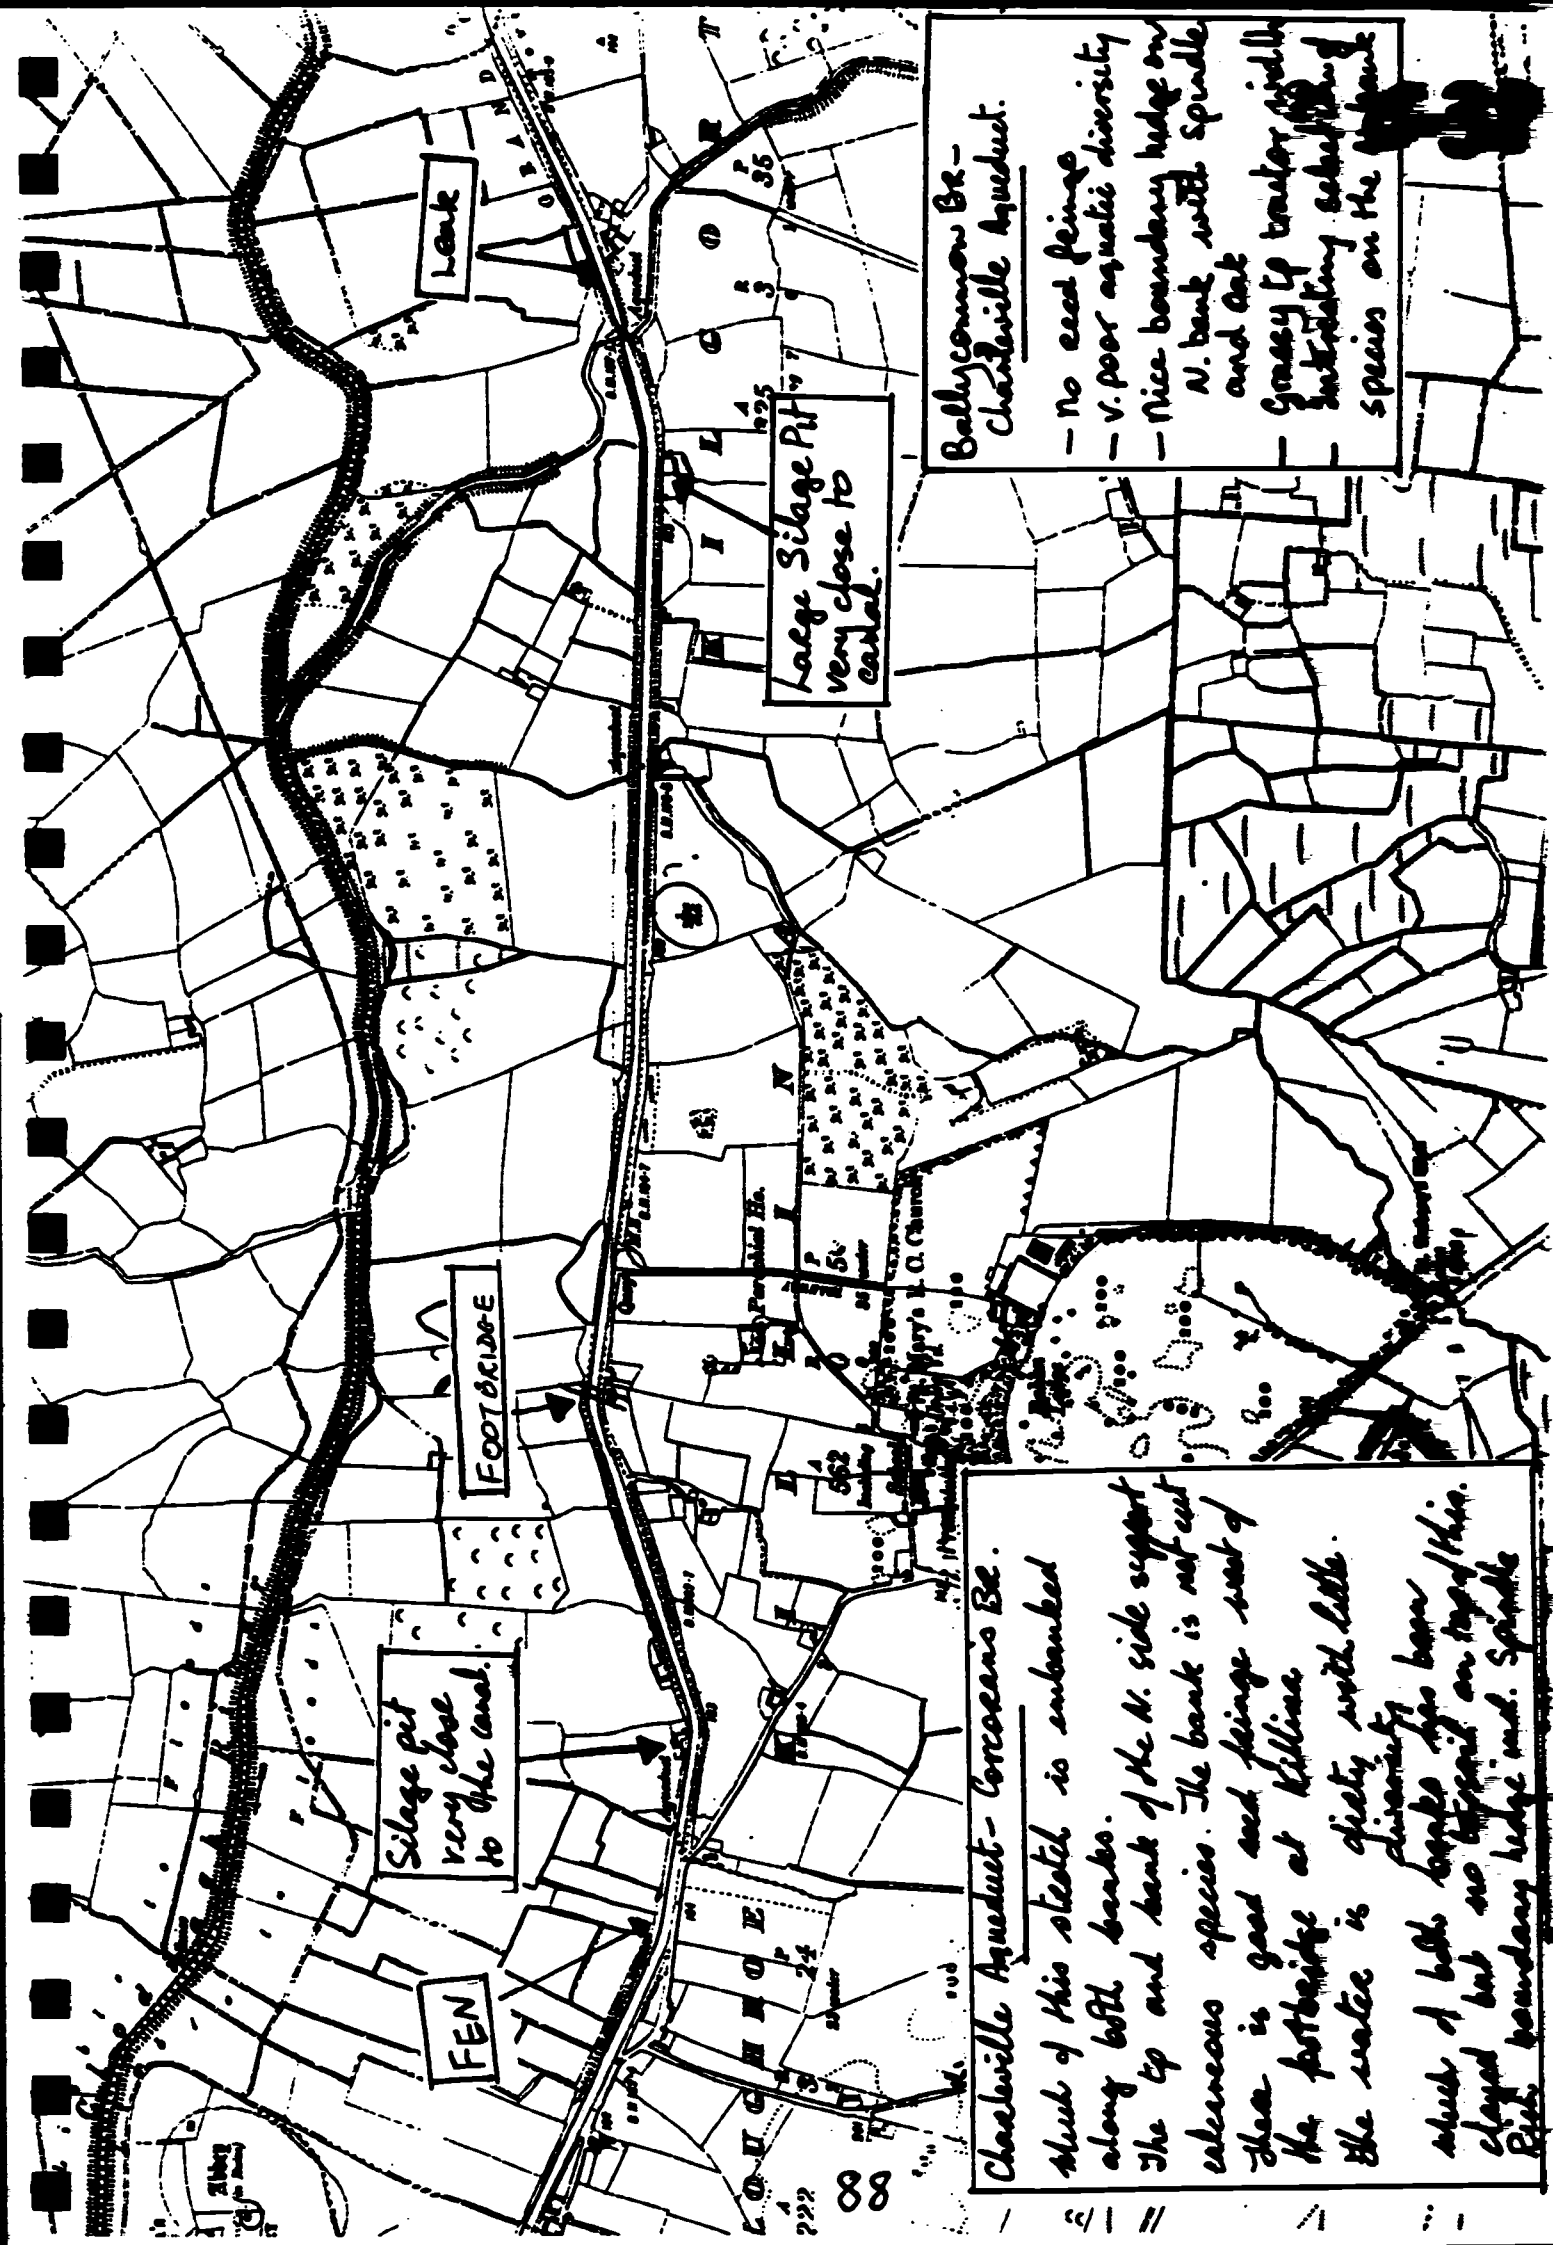
Ballyconnor Be.-
Charleville Aqueduct.

- no east fence
- v. poor aquatic diversity
- nice boundary hedge on N. bank with spindle and oak
- grassy top trailer with interesting scrubby species on the bank

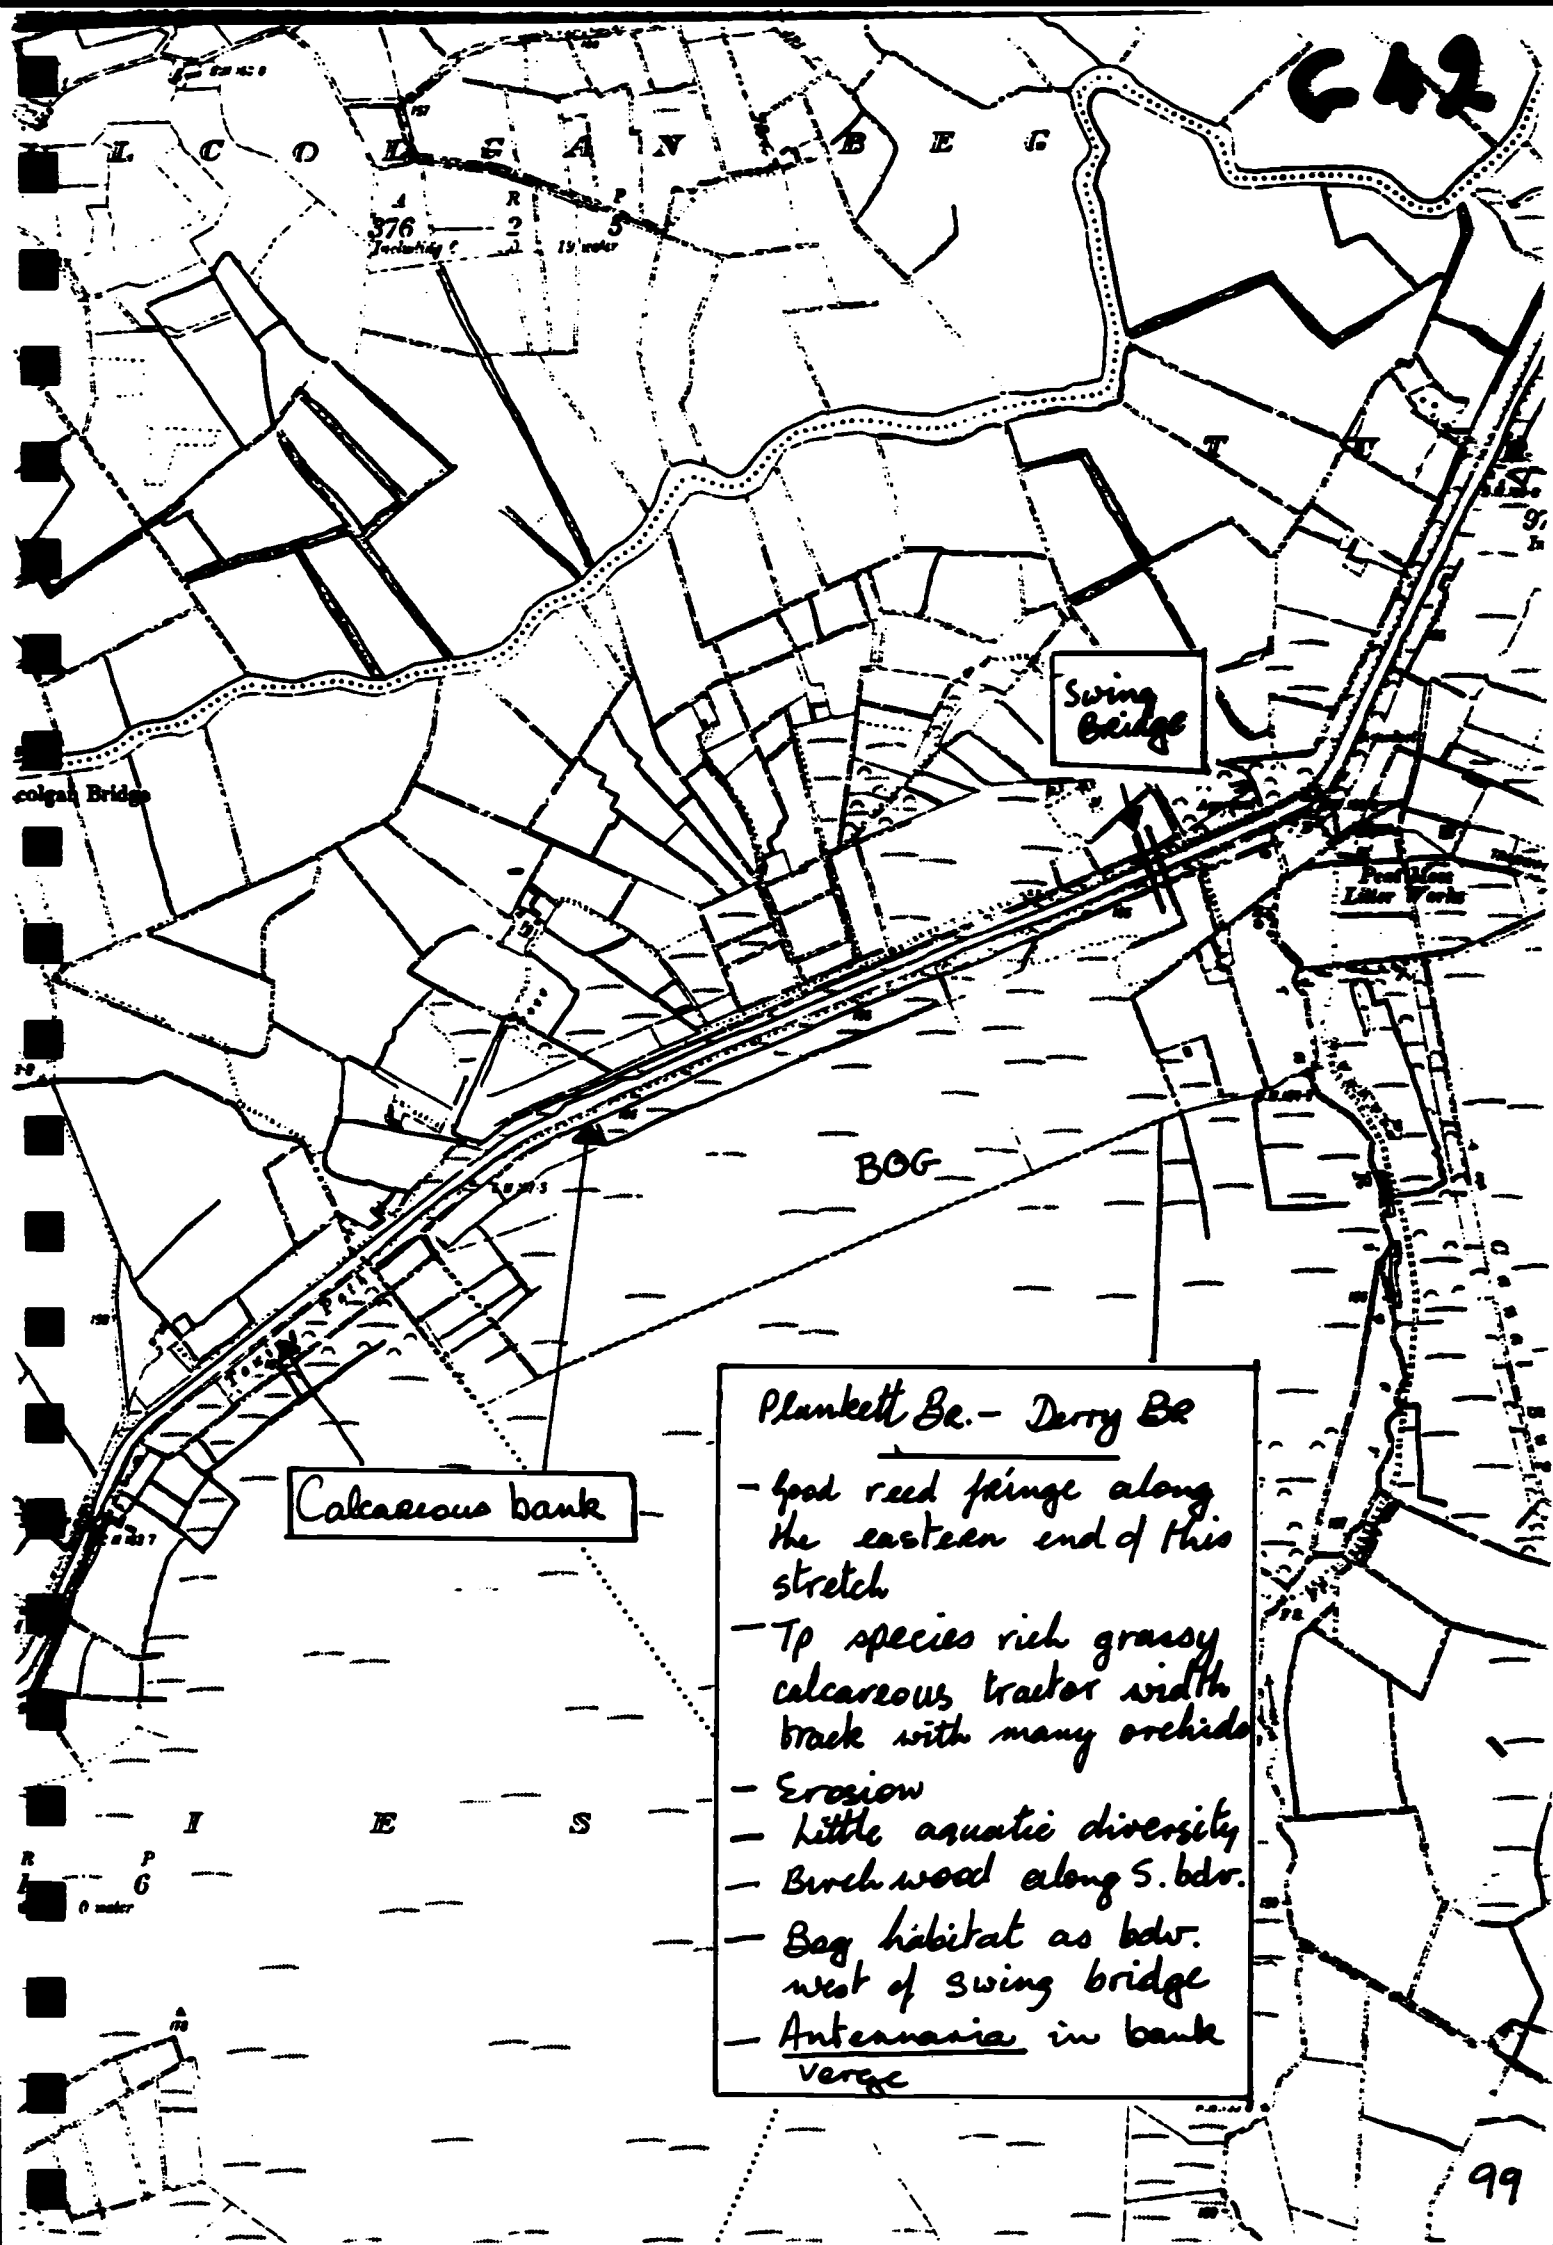
Plankett Be. - Derry Be

- Good reed fringe along the eastern end of this stretch
- Tp species rich grassy calcareous tractor with track with many orchids
- Erosion
- Little aquatic diversity
- Birch wood along S. bdr.
- Bog habitat as bdr. west of Swing bridge
- Antennaria in bank verge

- There is a towpath being cleared along the north bank. Ensure that it is only wide enough for machinery but not over wide. Leave some saplings on the bank. Once the towpath has been made and if grass is to grow on it cut it once a year at the end of the growing season and remove cuttings. A narrower path can be cut more frequently for pedestrian access.
- Do not remove all trees and scrub wholesale from the north bank.
- Protect the bank verge.
- Protect the reed fringe.
- Eliminate the use of Roundup.
- Continue to use Cutting Trials on the aquatic vegetation.
- Cover the repaired banks with peat.
