ECOLOGICAL SURVEY

GRAND CANAL

Part 2 Conservation Management Plan 1991

**Prepared for
The Wildlife Service and Waterways Section,
Office of Public Works. 1992.**

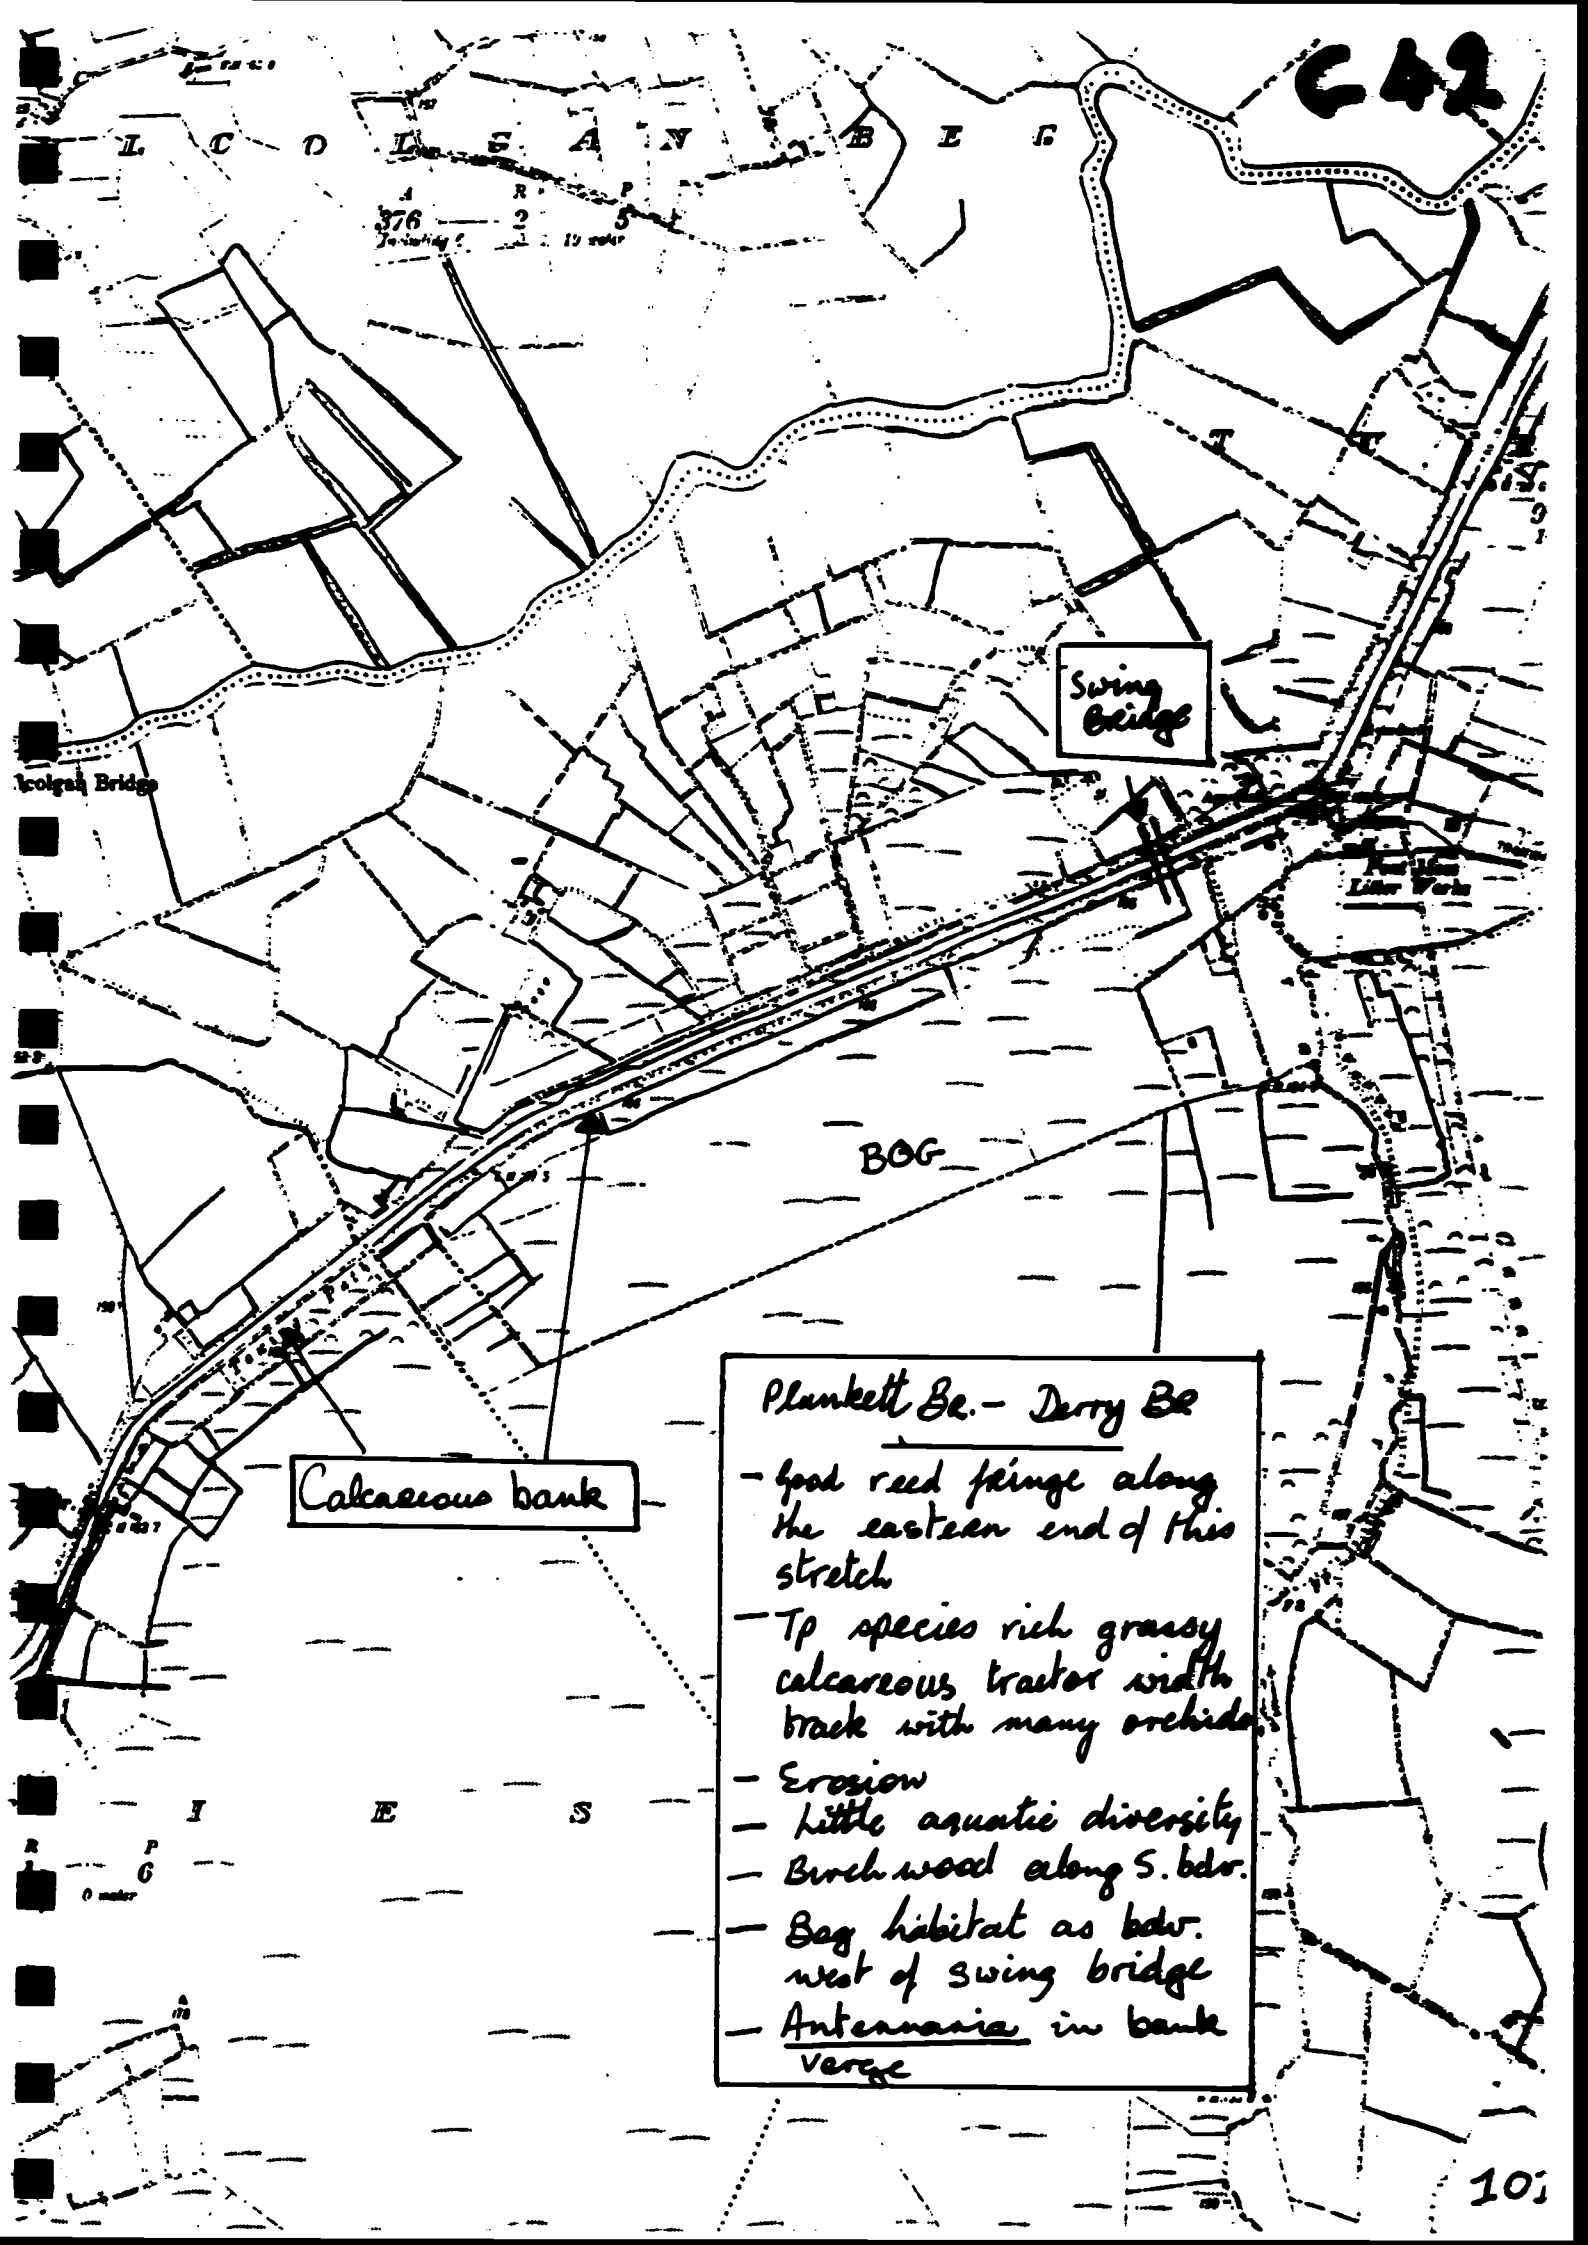
Plunkett Be. - Derry Be

- good reed fringe along the eastern end of this stretch
- Tp species rich grassy calcareous tractor with track with many orchids
- Erosion
- little aquatic diversity
- Birch wood along S. bdr.
- Bog habitat as bdr. west of swing bridge
- Antennaria in bank verge

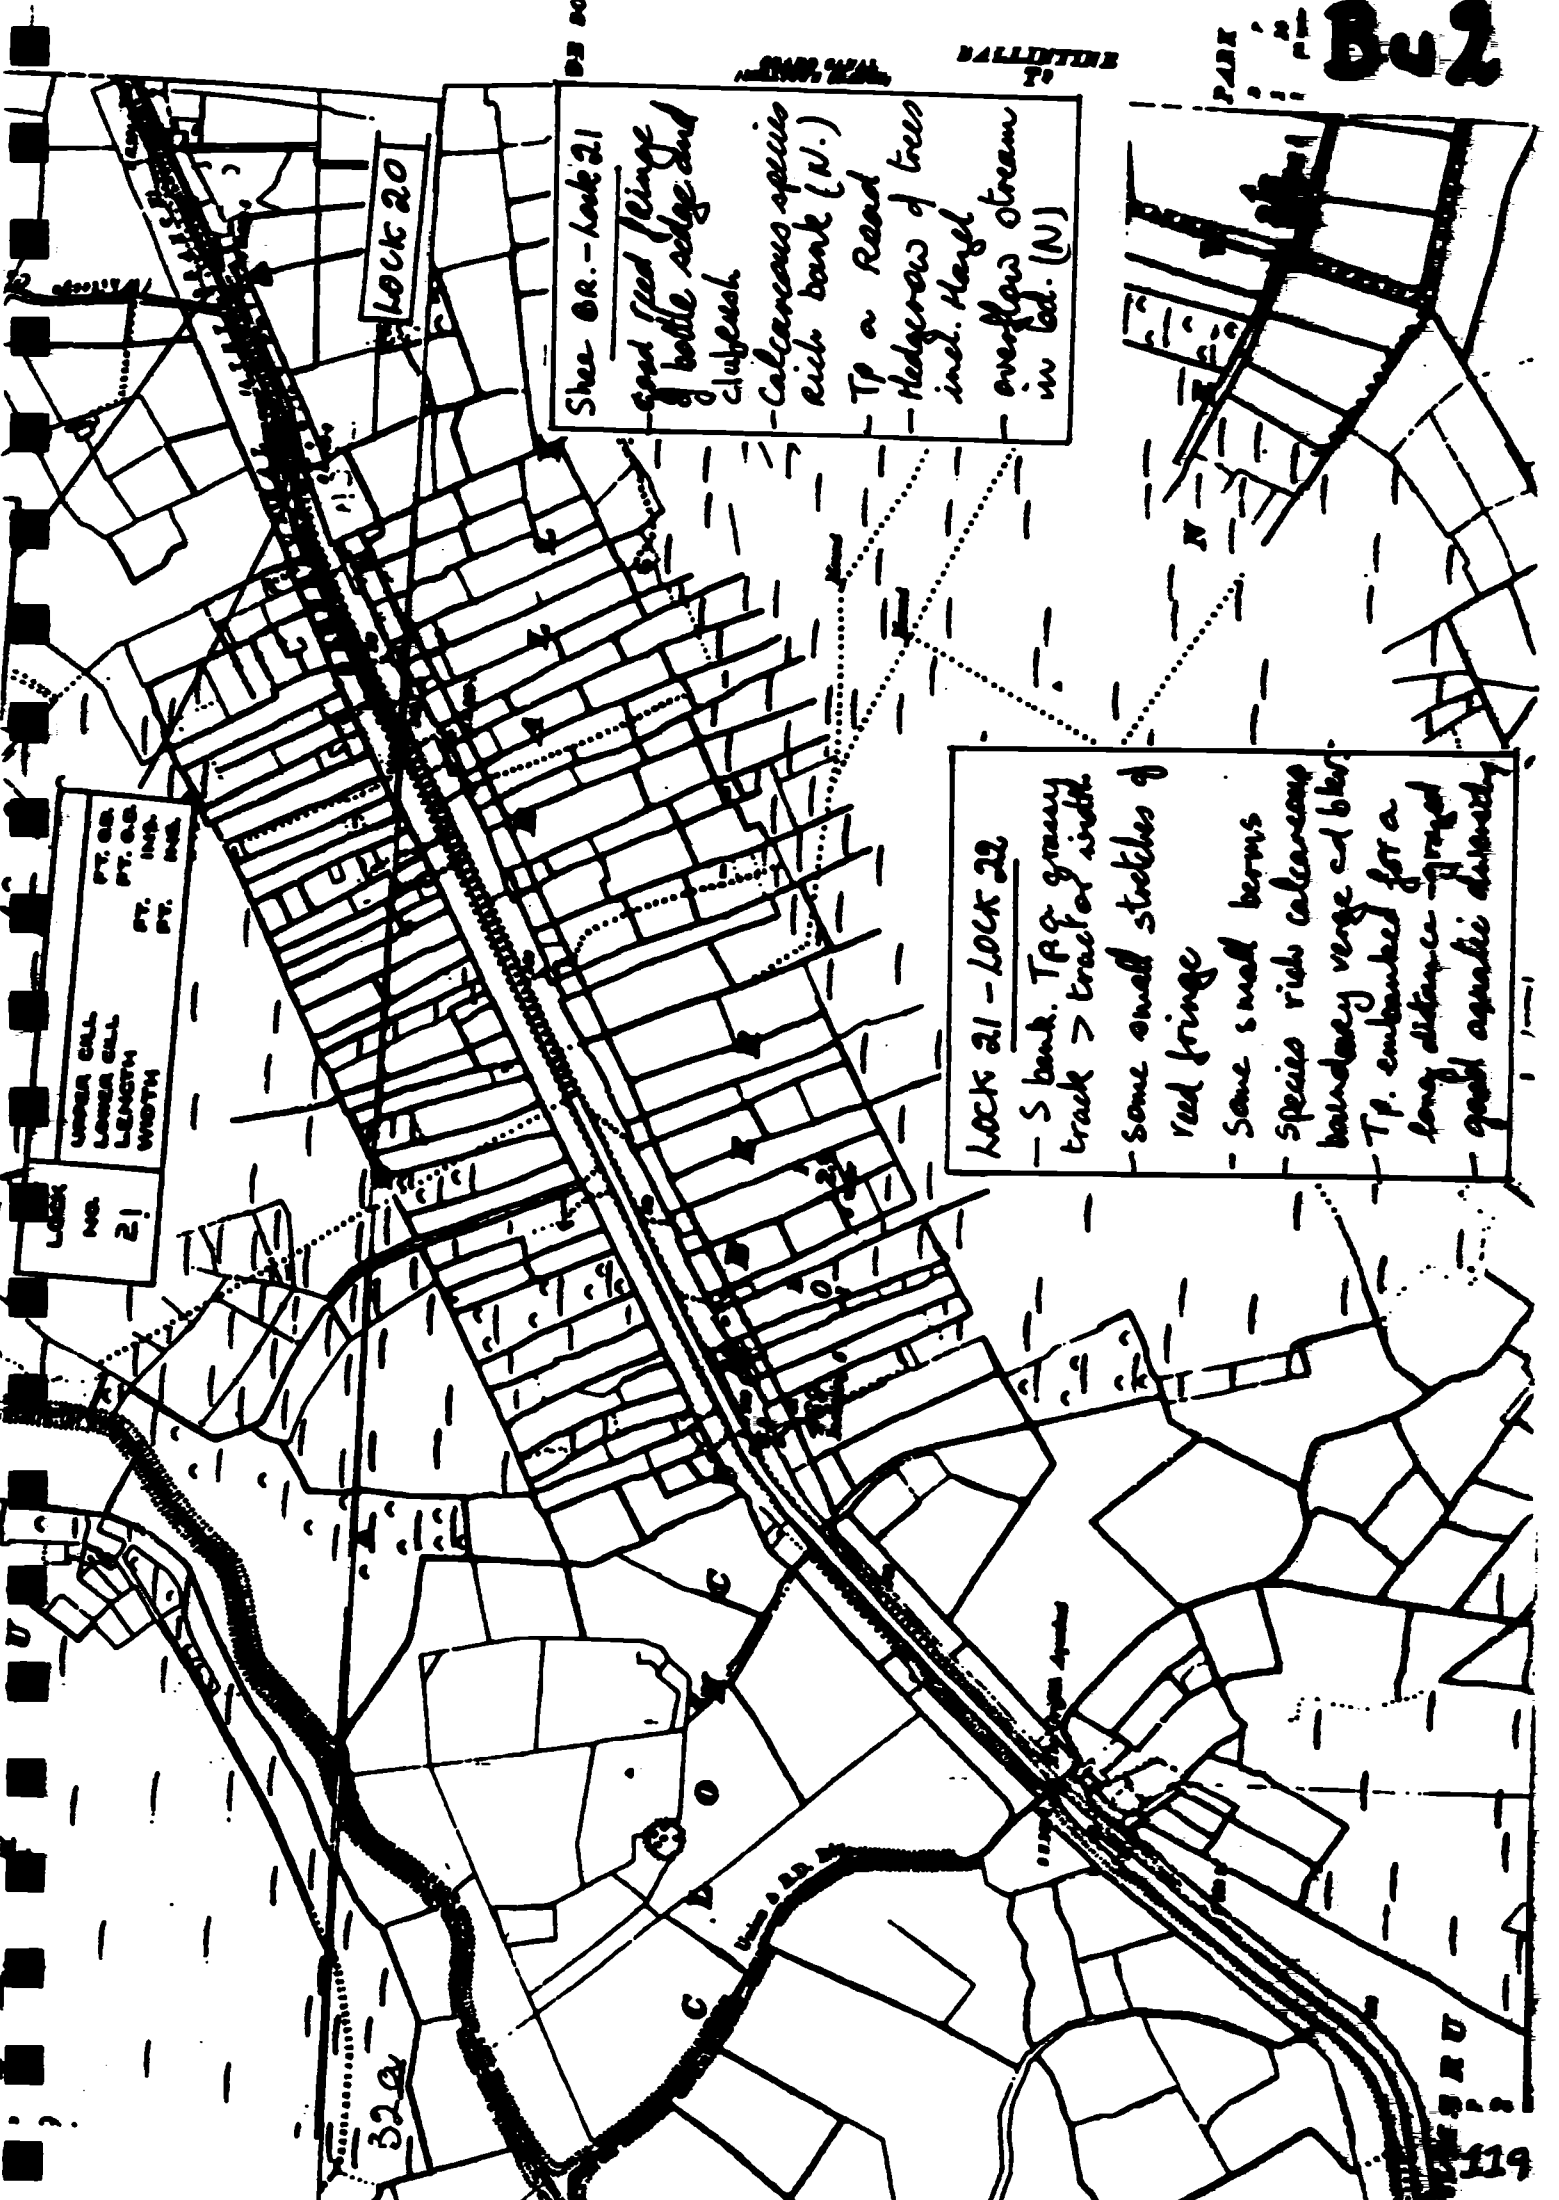
Shea BR. - Lock 21

- good feed fringe of bottle sedge and clough
- Calcareous species rich bank (N.)
- TP a Road
- Hedgerow of trees incl. Hazel
- overflow stream in bed. (N)

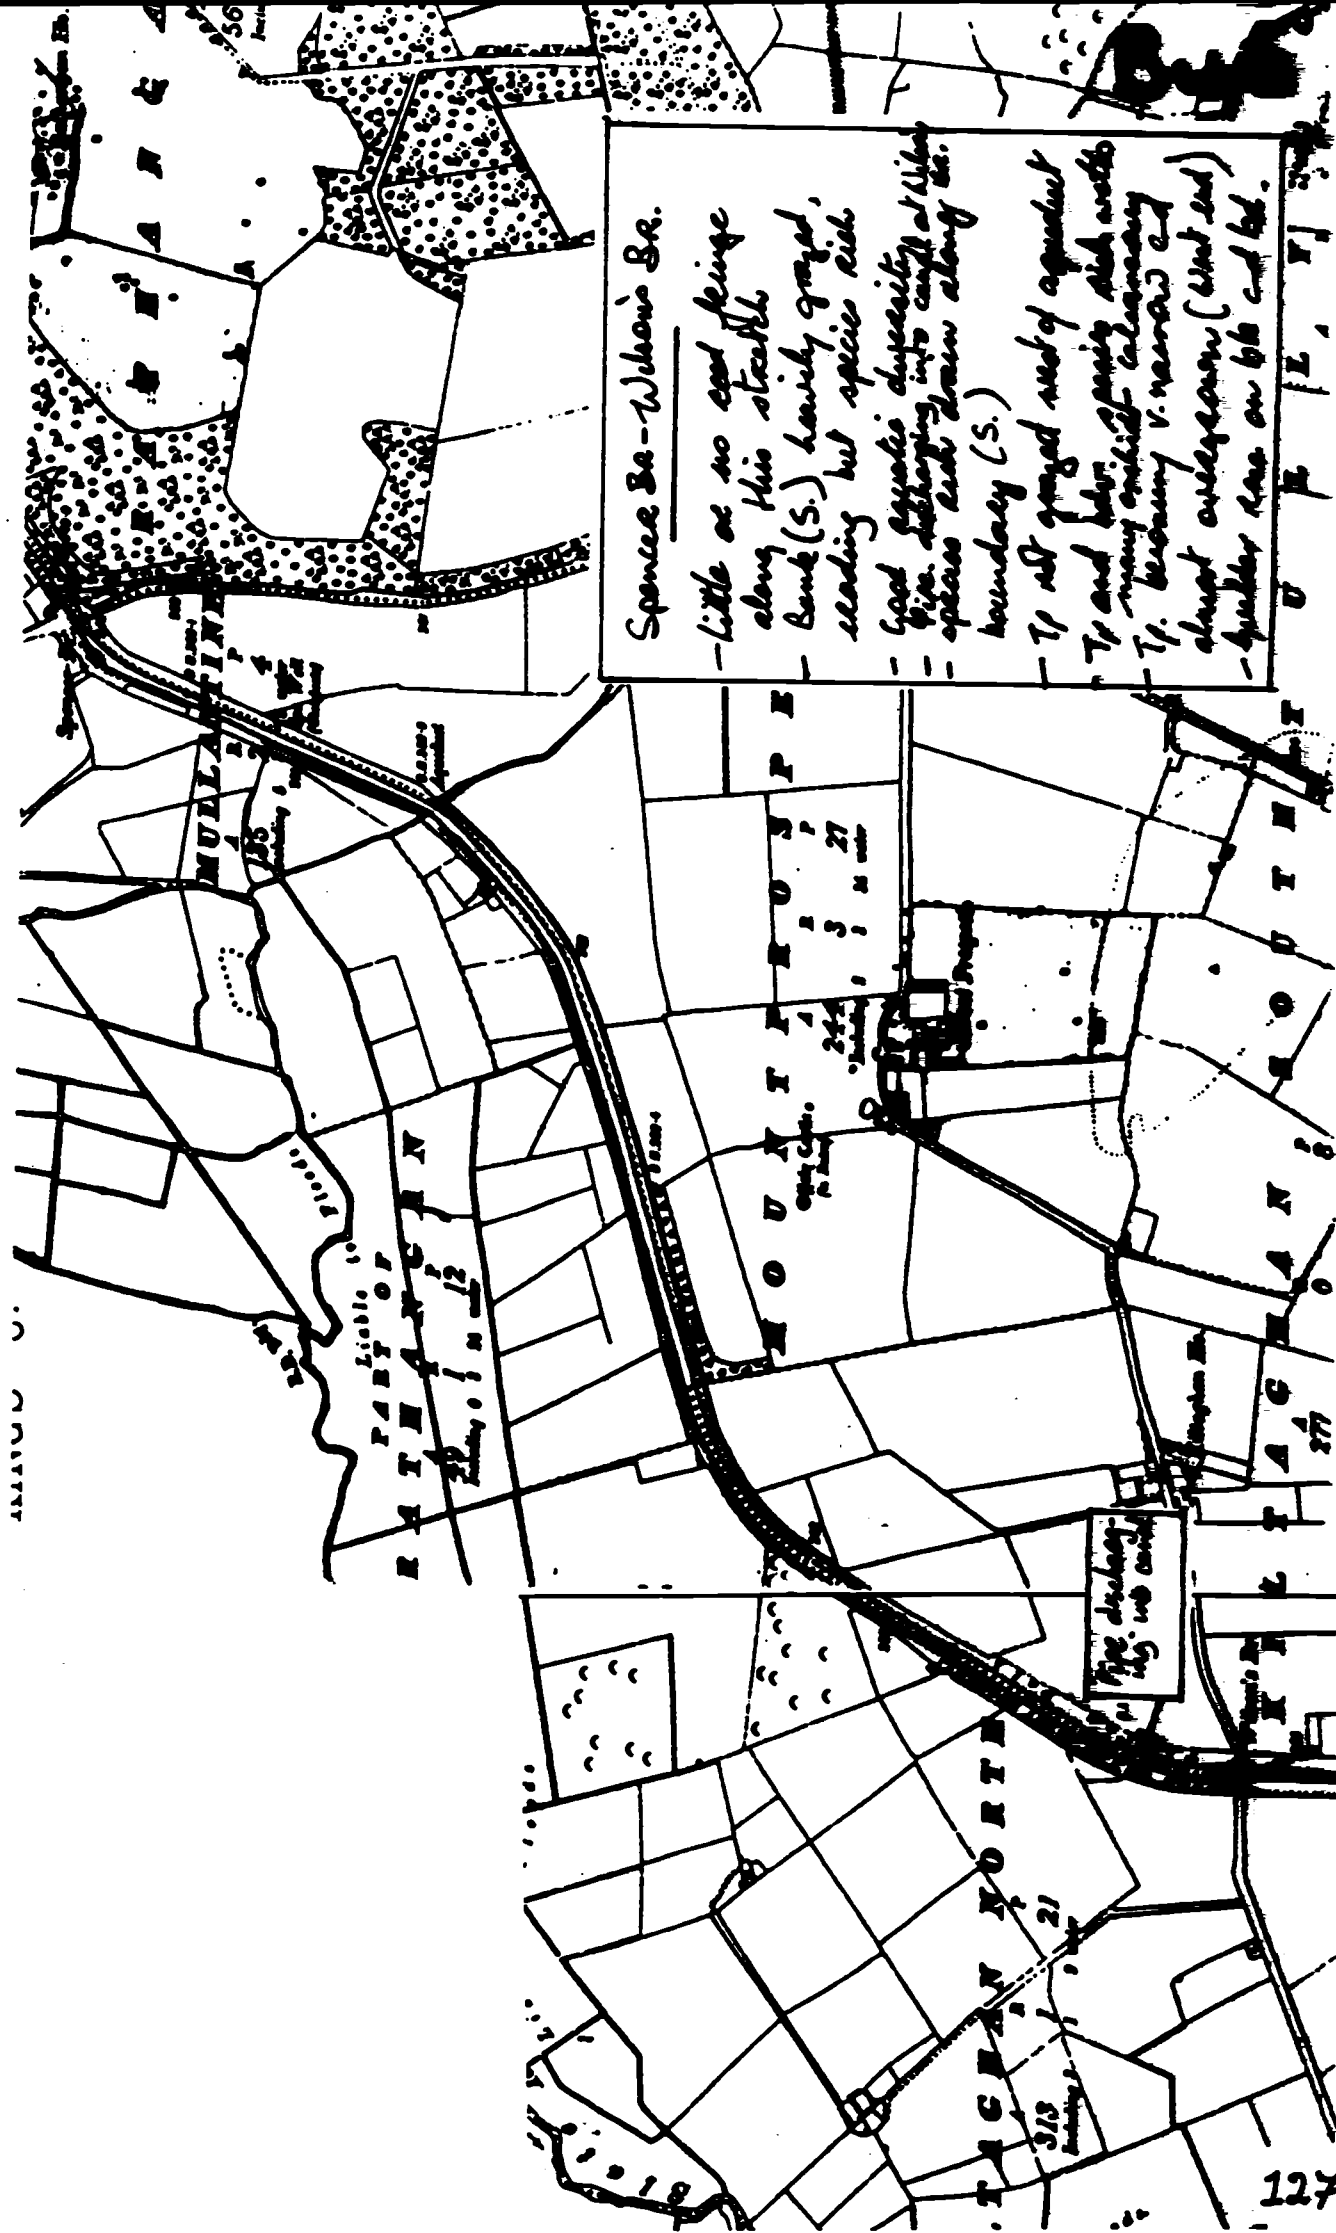
Spence Br - Wilson Br.

- little or no soil fringe along this stretch
- Bank (S.) heavily grazed, seeping but species rich
- Good species diversity
- Tip. sloping into canal at Wilson
- species bank drawn along the boundary (S.)
- Tip at grazed end of aqueduct
- Tip and below, species rich with many small calcareous
- Tip. becoming v. narrow and almost overgrown (west end)
- further down on both end but.

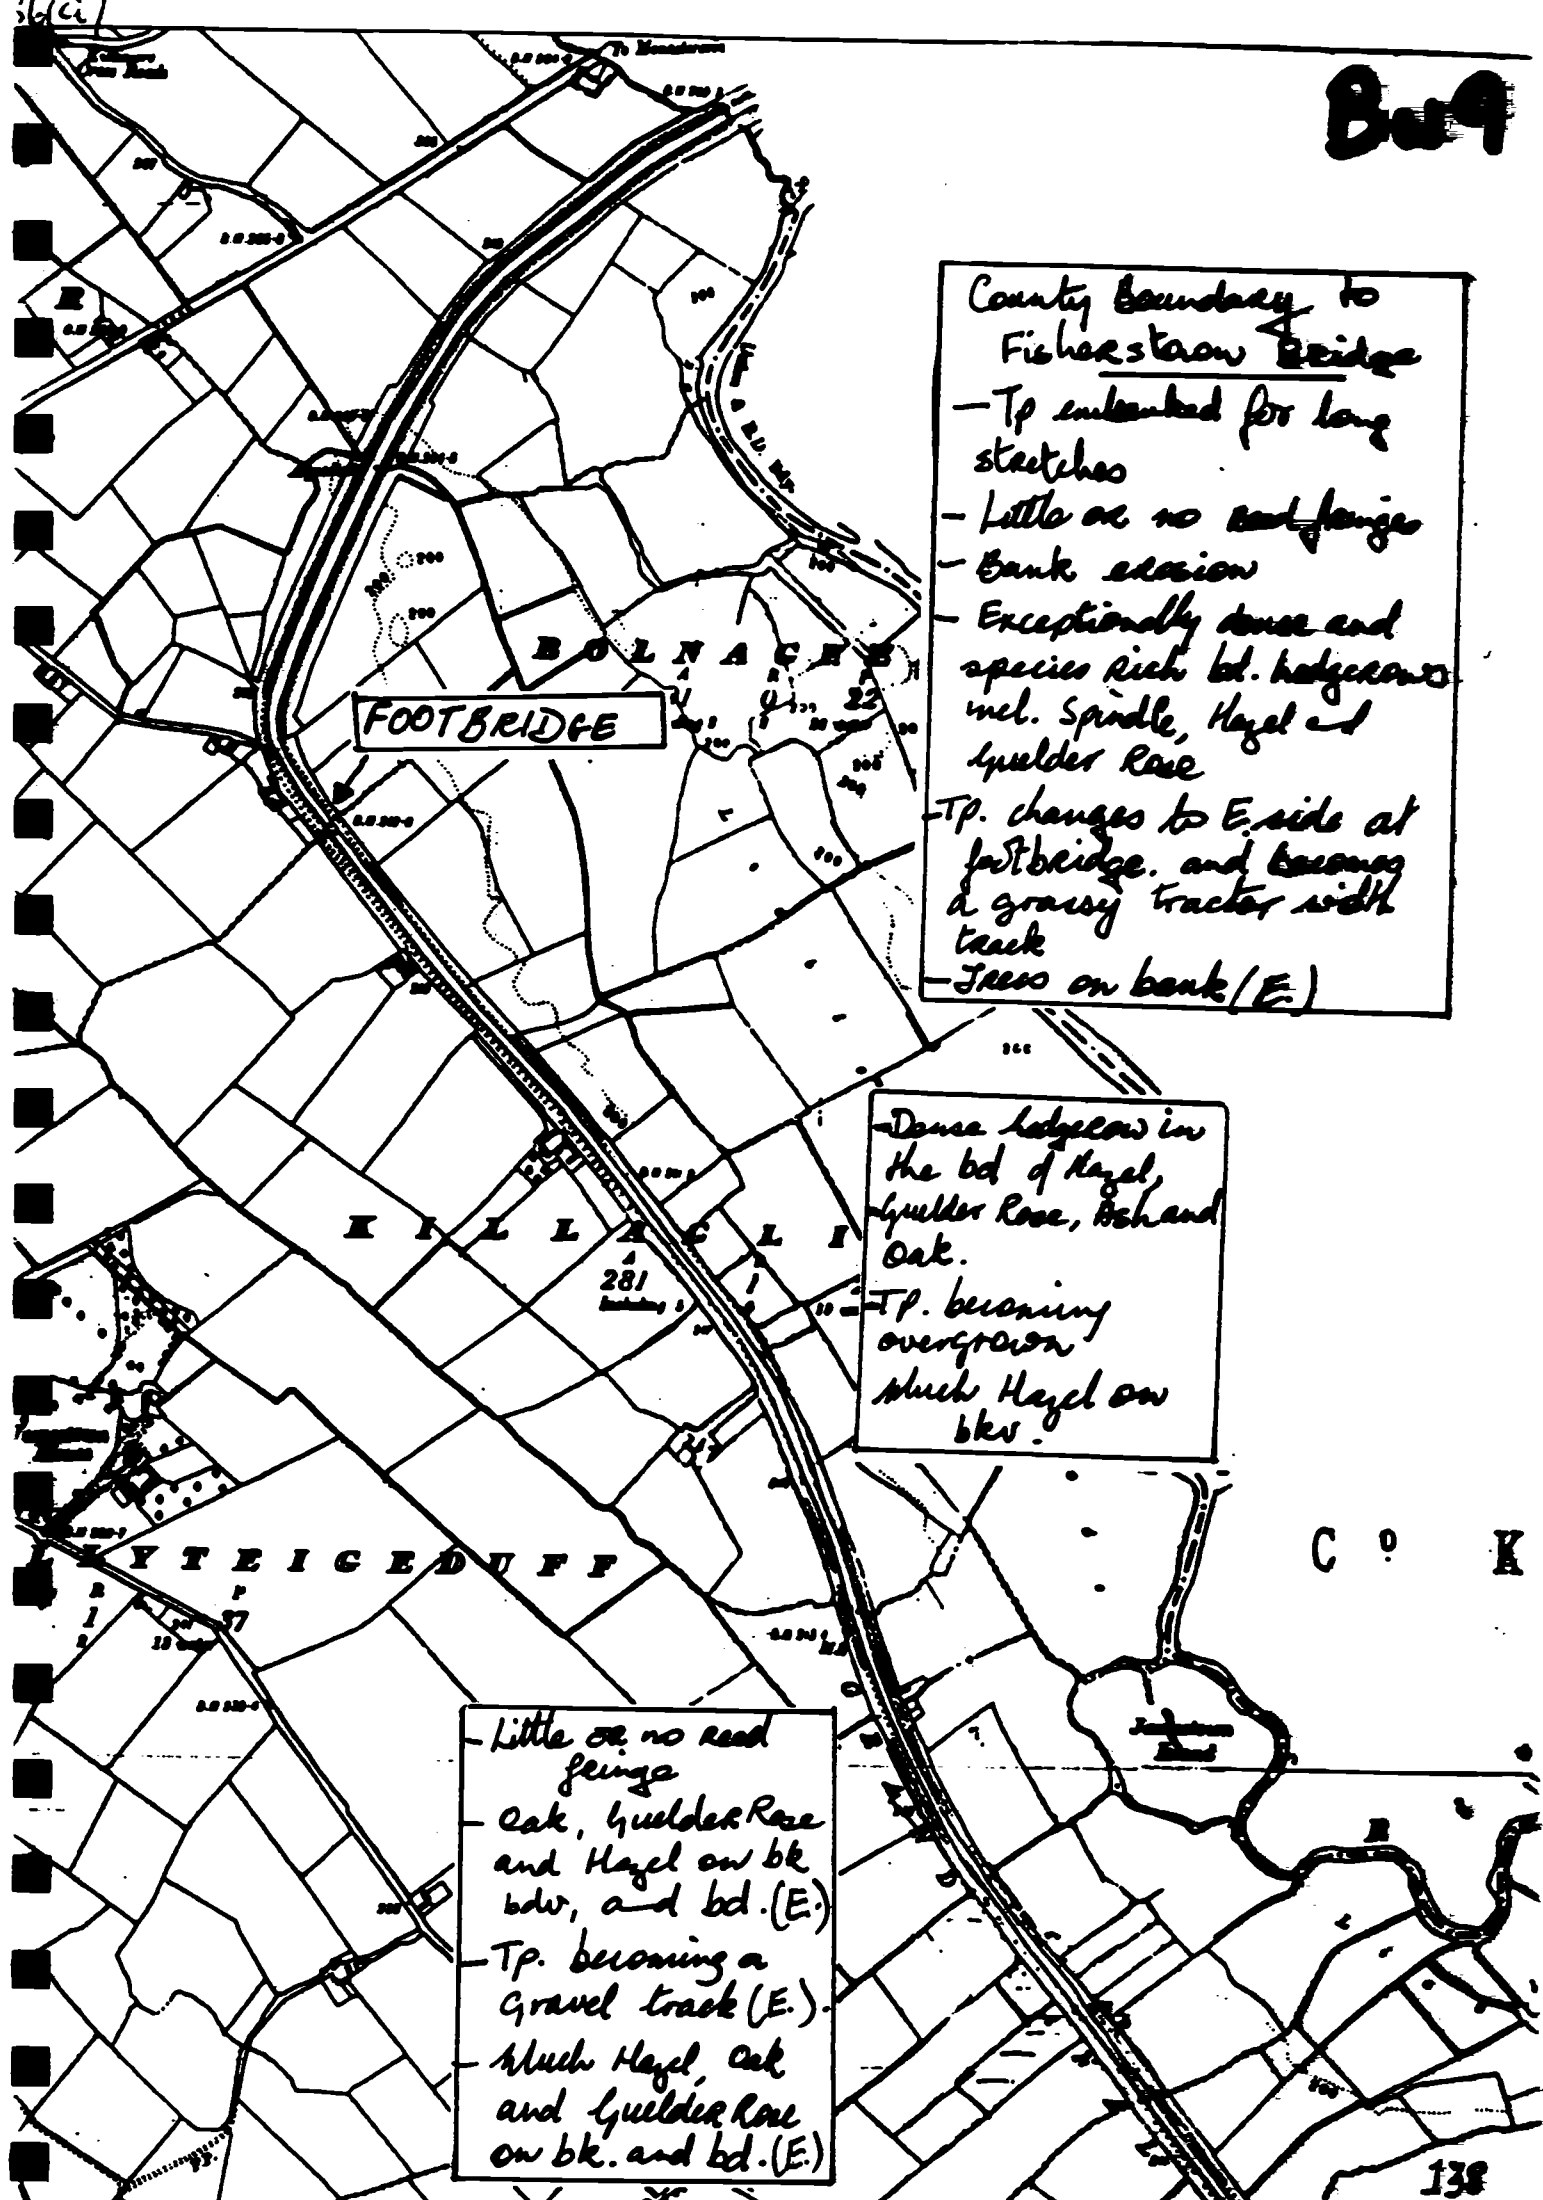
County Boundary to Fisherstown Bridge

- Tp. embanked for long stretches
- Little or no road fringe
- Bank erosion
- Exceptionally dense and species rich bd. hedgerows incl. Spindle, Hazel and Guelder Rose
- Tp. changes to E. side at footbridge. and becomes a grassy tractor with track
- Trees on bank (E.)

- Protect the dense scrub of the westbank in future canal operations.
- Protect the species rich east boundary hedgerow in future canal operations.
- Cut back some of the encroaching tree/shrub species of the east towpath. Spot-treat cut stumps and allow the towpath to develop as a meadow. Cut at the end of the growing season and remove cuttings.
- Continue to leave the channel free from herbicide treatment.
- Remove some saplings from the east-bank on a three year rotation.
- Cut trees and overhanging branches at the bank edges and spot-treat the stumps.

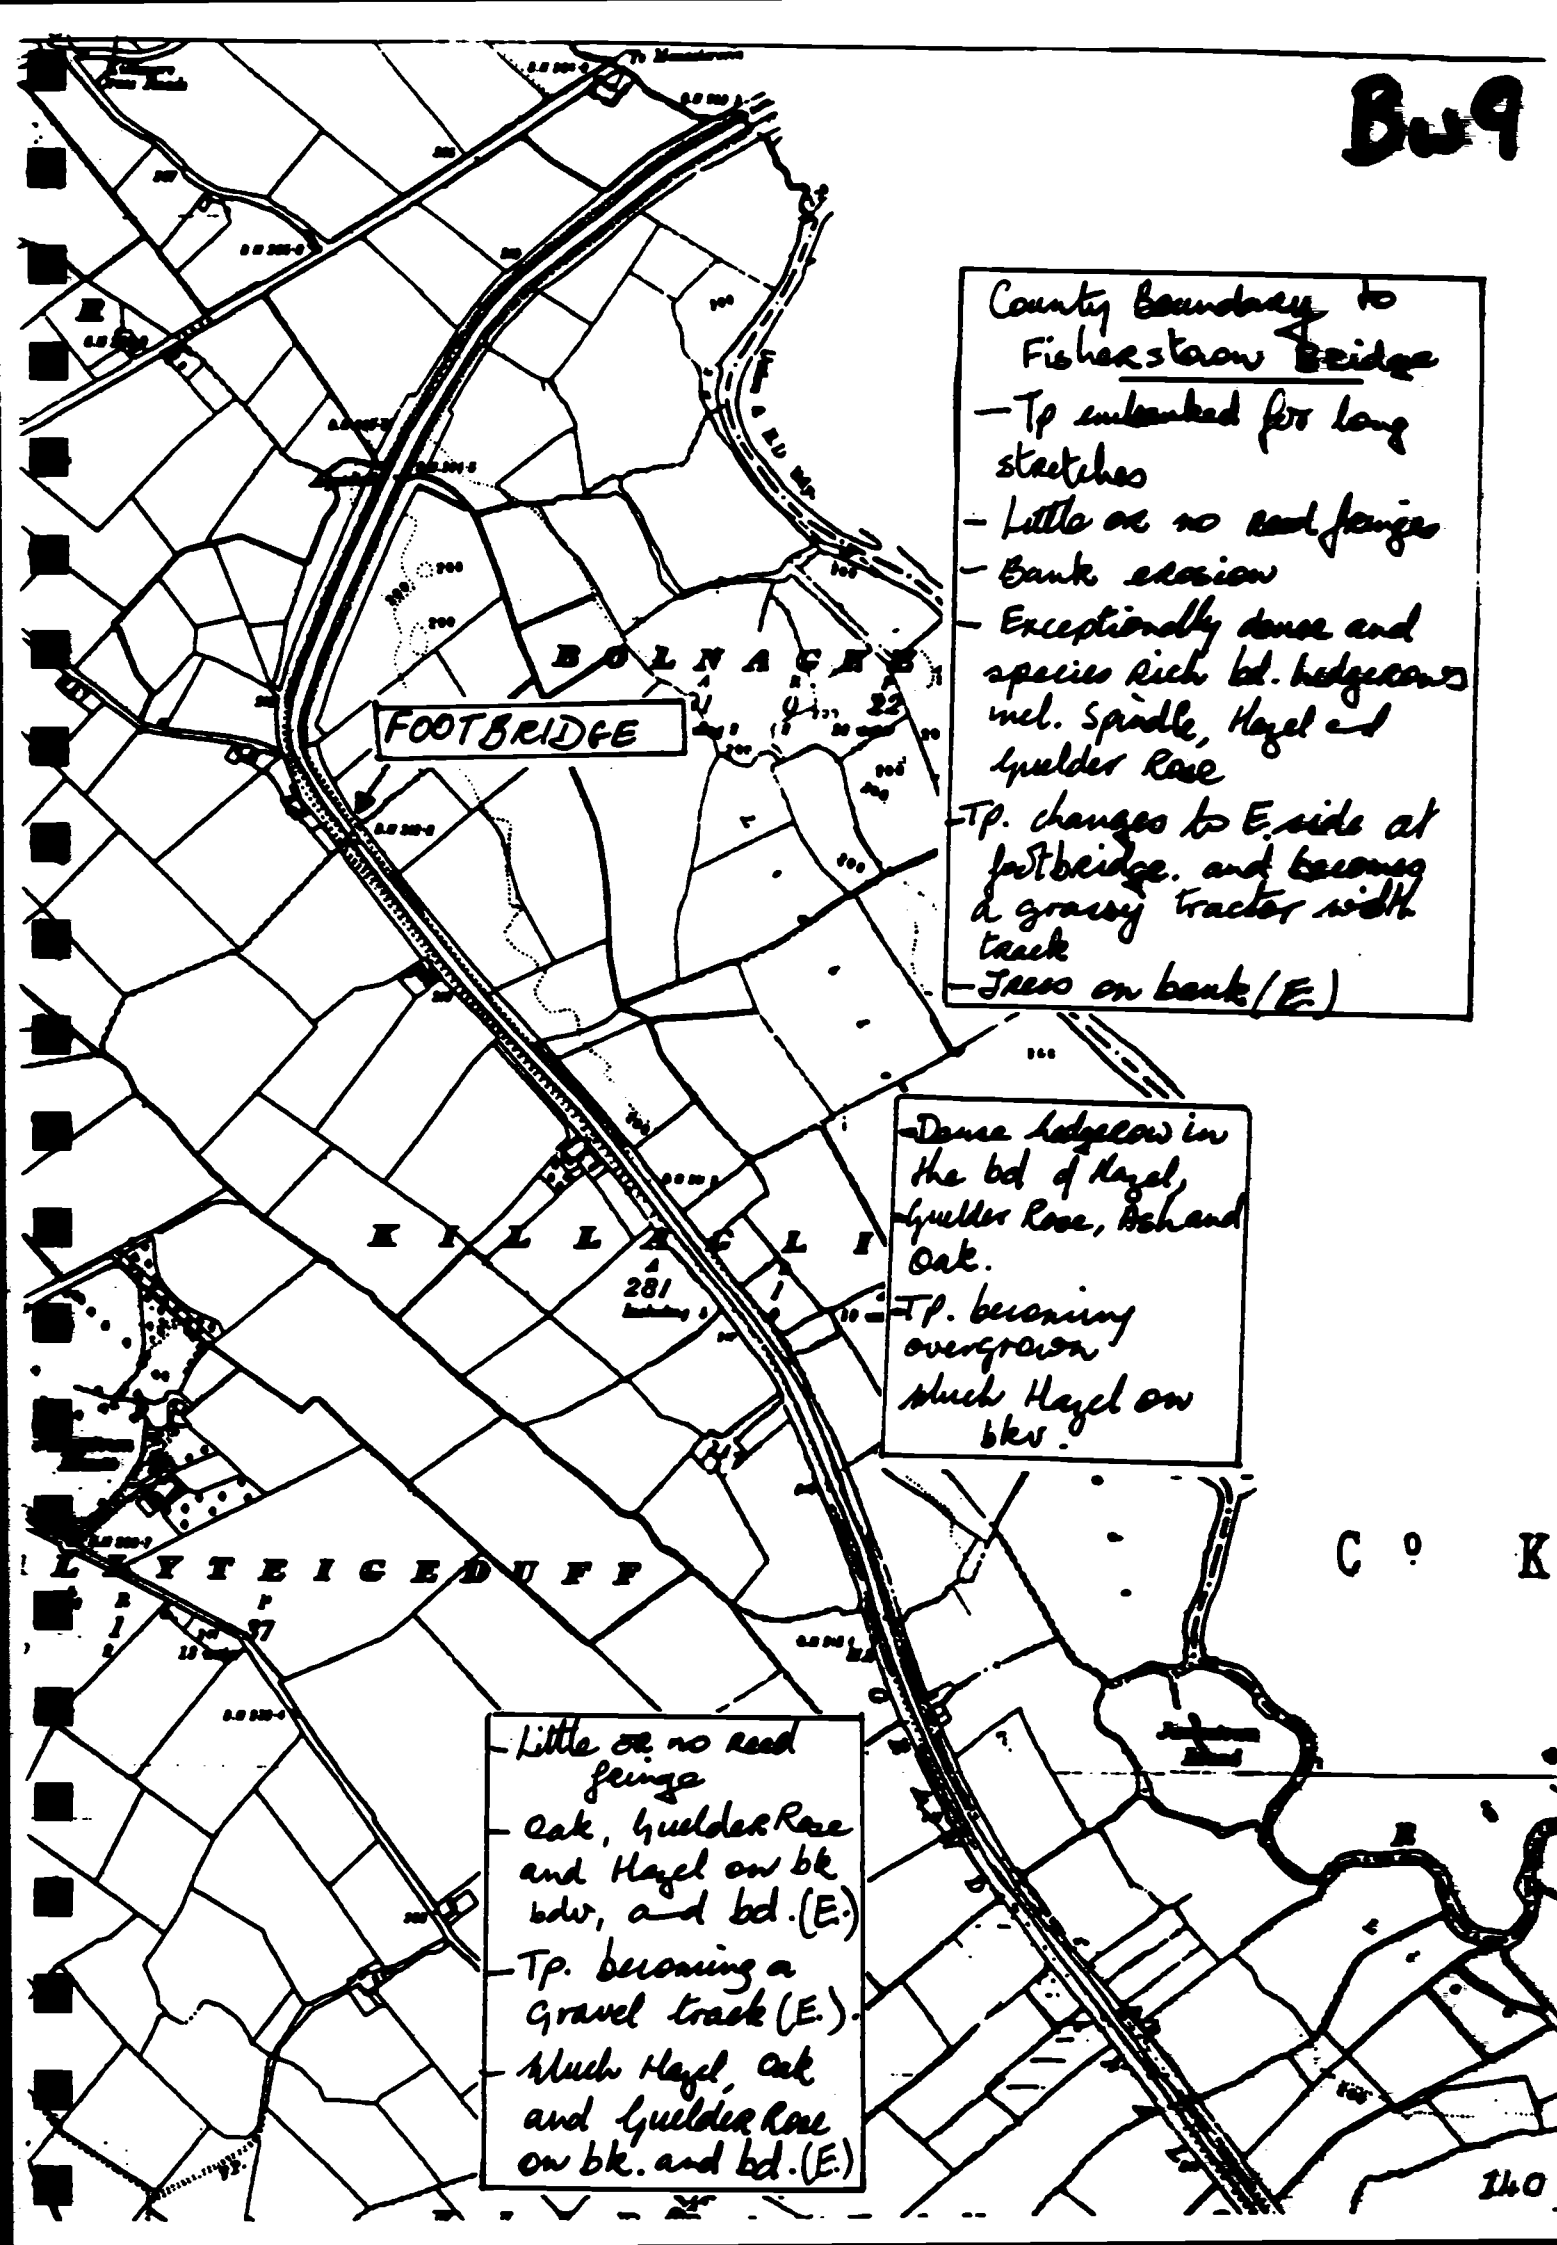
County Boundary to
Fisherstown Bridge

- Tp. embanked for long stretches
- Little or no road fringe
- Bank erosion
- Exceptionally dense and species rich bd. hedgerows incl. Spindle, Hazel and Guelder Rose
- Tp. changes to E. side at footbridge. and becomes a grassy tractor width track
- Trees on bank (E.)

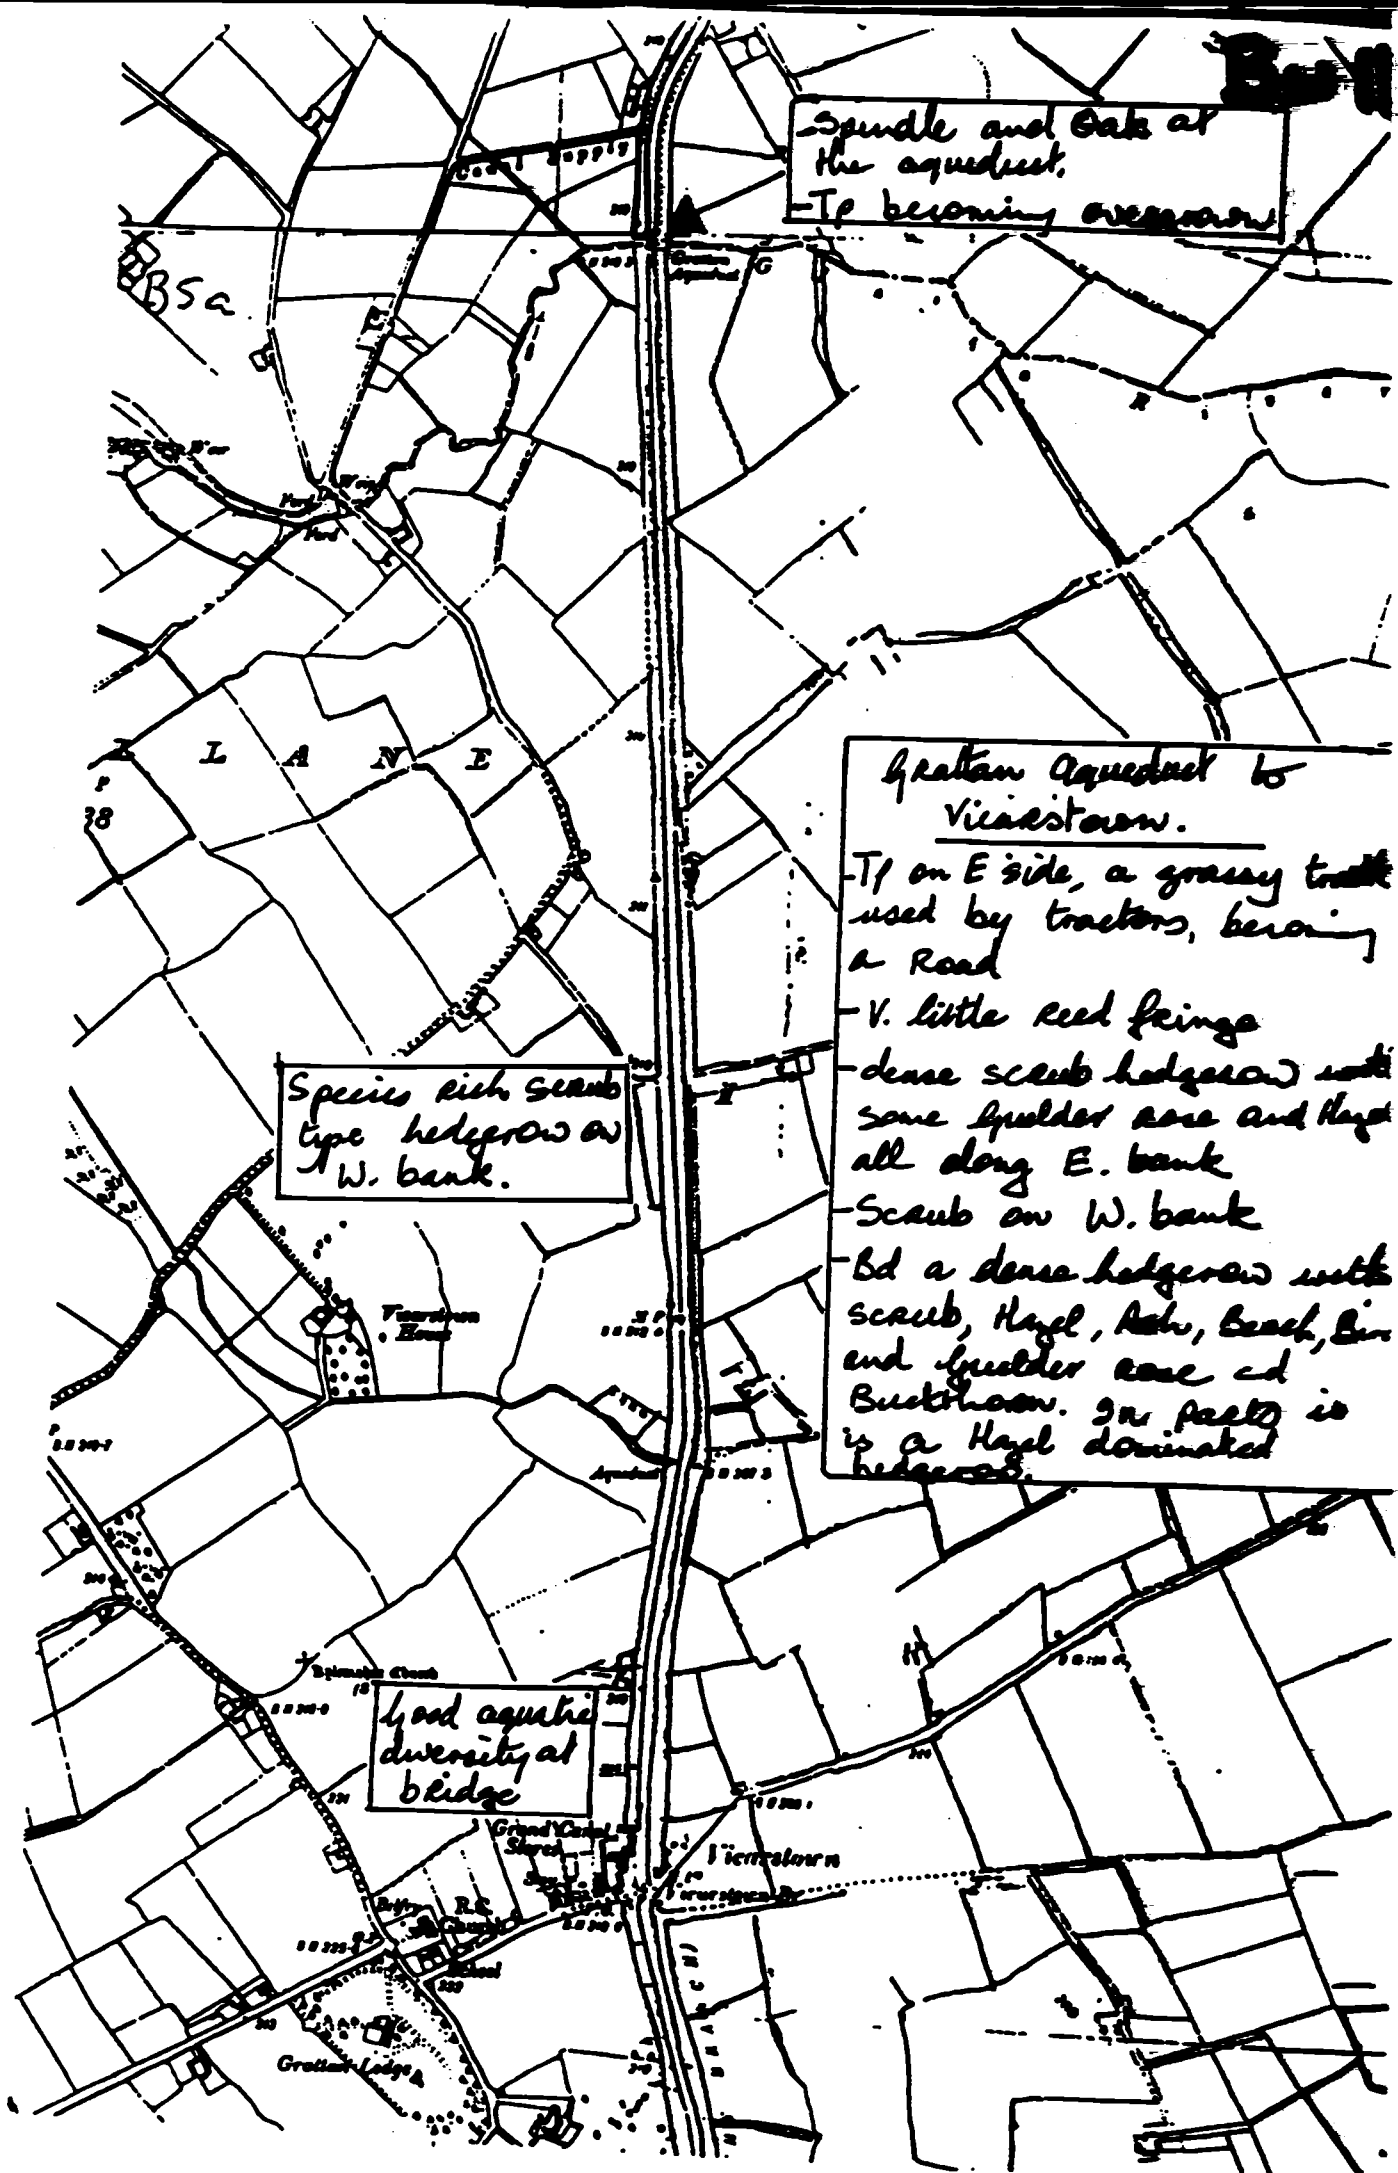
Spindle and Oak at the aqueduct.
- To becoming overgrown

Species rich scrub type hedgerow on W. bank.

- Allow scrub to develop along the west bank in the area between the 8 foot strip and the boundary. This area will not need cutting from 1993 onwards until such time as the trees and bushes begin to encroach on to the meadow strip.

- Allow scrub re-establish itself in the trench along the road at east of the canal (Plate 59).
- Monitor the revegetation of the soil mounds at the Camac Aqueduct.
