ECOLOGICAL SURVEY

GRAND CANAL

Part 2 Conservation Management Plan 1991

**Prepared for
The Wildlife Service and Waterways Section,
Office of Public Works. 1992.**

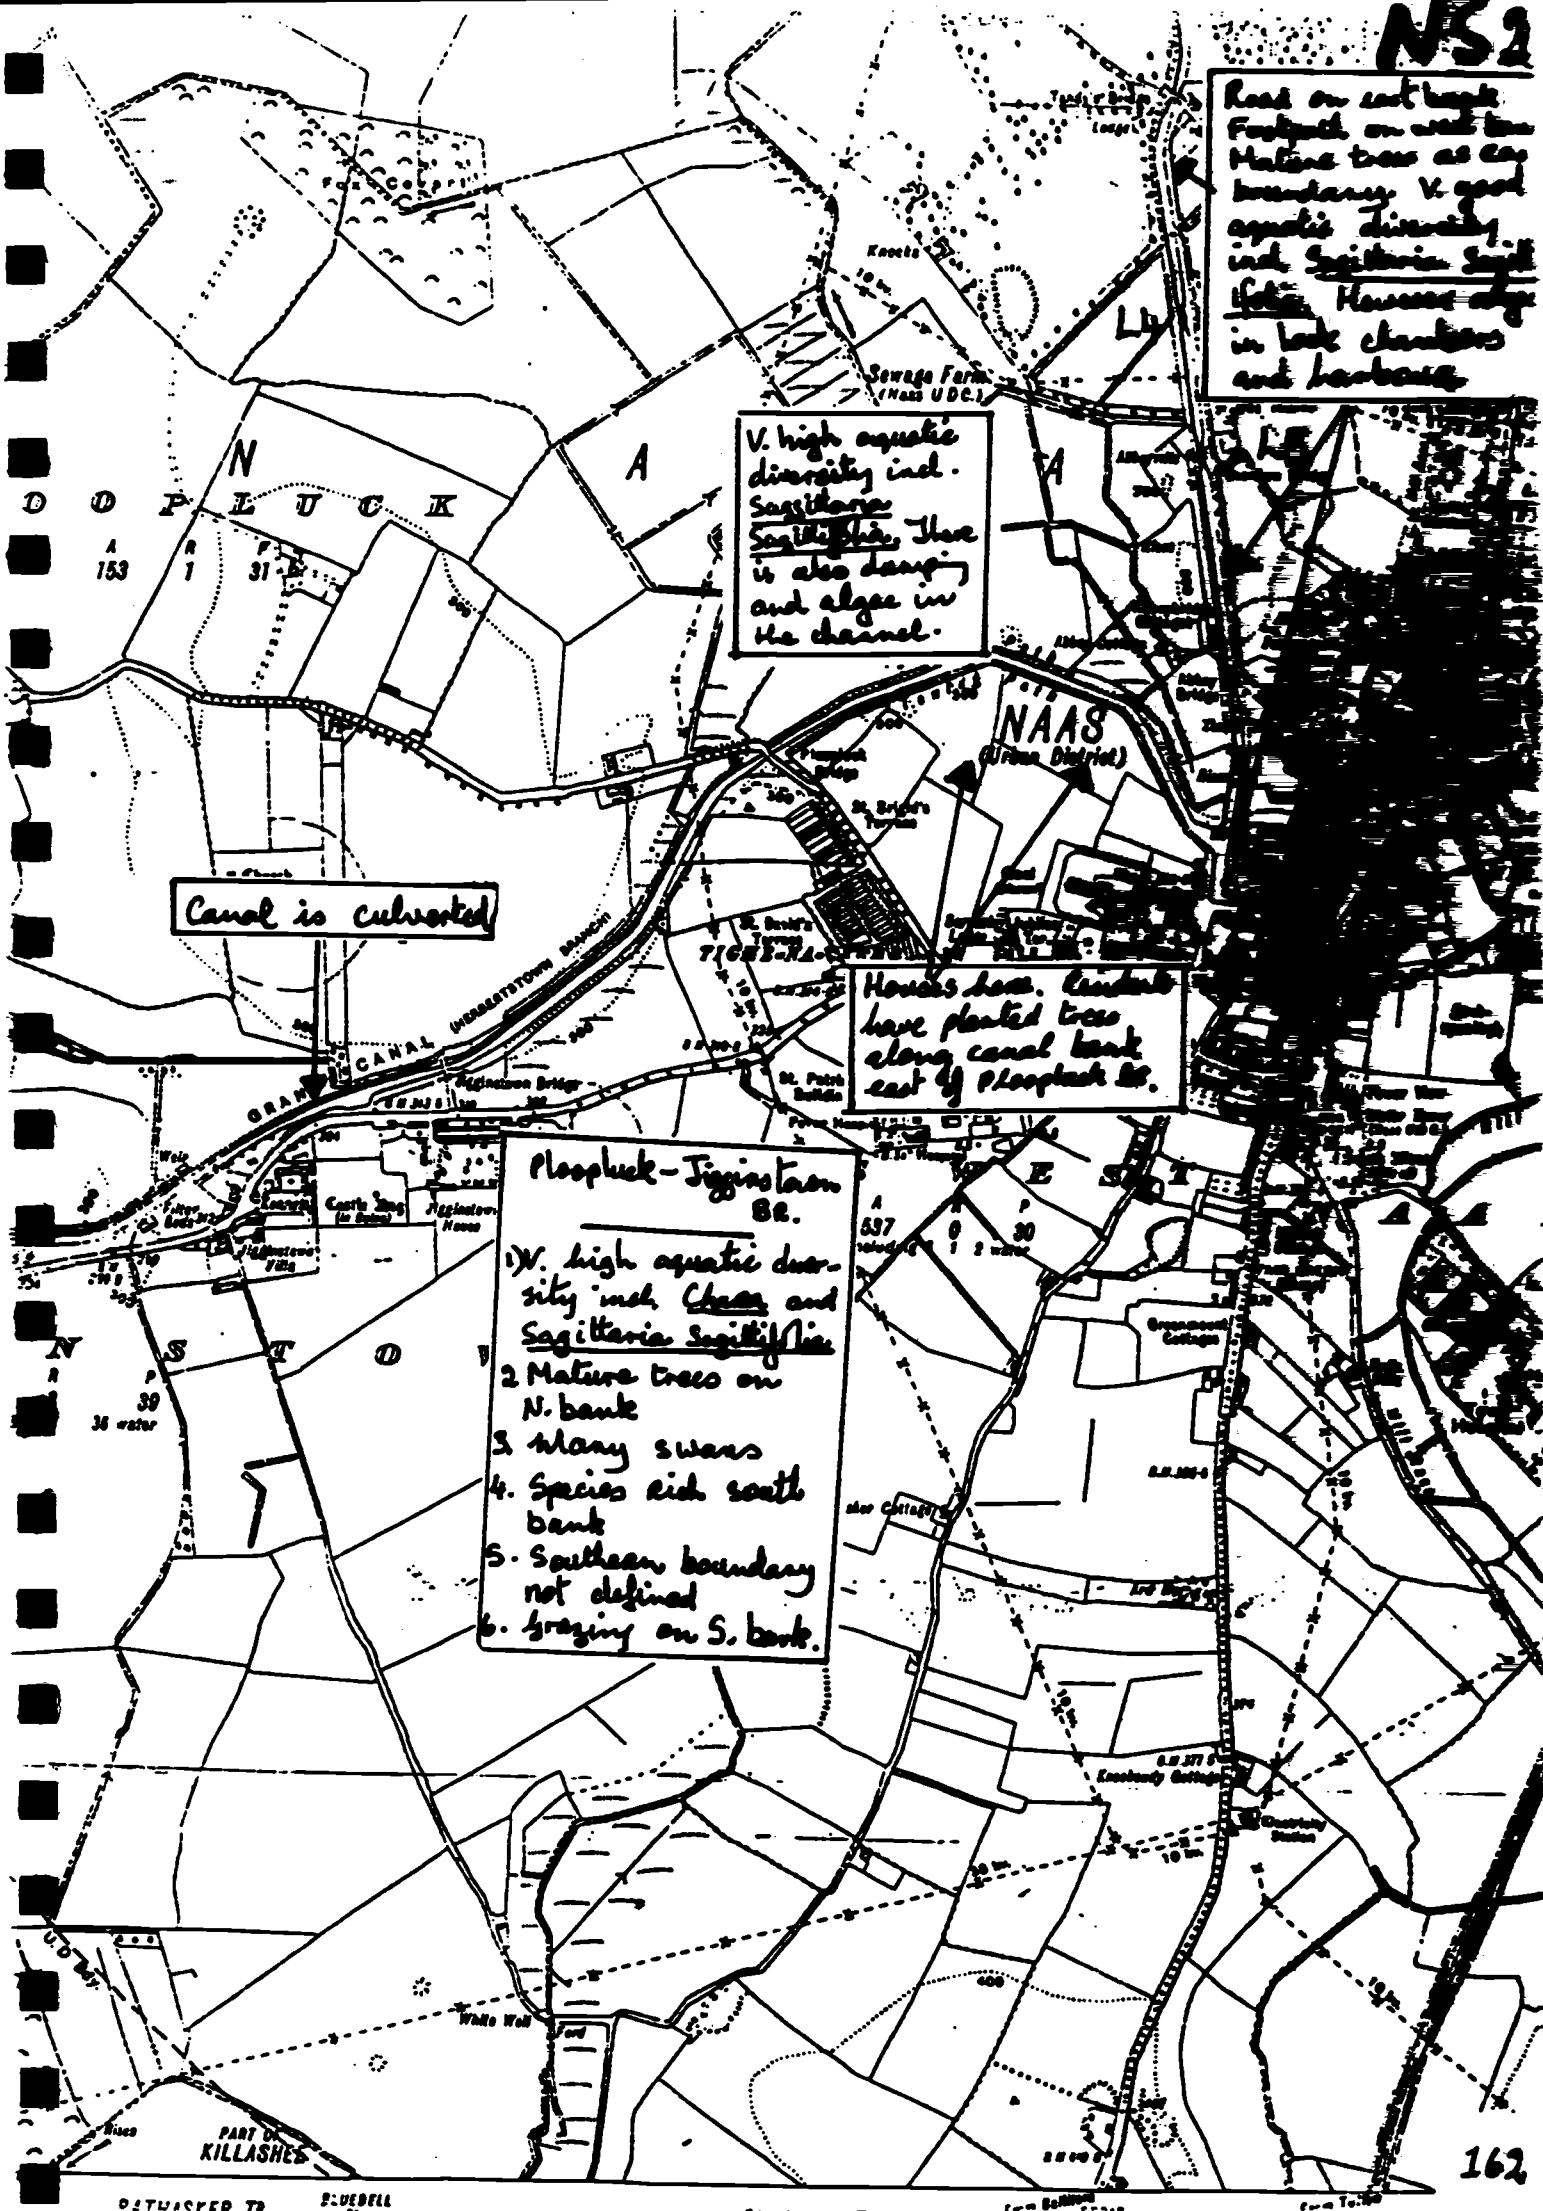
Ploophuck - Jigginstown
St.

1. V. high aquatic diversity incl. *Chama* and *Sagittaria Sagittifolia*
2. Mature trees on N. bank
3. Many swans
4. Species rich south bank
5. Southern boundary not defined
6. Grazing on S. bank.
