# Monitoring and Assessment of EU Habitats Directive Annex I Priority Habitat Petrifying Springs, 2025

## Irish Wildlife Manuals 160

## **Monitoring and Assessment of EU Habitats Directive Annex I Priority Habitat Petrifying Springs, 2025**

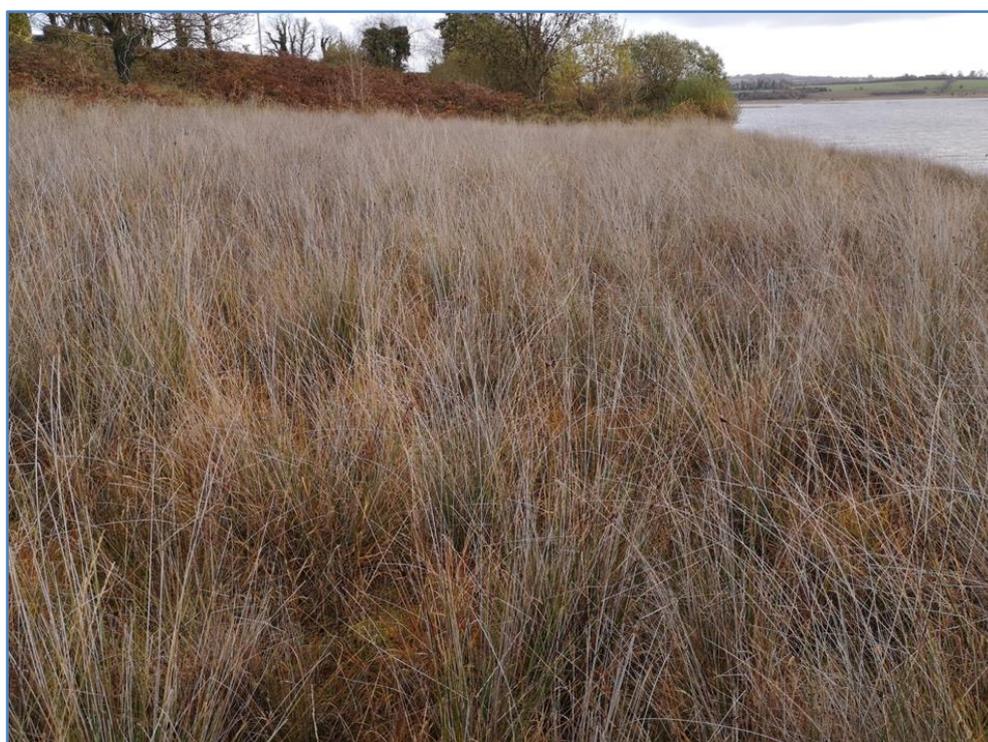
**Photograph 1** North face shore of Annaghmore Lough (view to east) with *Schoenus* fen with petrifying spring seepages. Photograph George Smith.

Site management	Reinstate grazing/ encourage higher grazing of spring area
Survey	Survey of remaining area of SAC that was not surveyed in 2023
Hydrogeology	None

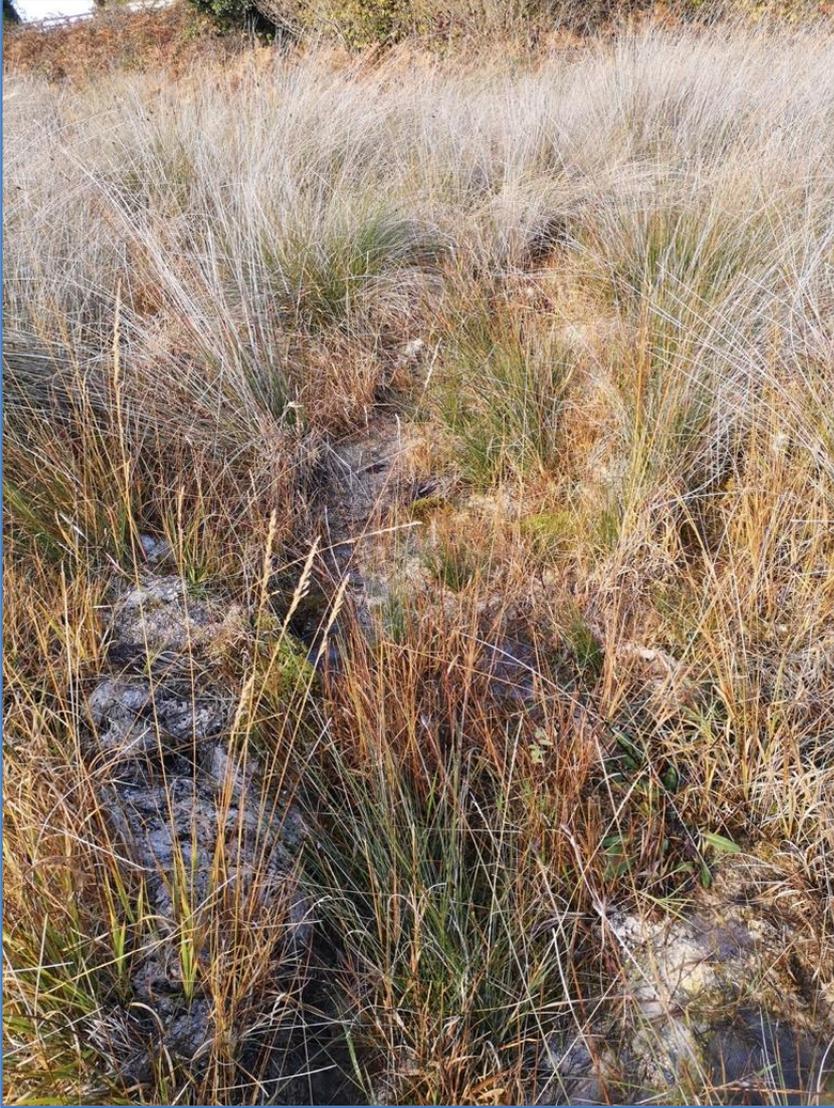
**Photograph 2** *Schoenus nigricans* petrifying spring vegetation community. Photograph George Smith.

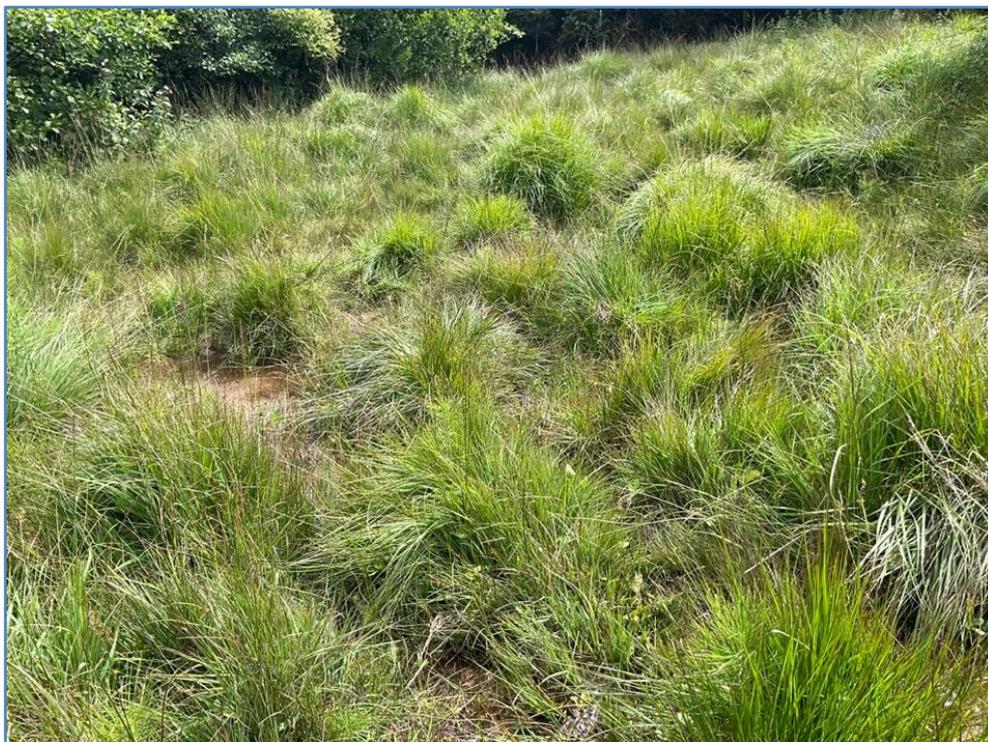
**Photograph 1** Alkaline fen with petrifying spring seepages, *Molinia caerulea* abundant. Photograph Joanne Denyer.

Site management	Extensive grazing in alkaline fen area, reduction of deer in woodland areas
Survey	Repeat survey of springs in fen area in next three years to assess if any further reductions in positive indicator species or tufa formation. Protection of sensitive habitats during surveys and investigations for adjacent planning applications – surveys only in consultation with NPWS to ensure minimisation of trampling damage.
Hydrogeology	Water sampling in alkaline fen area to investigate possible cause of tufa reduction.

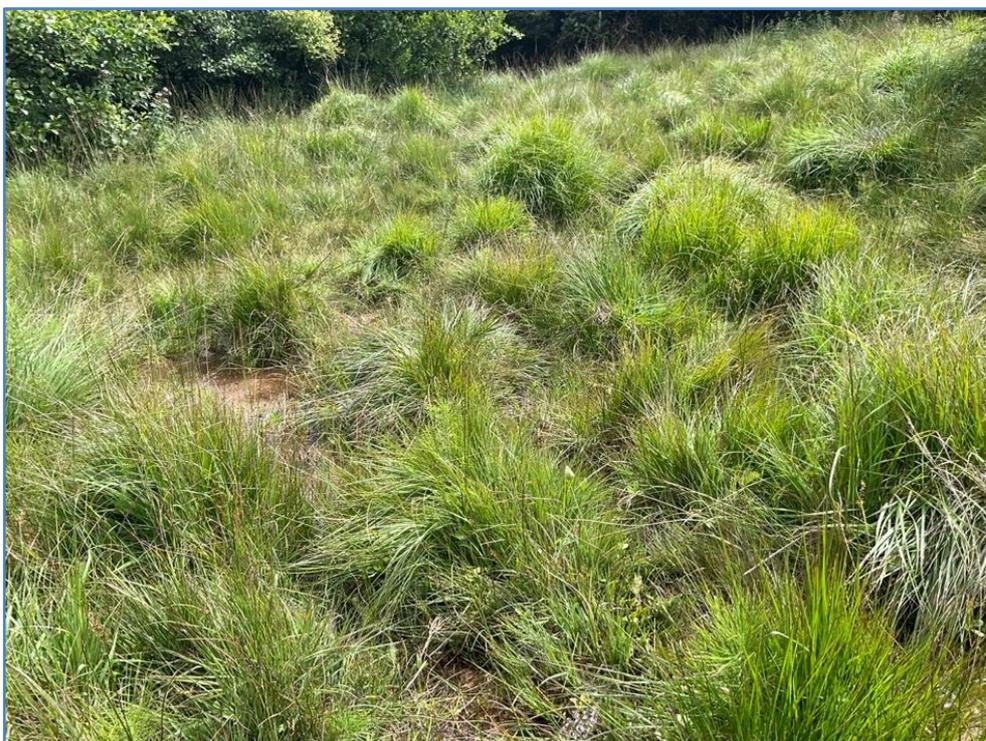
**Photograph 1** Petrifying spring line in tall *Schoenus fen* (view to NE). Photograph Joanne Denyer.

Site management	Introduce low level of grazing or other management to reduce vegetation height
Survey	Walk-over survey of remainder of site (particularly south of lake) to check for additional petrifying springs
Hydrogeology	Investigate pollution source and monitor water levels

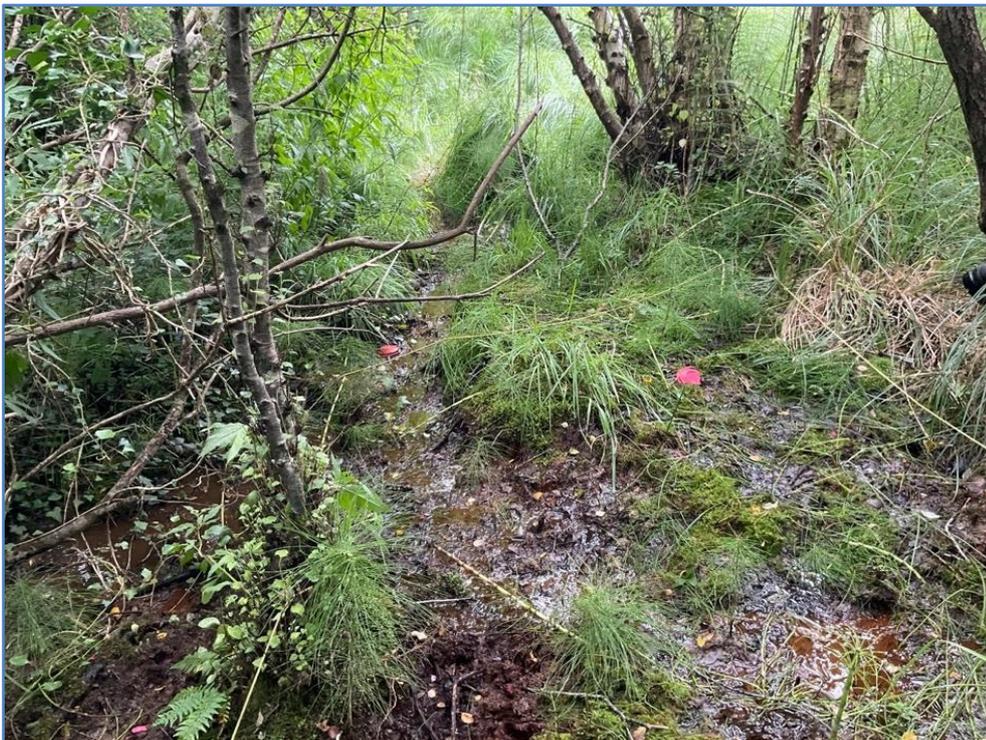
**Photograph 2** Petrifying spring in overgrown reed swamp area. Photograph Joanne Denyer.

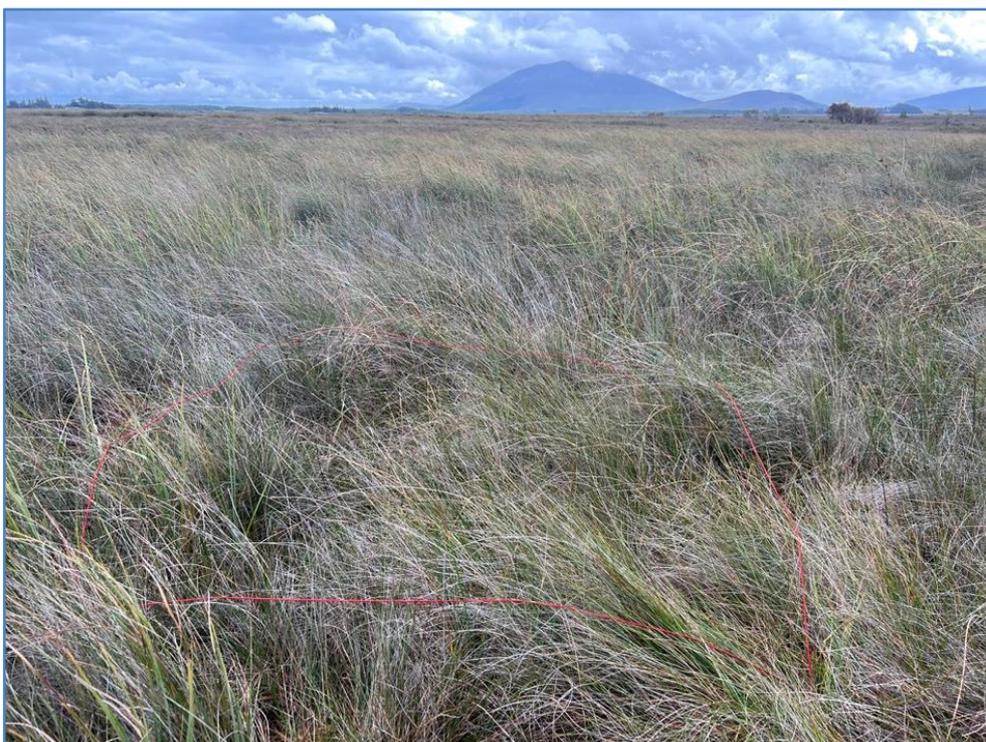
**Photograph 1** *Schoenus* fen with petrifying spring flushes throughout. Photograph Joanne Denyer.

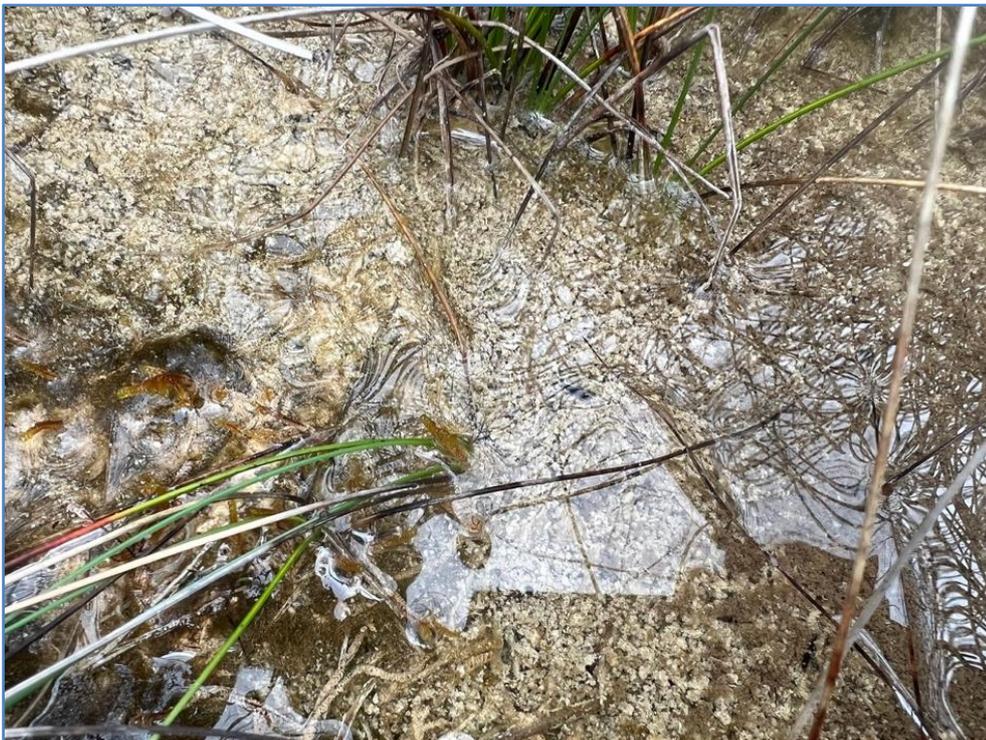
**Photograph 2** Extensive strong paludal tufa formation in petrifying spring flush areas. Photograph Joanne Denyer.

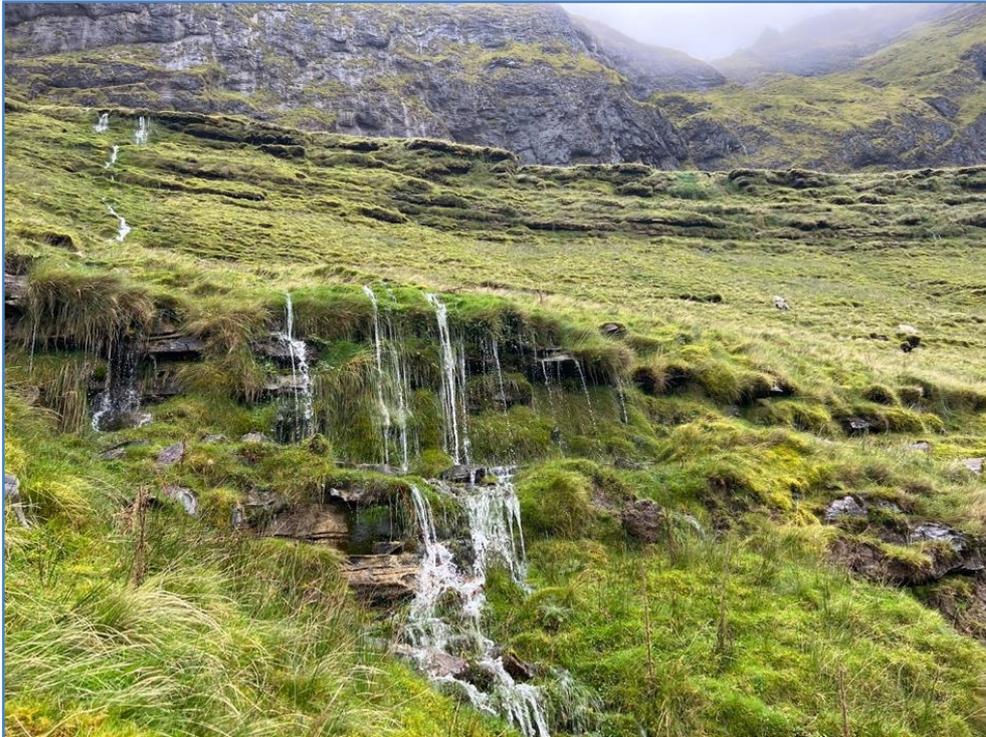
**Photograph 1** Waterfall at Gleniff, Annacoona, with cascade tufa formation and rare bryophytes. Photograph Joanne Denyer.

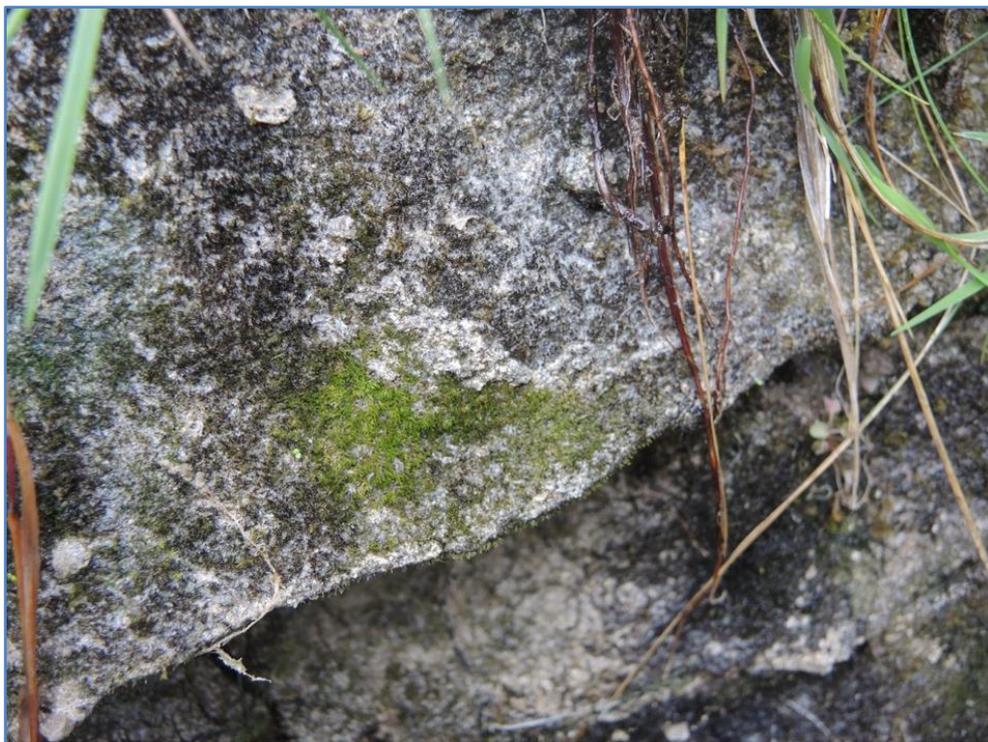
**Photograph 2** Rare bryophytes *Seligiera patula* (green) and *Seligiera oelandica* (black) on tufa covered rocks in petrifying spring at Gleniff, Annacoona. Photograph Joanne Denyer.

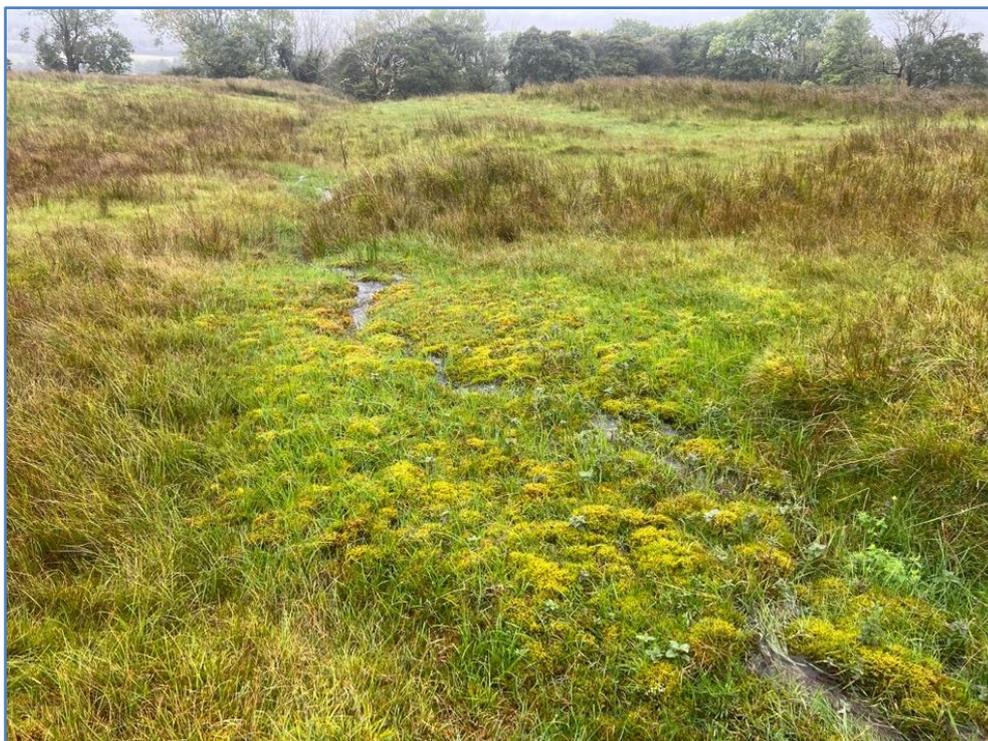
**Photograph 3** Species-rich petrifying spring flush below springhead, on lower ground below Eagle's Rock, Glenade. Photograph Joanne Denyer.

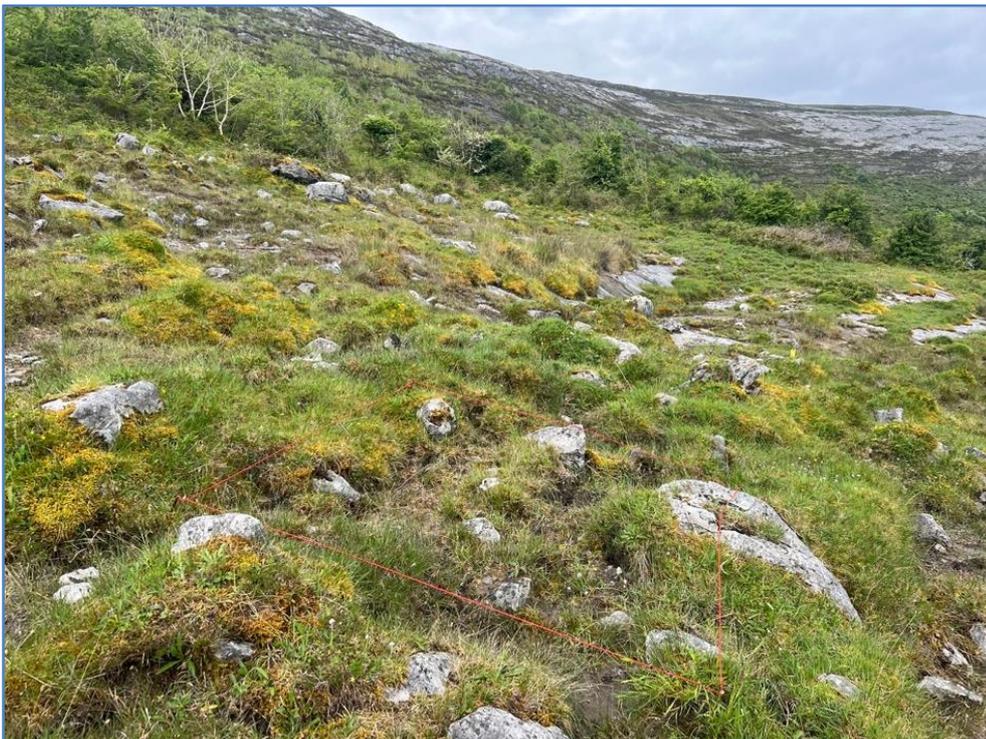
**Photograph 1** Species-rich petrifying spring vegetation with rare moss *Orthothecium rufescens* on flushed limestone pavement with paludal tufa. Photograph Joanne Denyer.

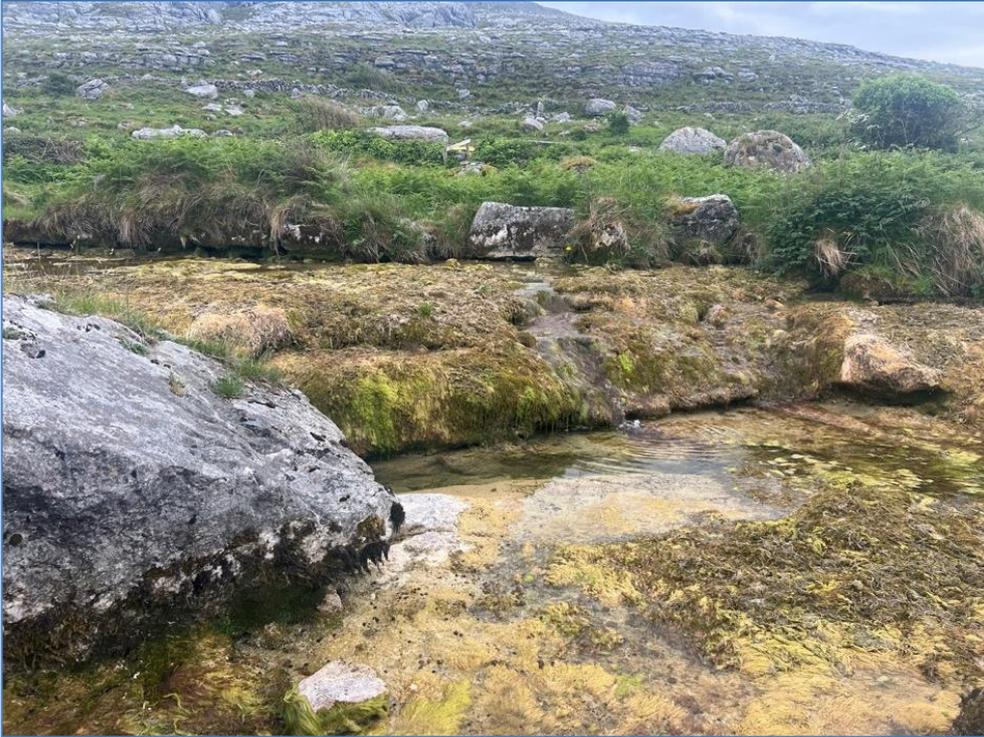
**Photograph 2** Tufa formation and diverse algal communities in seasonal limestone river (Caher River). Photograph Joanne Denyer.

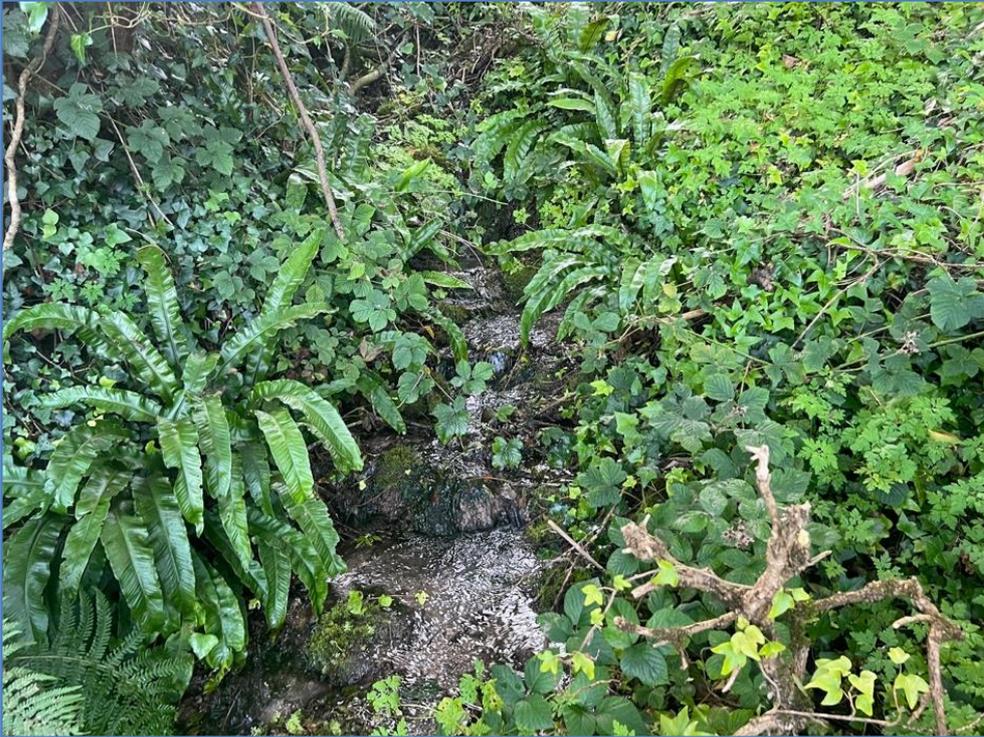
**Photograph 1** View of massive cascade mound, at least 2 m in height, dominated by negative bryophyte indicator species *Cratoneuron filicinum*. Photograph Joanne Denyer.

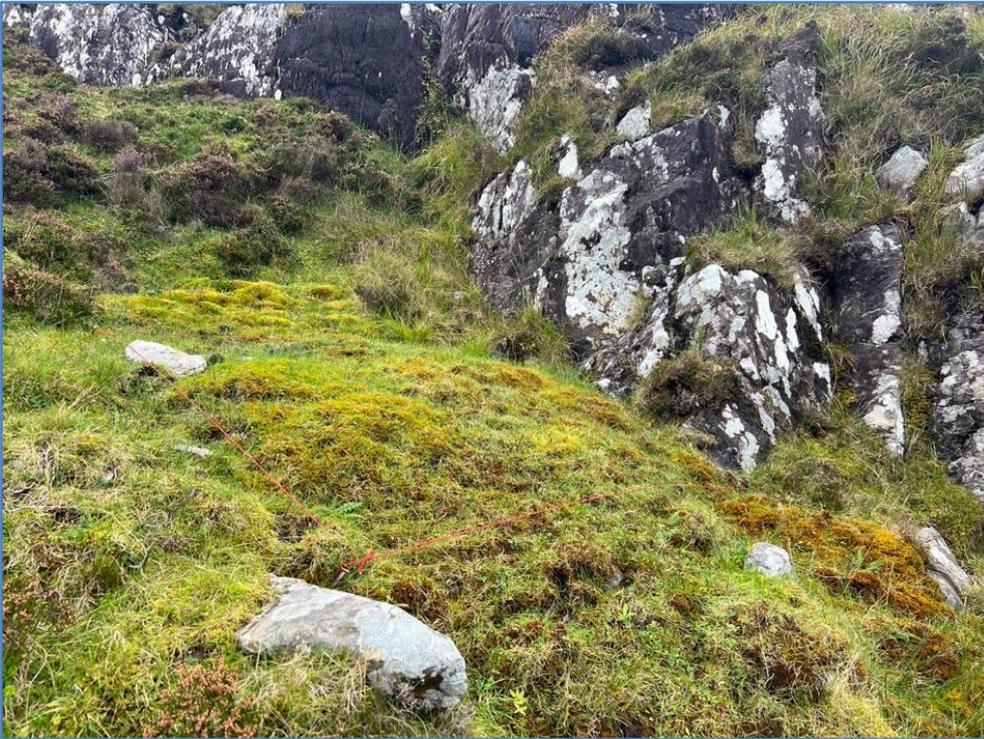
There was a slight increase in the number of positive indicator species from the baseline survey (2014) but no other changes. Tufa cover was sparse in both surveys. The plot is heavily grazed but at present this is not causing the plot to fail the condition assessment.

**Photograph 2** Petrifying spring dominated by *Palustriella commutata*. Heavily grazed. Photograph Joanne Denyer.

Site management	Reduce levels of sheep grazing
Survey	No further survey required in short-term
Hydrogeology	None

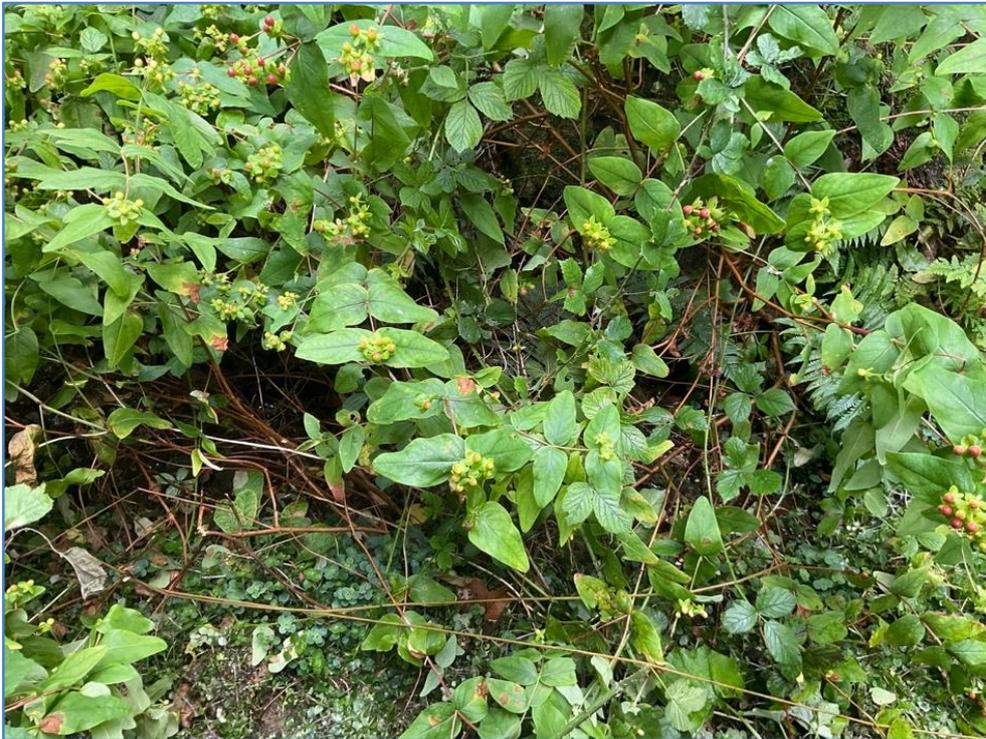
**Photograph 1** Densely shaded petrifying spring vegetation in stream. Photograph Joanne Denyer.

Site management	Consider removal of dense vegetation over stream (in consultation with petrifying spring ecologist).
Survey	No further survey required in short-term
Hydrogeology	Investigate source of elevated nitrate

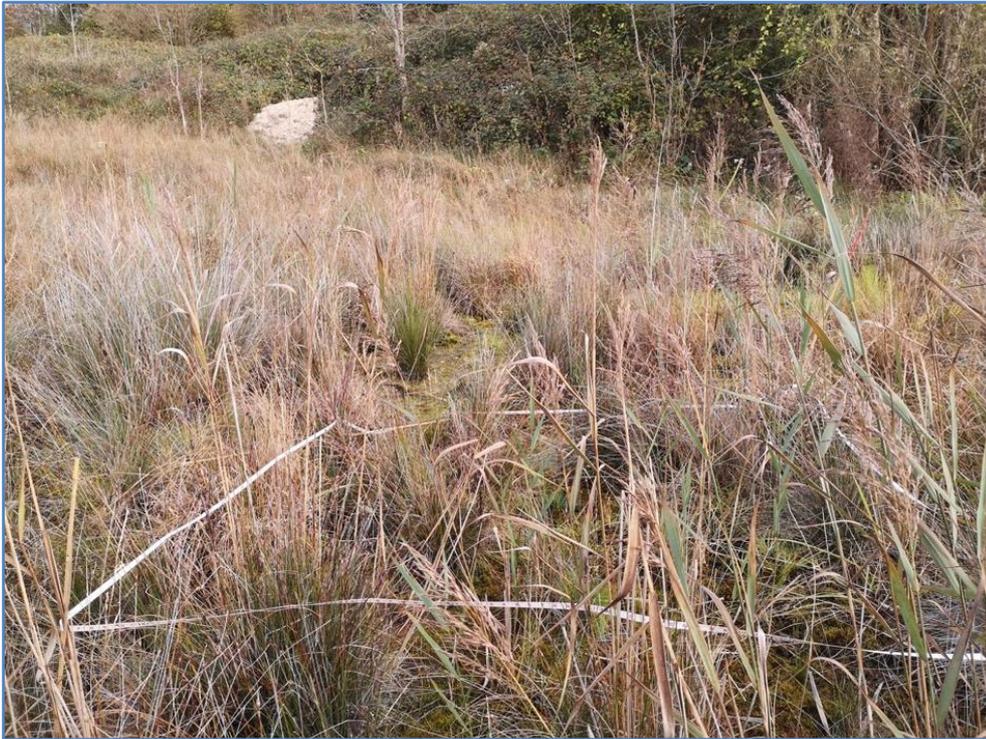
**Photograph 2** Petrifying spring vegetation becoming overgrown with tall *Phragmites australis*. Photograph George Smith.

Site management	Consider grazing of overgrown petrifying spring/ fen vegetation
Survey	No further survey required in short-term
Hydrogeology	Investigate source of elevated nitrate and phosphate and possible changes to water flow.

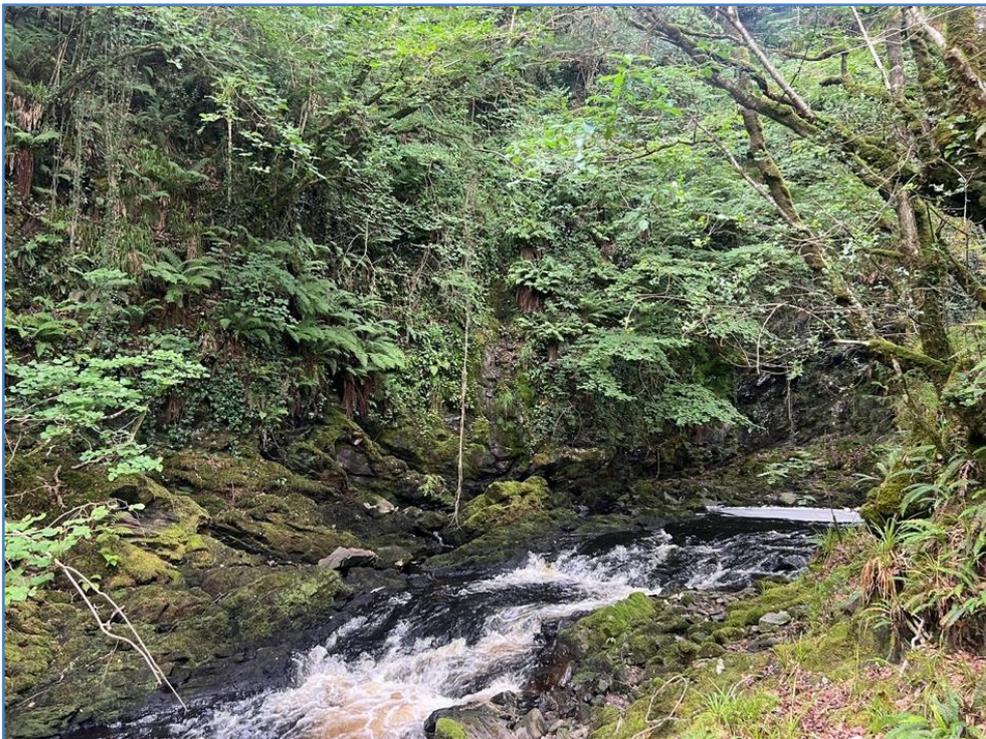
**Photograph 1** View of petrifying spring in wooded gorge from opposite river bank.  
Photograph Joanne Denyer.

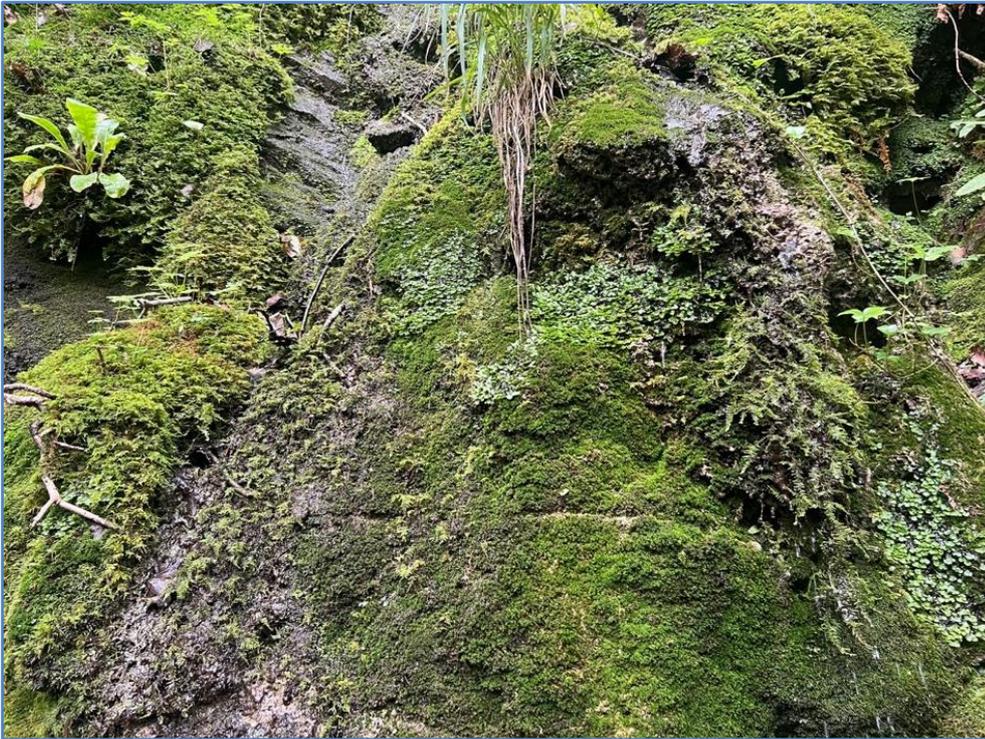
**Photograph 2** Cascade tufa dominated by *Eucladium verticillatum* in the petrifying spring. Photograph Joanne Denyer.

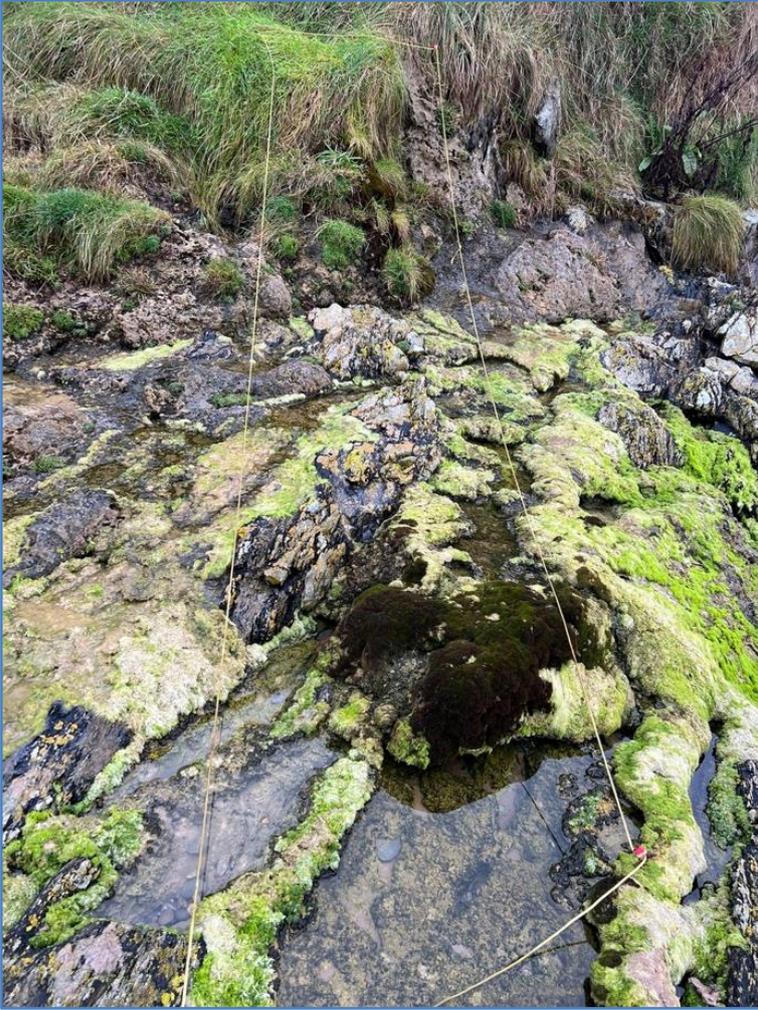
**Photograph 2** Coastal petrifying spring vegetation at high tide line, south of Ardmore Point. Photograph Joanne Denyer.

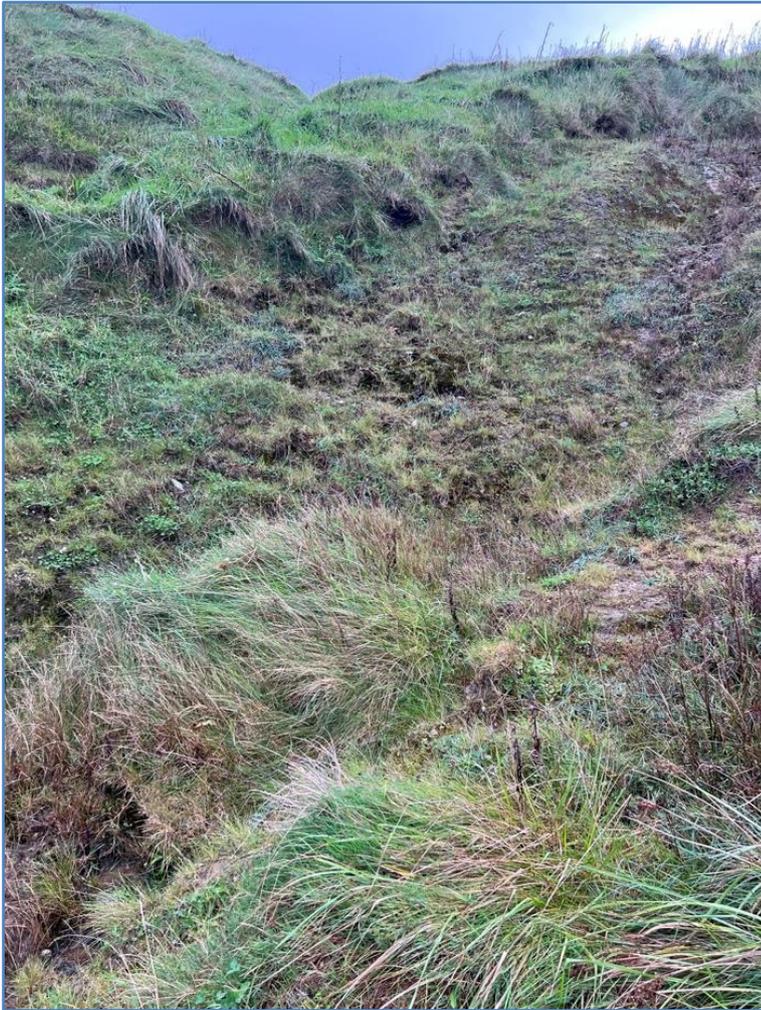
**Photograph 3** Coastal seepage in slump area on Ardmore Point with species-rich small sedge petrifying spring vegetation. Photograph Joanne Denyer.

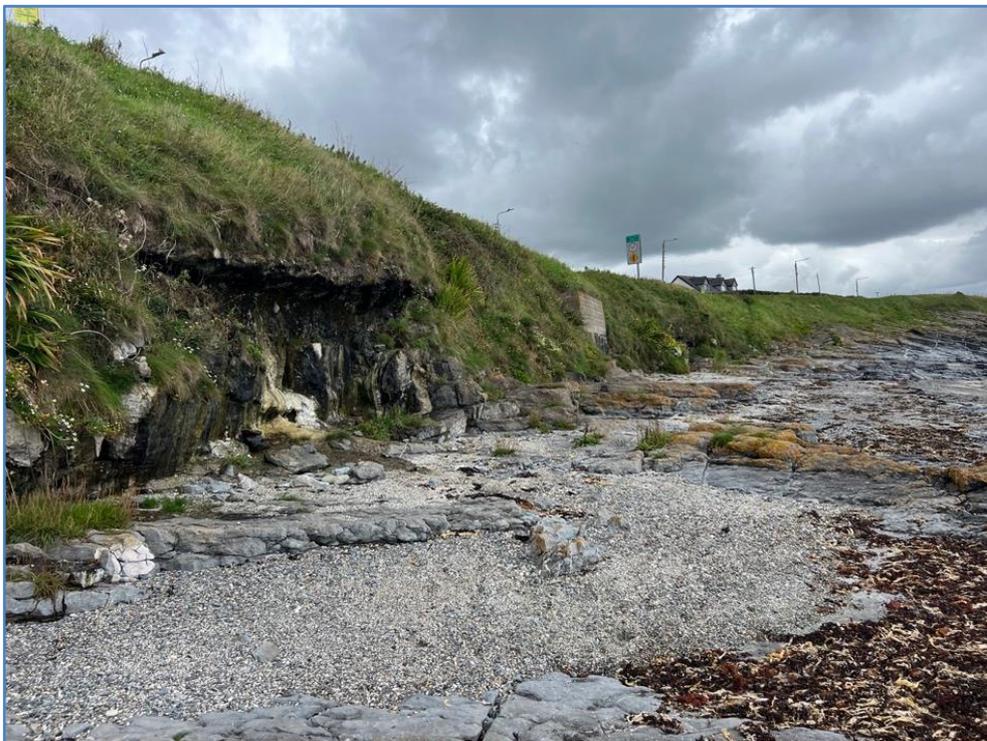
**Photograph 1** Seepage zone along low cliffs above shoreline, view to north. Photograph Joanne Denyer.

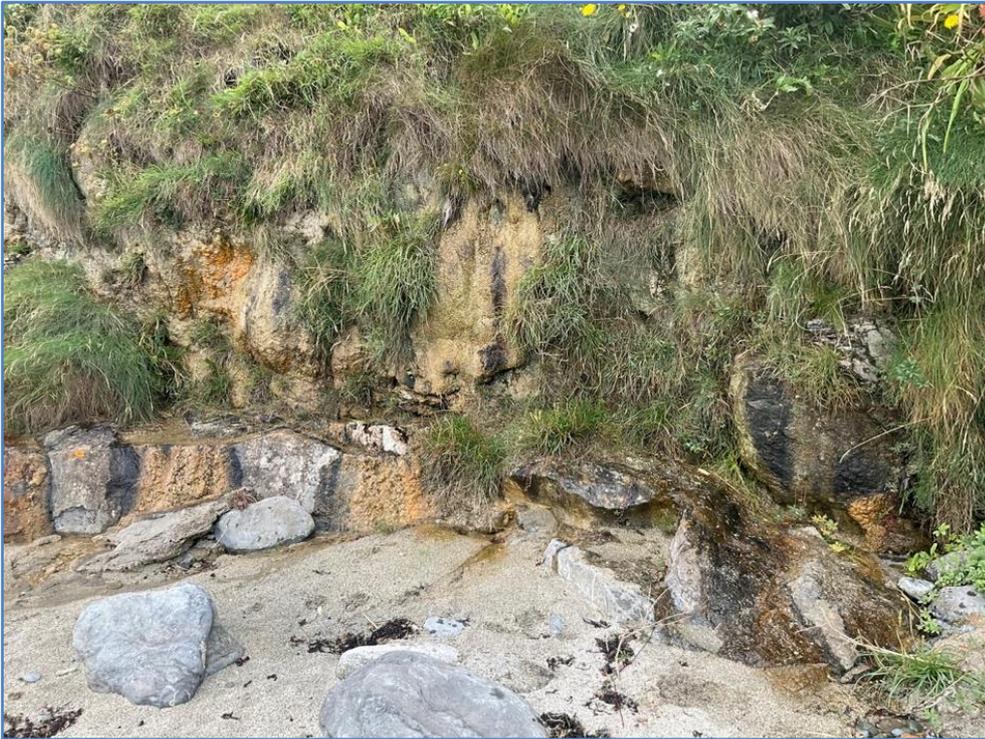
**Photograph 2** Cascade tufa with petrifying spring vegetation. Photograph Joanne Denyer.

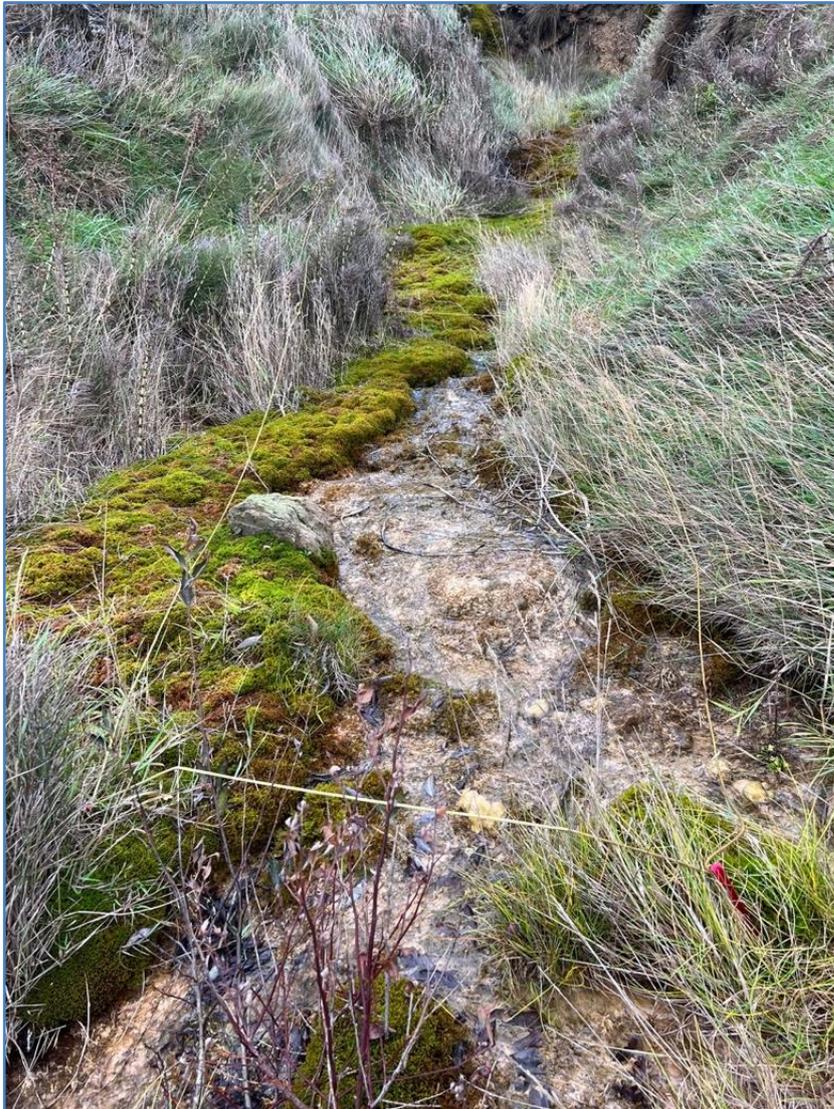
**Photograph 1** Petrifying spring vegetation below springhead, dominated by *Palustriella commutata* and with stream crust tufa present. Photograph Joanne Denyer.

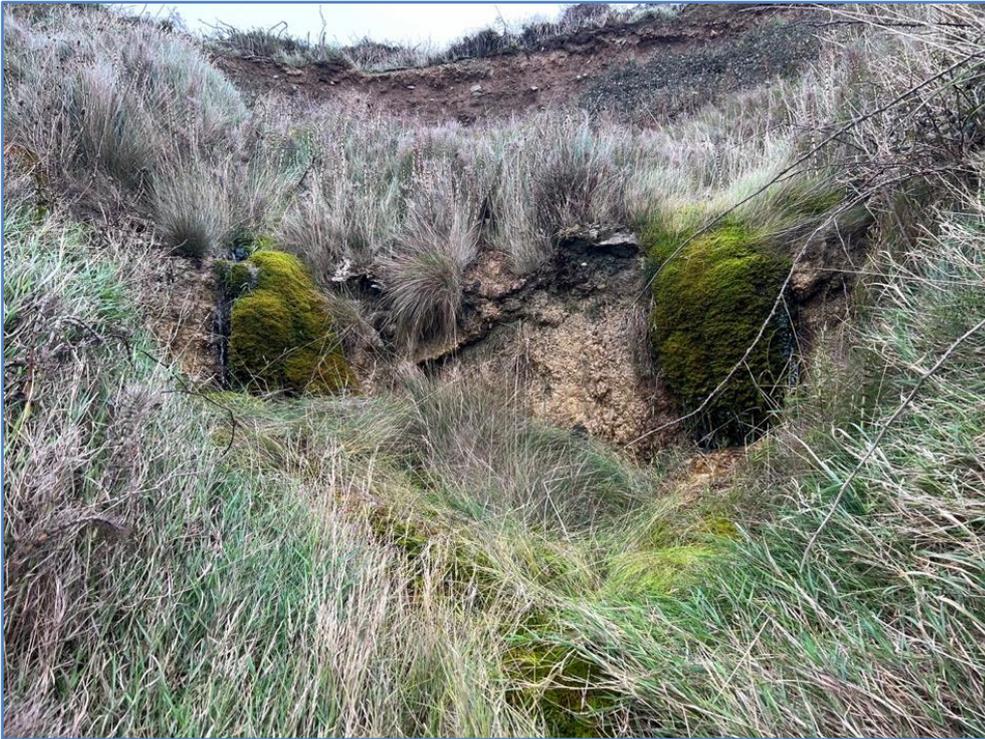
**Photograph 2** Cascade tufa at springhead with mounds of *Palustriella commutata*.  
Photograph Joanne Denyer.

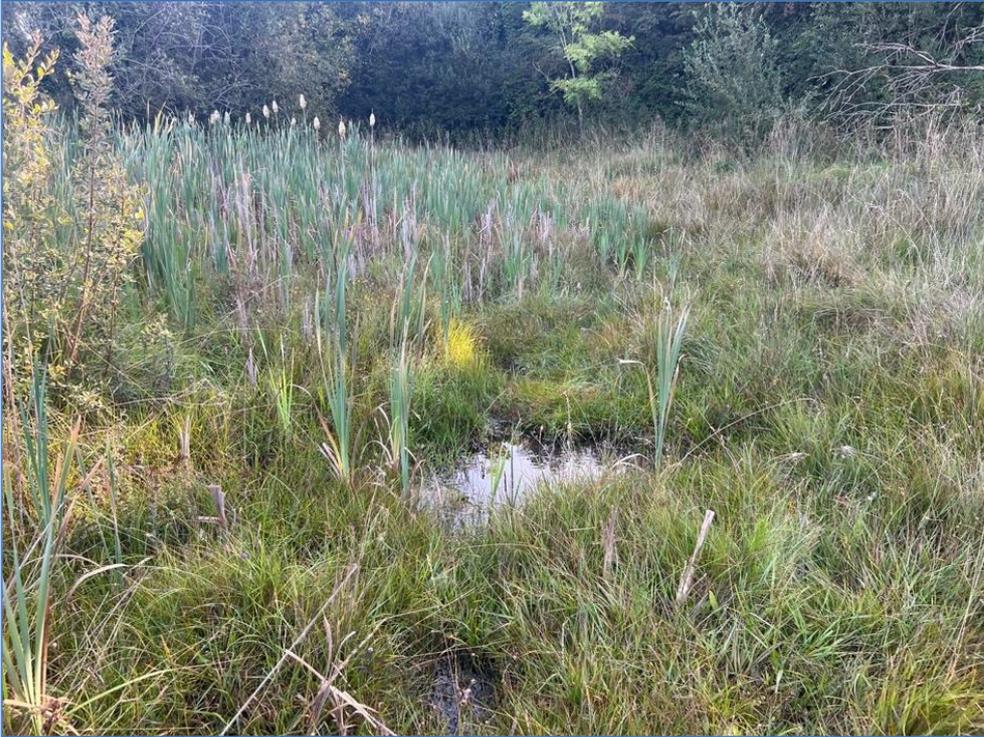
**Photograph 1** Petrifying spring vegetation on upper terrace which has now infilled from open pools in 2011. Photograph Joanne Denyer.

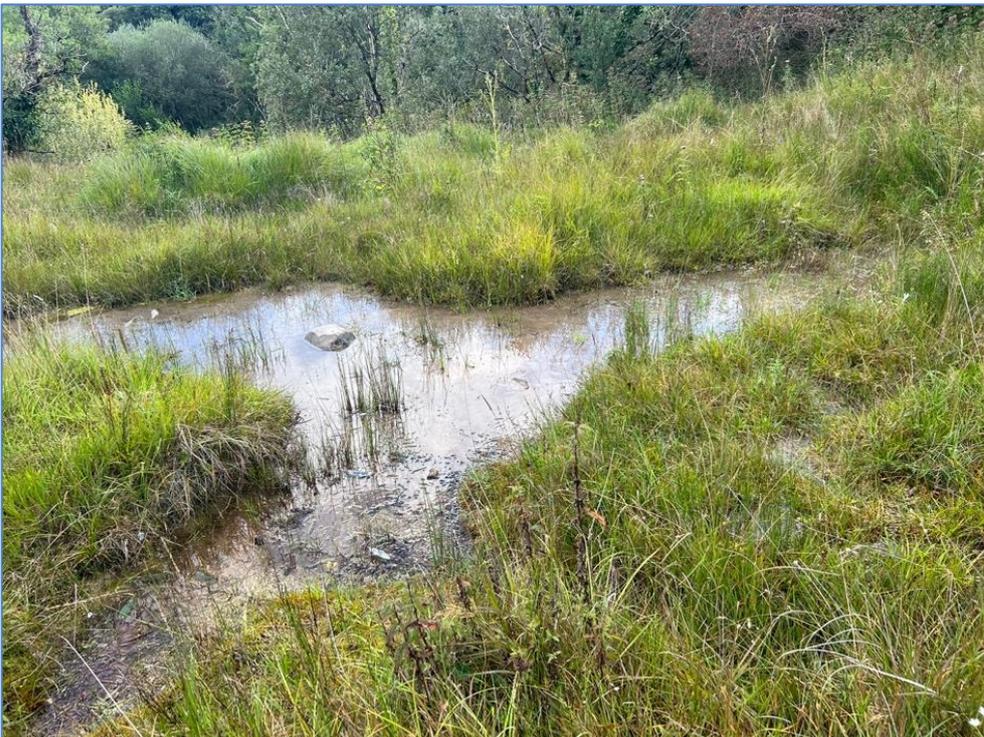
**Photograph 2** Petrifying spring vegetation and open pool on middle terrace. Photograph Joanne Denyer.

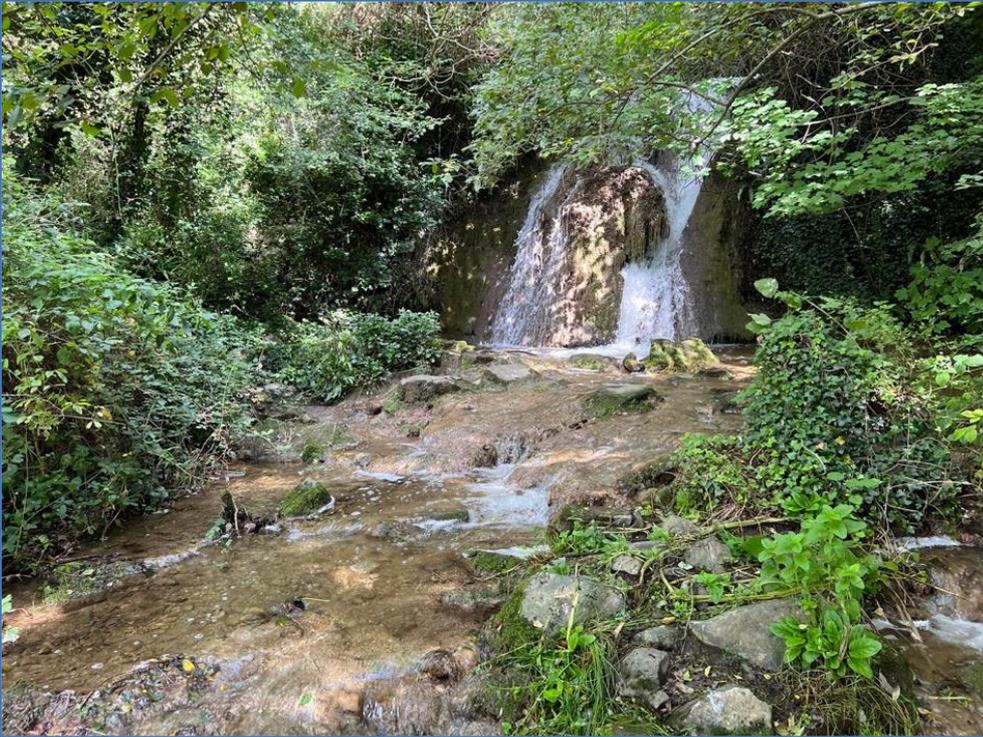
**Photograph 3** Massive cascade tufa formation and extensive stream crust below waterfall, Louisa Bridge north. Photograph Joanne Denyer.

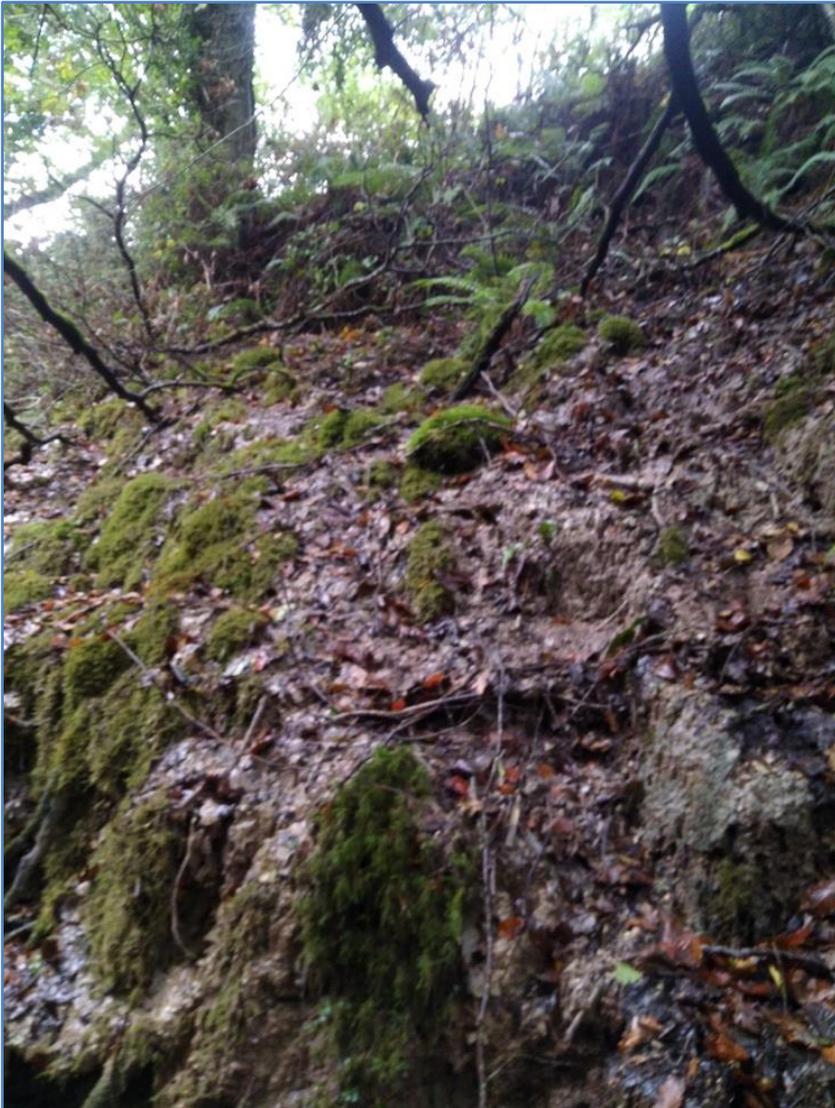
**Photograph 1** Wooded petrifying spring with cascade tufa in Glinsk Grove. Photograph George Smith.

Site management	Removal/ thinning of dense <i>Fagus sylvatica</i> in Glinsk Grove
Survey	No further survey required of SAC in short-term but additional spring sites in Slieve Bloom Mountains (outside of SAC) should have monitoring undertaken as many have not been surveyed since 2012-2013.
Hydrogeology	Investigate source of elevated phosphates and nitrates
