# Monitoring and Assessment of EU Habitats Directive Annex I Priority Habitat Petrifying Springs, 2025

## Irish Wildlife Manuals 160

## **Monitoring and Assessment of EU Habitats Directive Annex I Priority Habitat Petrifying Springs, 2025**

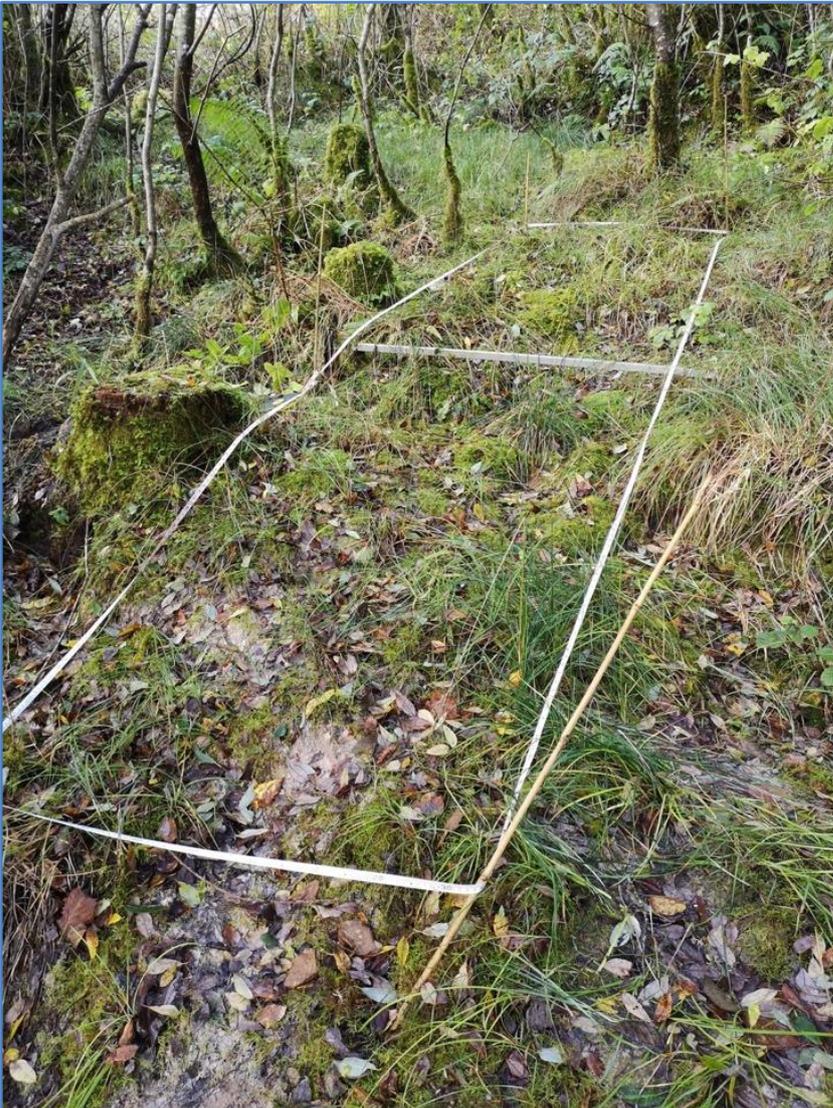
**Photograph 2** Wooded petrifying spring Camcor River Valley in area recently cleared of conifers. Photograph George Smith.

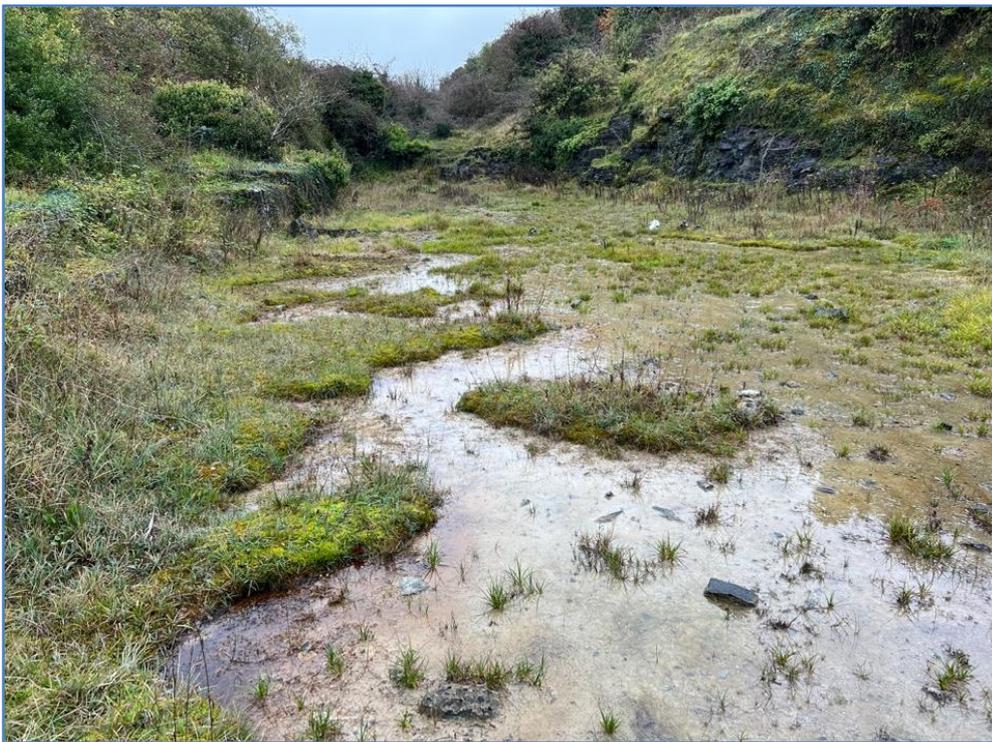
**Photograph 1** Species-rich petrifying spring vegetation in north of quarry with pool formation and soft paludal tufa. Photograph Joanne Denyer.

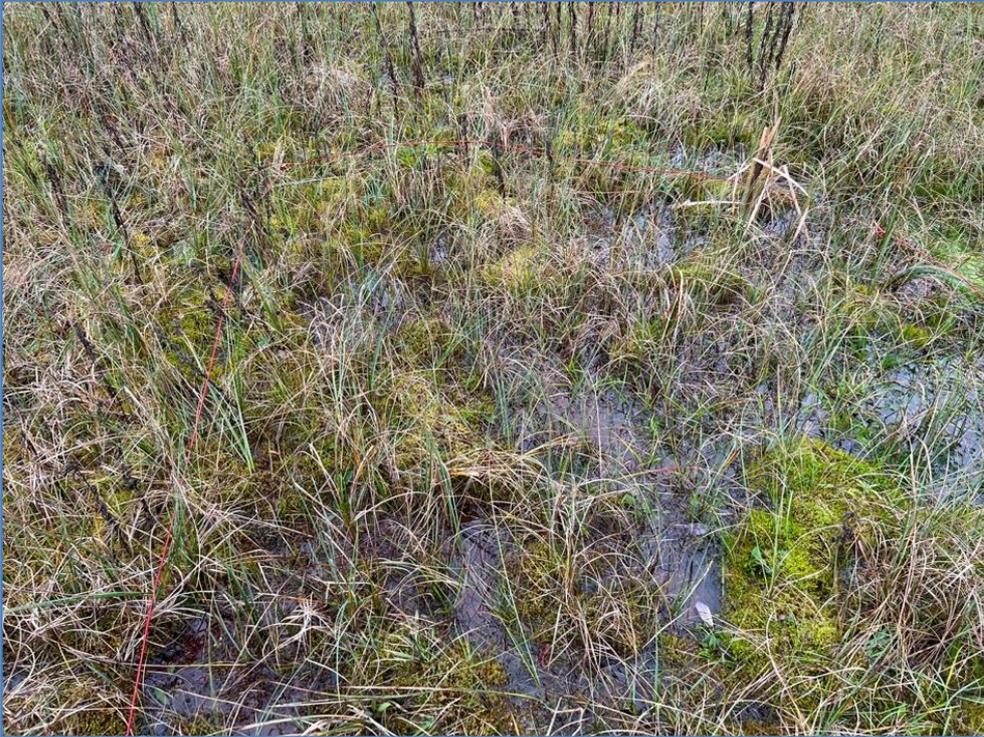
**Photograph 2** Species-rich petrifying spring vegetation middle section of quarry in transition mire/ alkaline fen with standing water. Photograph Joanne Denyer.

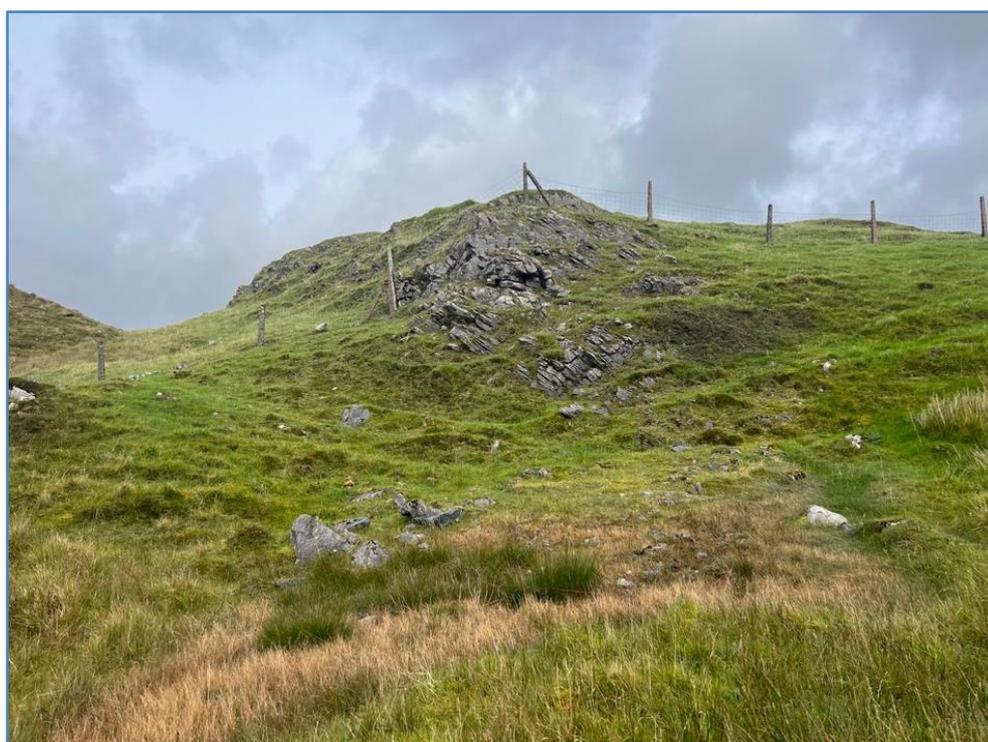
**Photograph 1** Species-rich petrifying spring/ flush in north of site at base of rocky slope. Photograph Joanne Denyer.

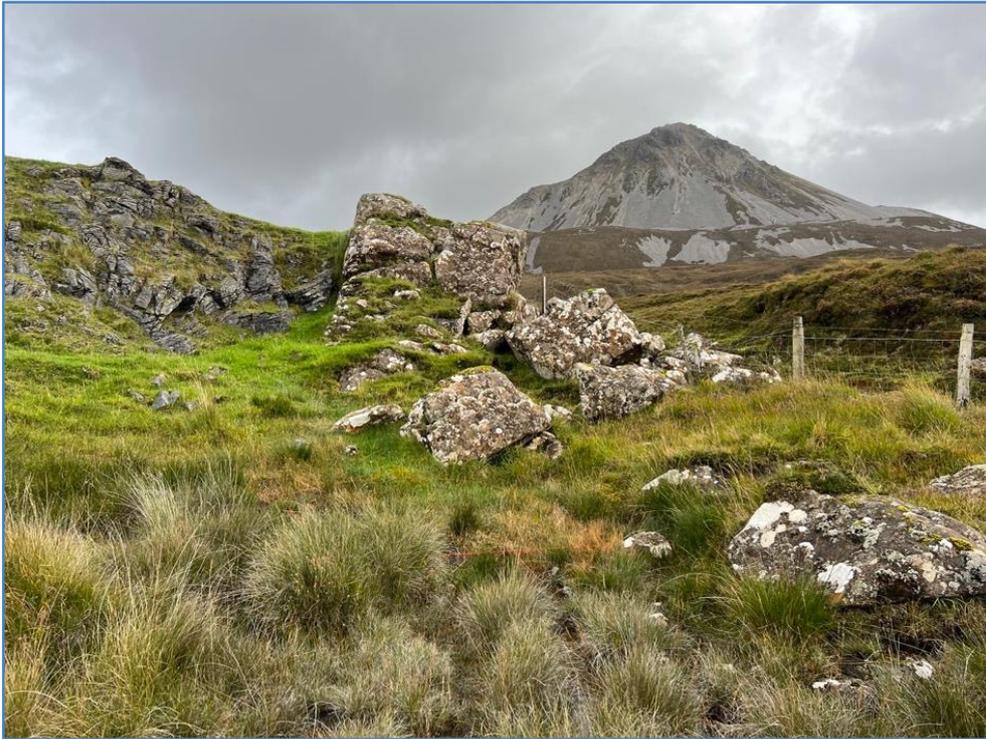
**Photograph 2** Species-rich petrifying spring/ flush in south of site, grading into transition mire. Photograph Joanne Denyer.

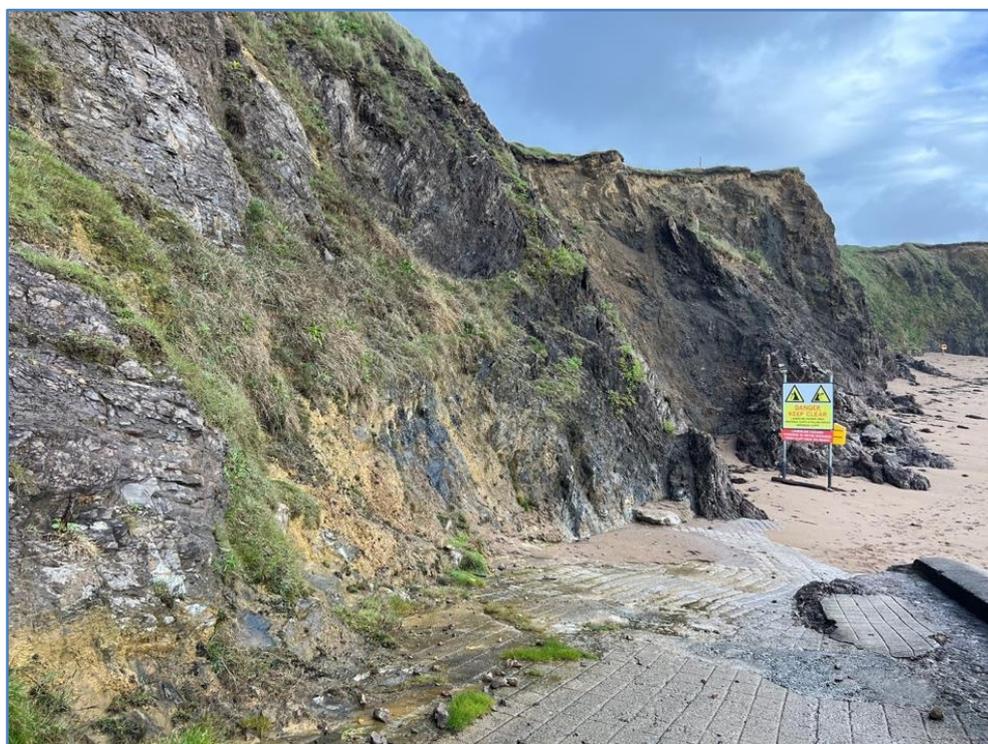
**Photograph 1** Coastal petrifying spring seepage with cascade tufa at Baginbun Beach West. Photograph Joanne Denyer.

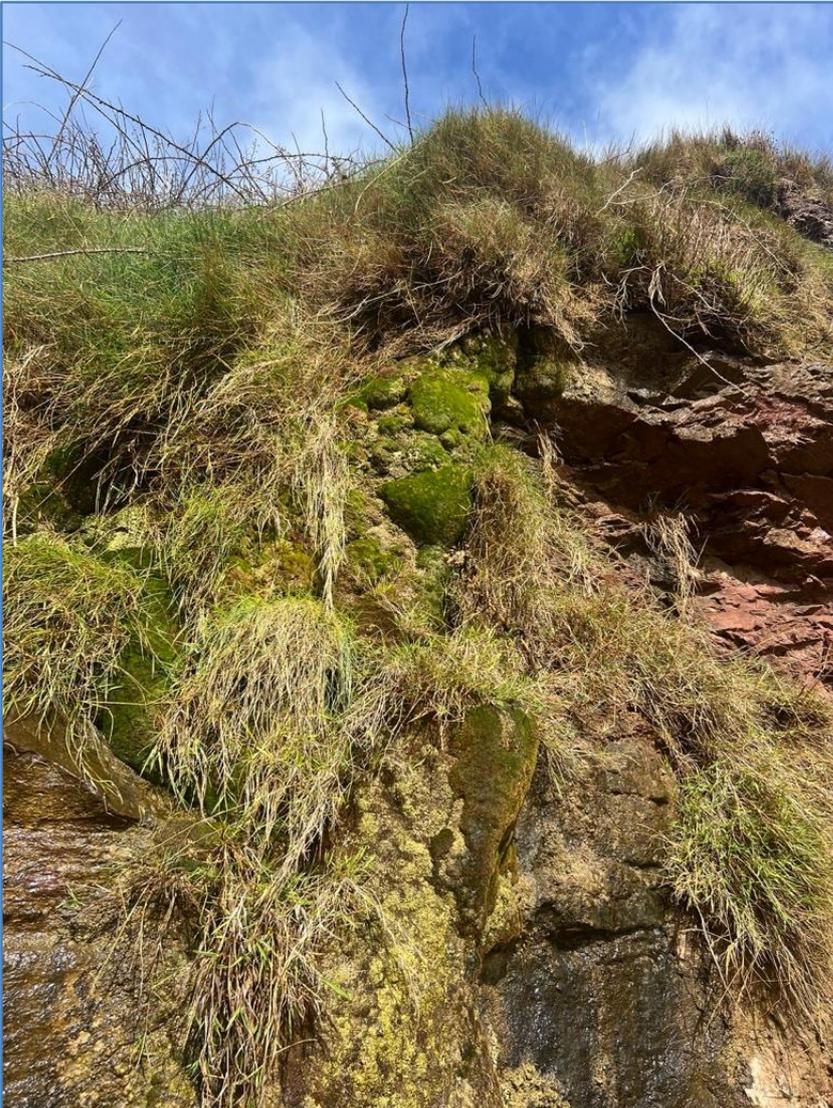
**Photograph 2** Coastal petrifying spring seepage with cascade tufa and cushions of *Didymodon tophaceus* and *Eucladium verticillatum* at Sandeel Beach. Photograph Joanne Denyer.

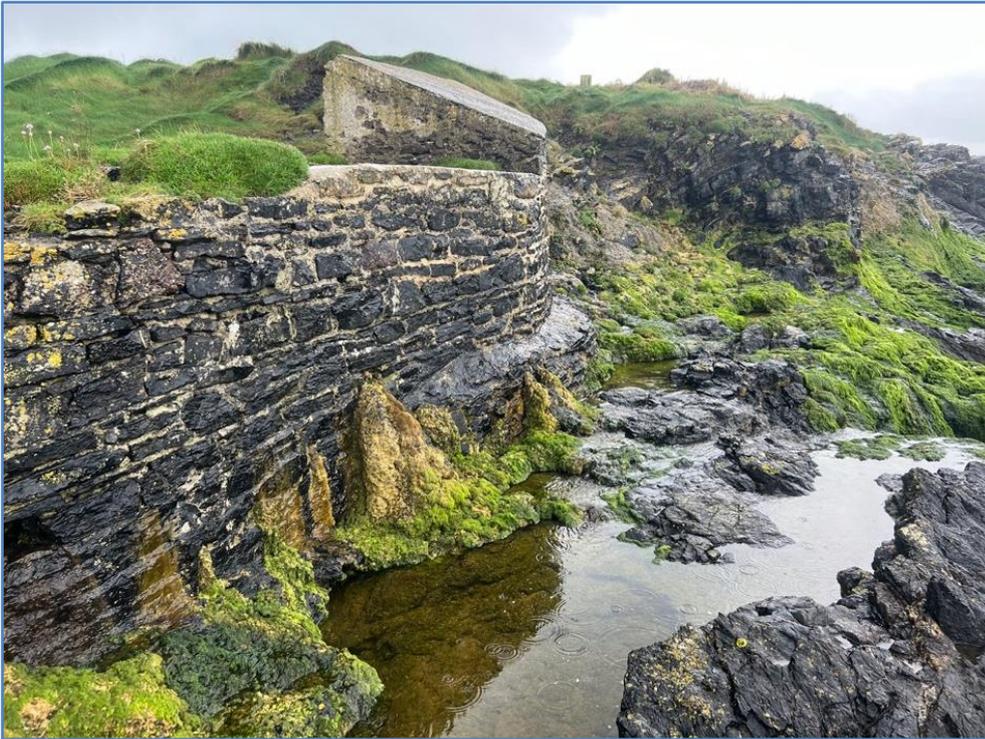
**Photograph 3** Coastal petrifying spring seepages with cascade tufa formed around old Holy Well at Rock Well, Churchtown. Photograph Joanne Denyer.

Site management	Ensure that petrifying springs around Rock Well are protected from any restoration works to the old well
Survey	No further survey required in short-term
Hydrogeology	Investigate source of elevated phosphates and nitrates

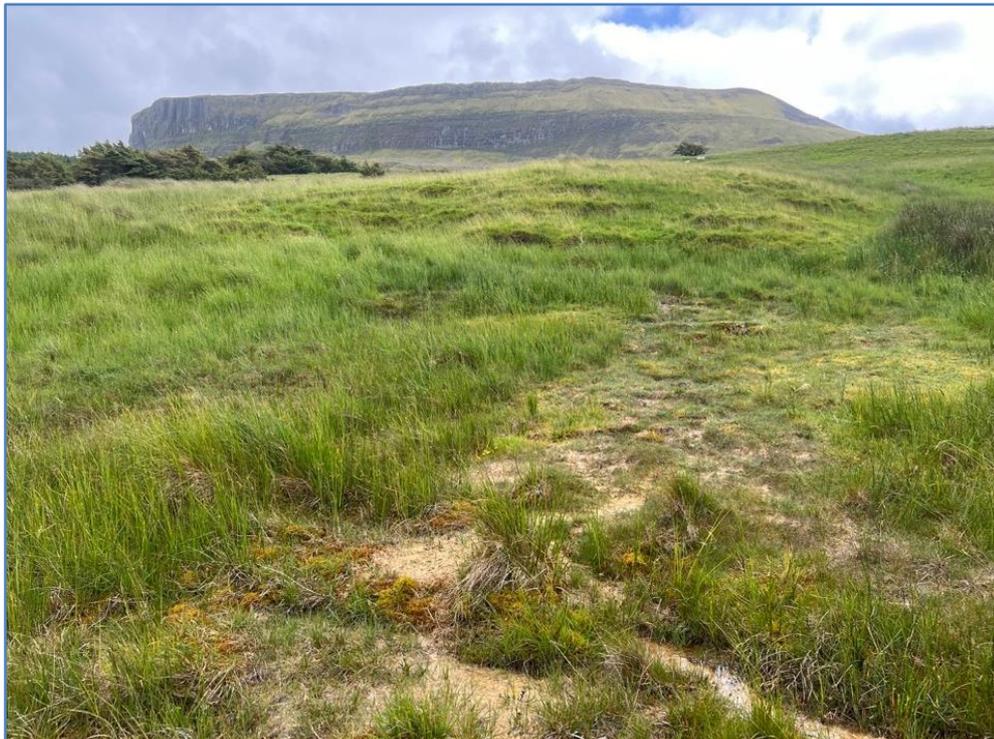
**Photograph 1** North face of Arroo (view to south from lower slopes) with species-rich petrifying spring (flush) in foreground. Photograph Joanne Denyer.

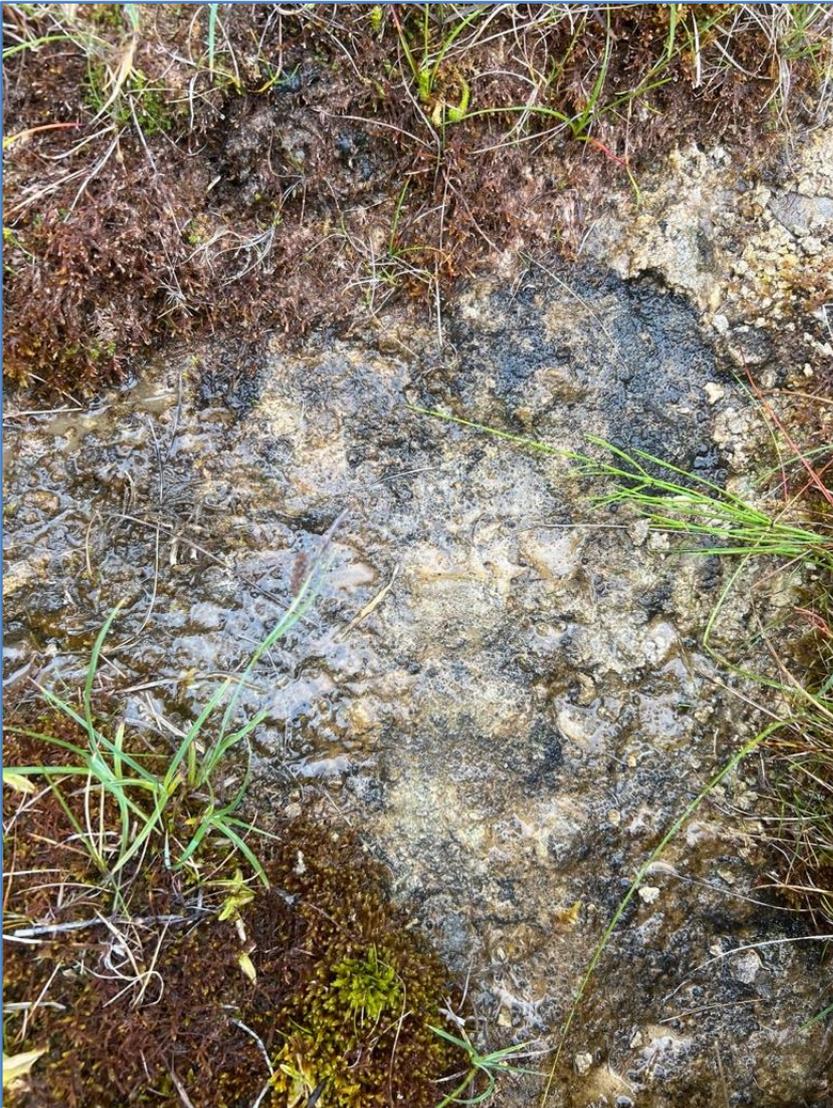
**Photograph 2** Species-rich petrifying spring on upper slopes of Arroo, with stream crust tufa and the rare bryophyte *Seligeria oelandica* (very small black moss). Photograph Joanne Denyer.

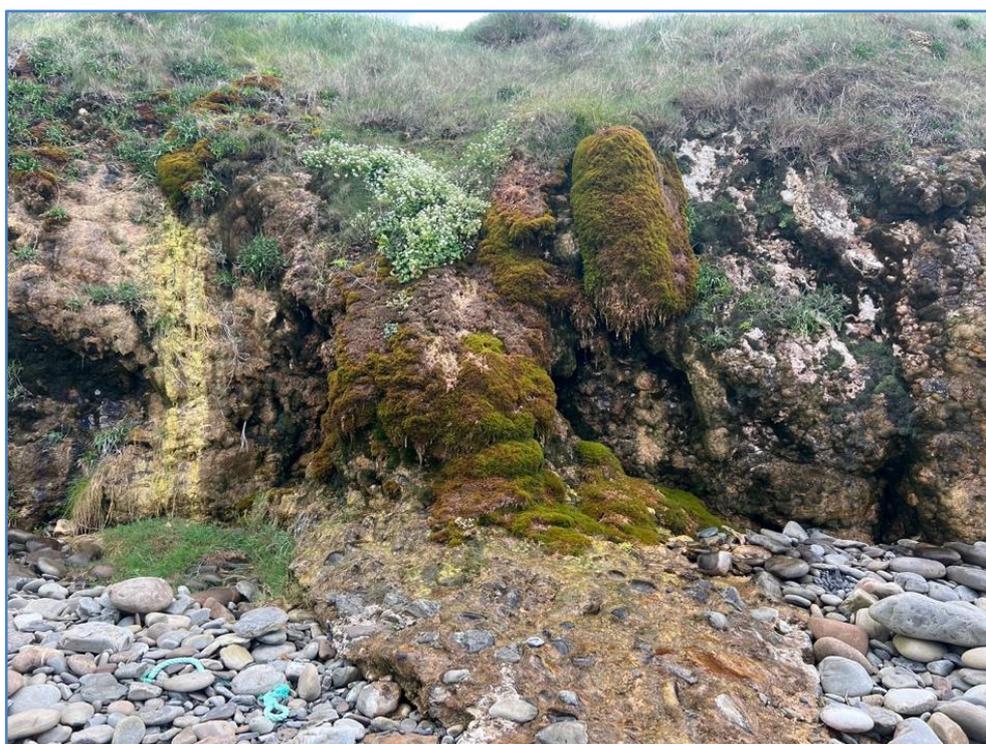
**Photograph 1** Coastal petrifying spring with massive cascade tufa formation, extending onto beach below, southern beach. Photograph Joanne Denyer.

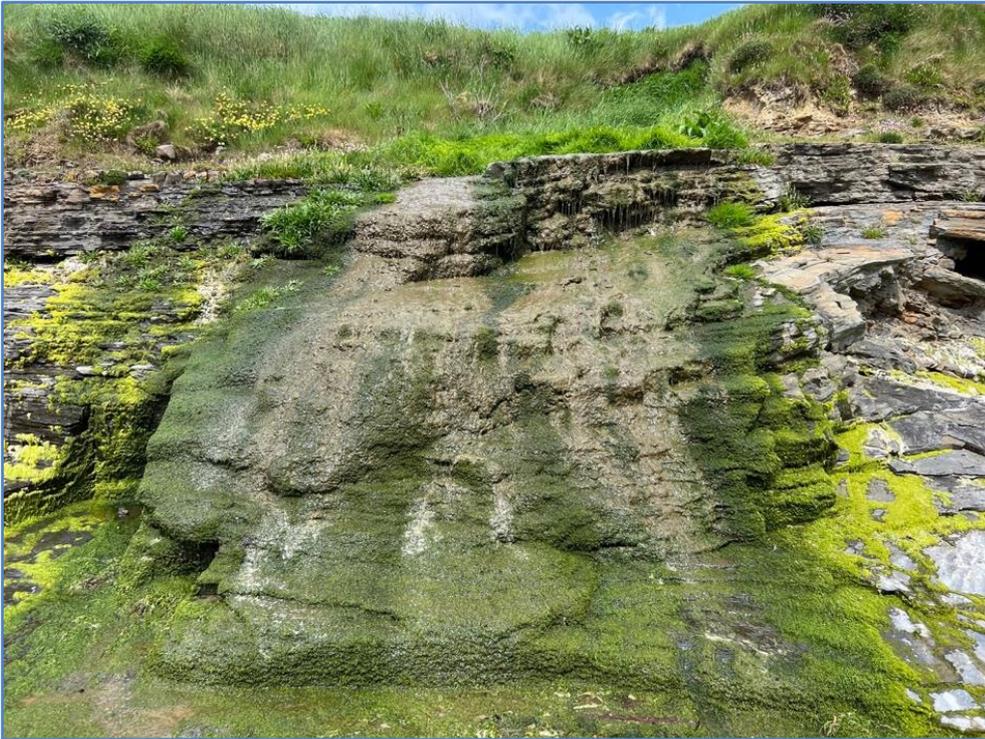
No. monitoring plots	7
% pass rate	71 %
Main criteria for failing S&F	Negative bryophyte; nitrate; phosphate

**Photograph 2** Highly polluted petrifying spring discharging over coastal rocks at north of beach. Photograph Joanne Denyer.

Site management	No change
Survey	Monitoring of polluted petrifying spring (Sh06) in northern part of site
Hydrogeology	Investigate source of elevated phosphates and nitrates

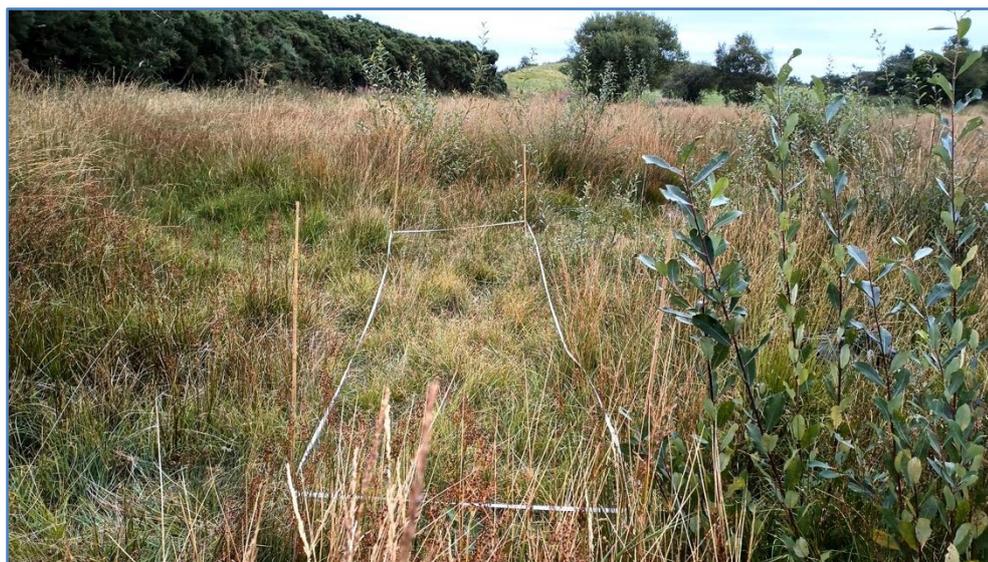
No. monitoring plots	4
% pass rate	0 %
Main criteria for failing S&F	Negative woody species; vegetation height

**Photograph 1** Petrifying spring vegetation at plot P01. Photograph George Smith

Site management	Introduce grazing or other management to open vegetation and reduce vegetation height. Ensure that petrifying spring locations are protected from installation of any hydrological monitoring equipment.
Survey	No further survey required in short-term
Hydrogeology	Investigate whether there have been changes in hydrology, as springs dry at time of survey.

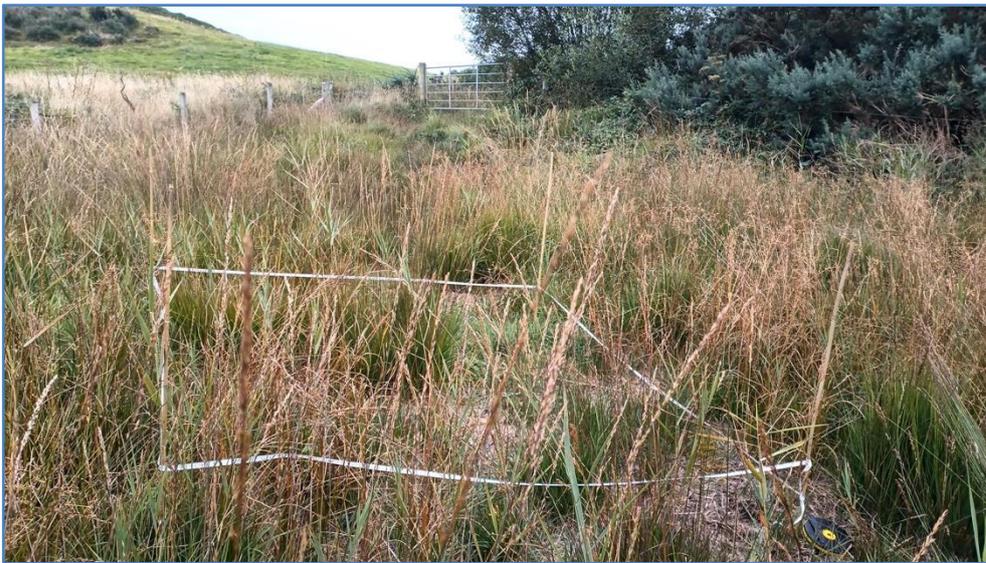
Photograph 2 Petrifying spring vegetation at plot P03. Photograph George Smith.

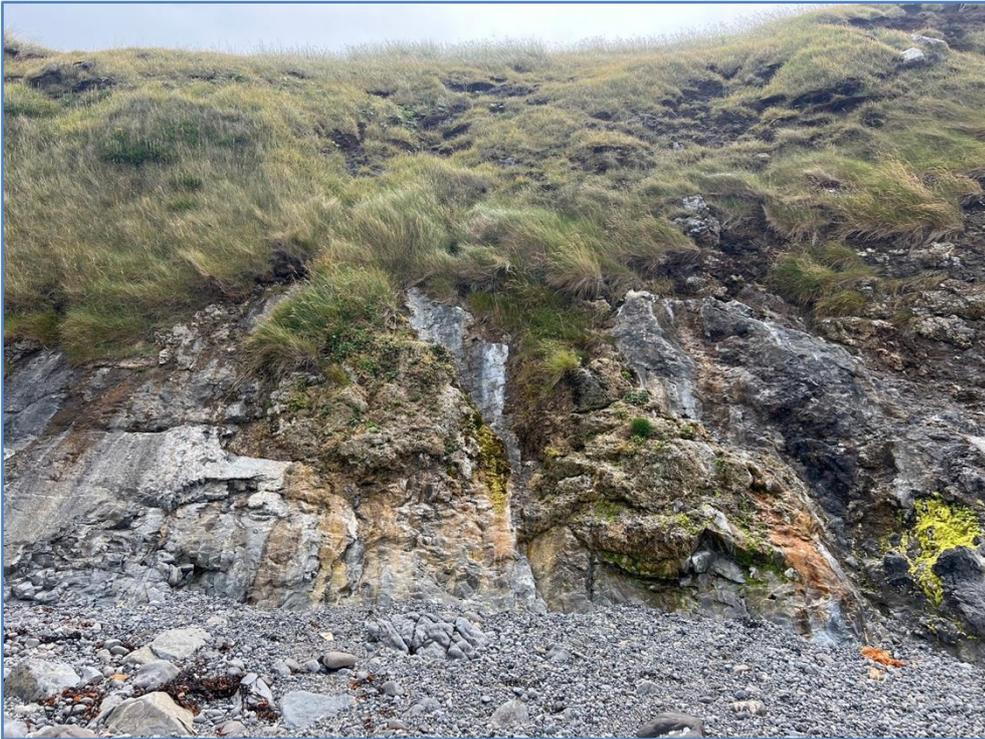
**Photograph 2** Cascade tufa on coastal slopes at Rosses Point. Photograph Joanne Denyer.

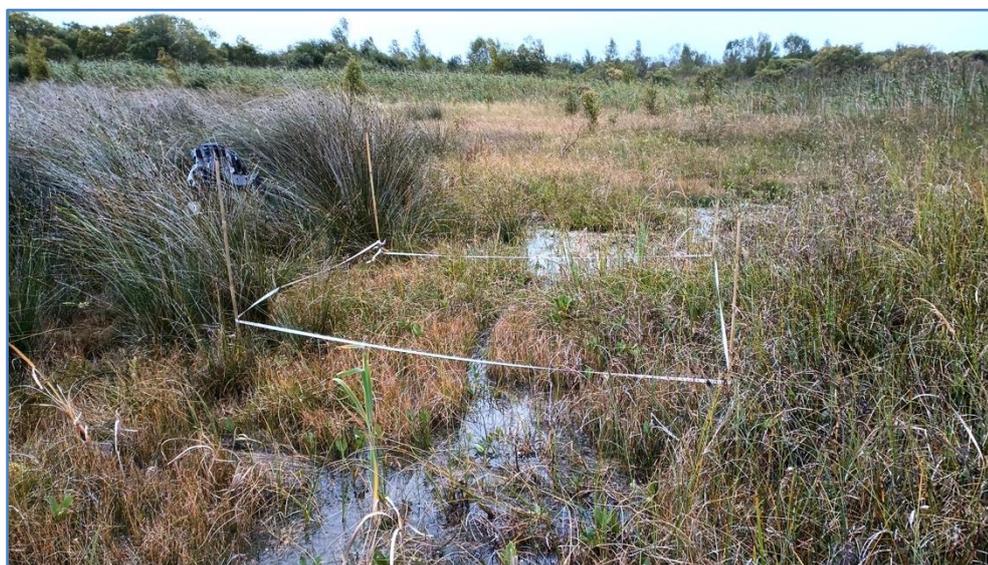
No. monitoring plots	2
% pass rate	100 %
Main criteria for failing S&F	Phosphate may be slightly elevated (field test kit appeared to colour slightly but water sample not clear). However, no impact on condition of petrifying springs.

**Photograph 1** Petrifying spring/ flush vegetation at base of esker. Photograph George Smith.

Site management	No change to current low levels of cattle grazing
Survey	Survey of remaining area of SAC that was not surveyed in 2023, particularly eastern section of esker base.
Hydrogeology	Laboratory testing of water sample to assess if phosphates elevated

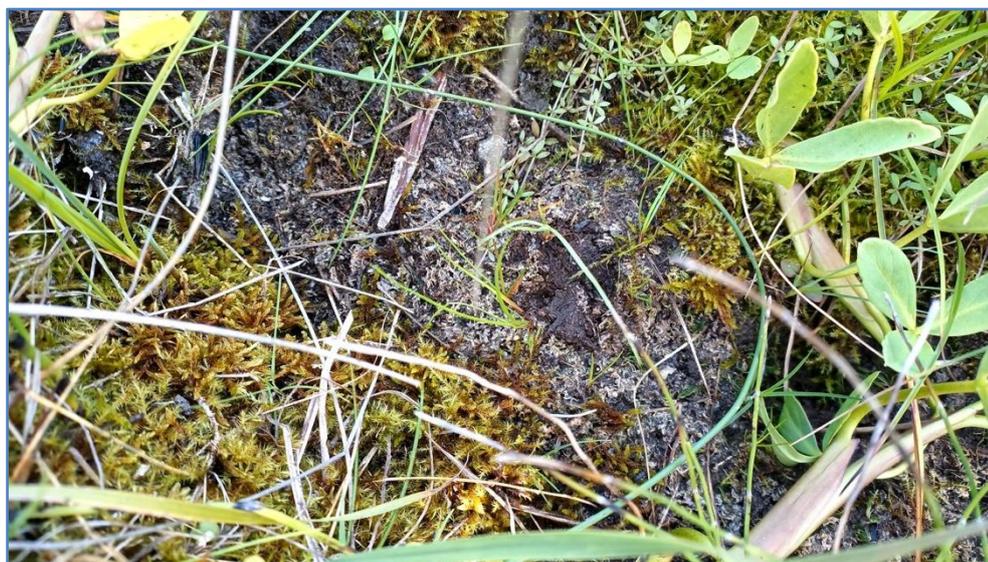
**Photograph 2** Paludal tufa on bryophytes in petrifying spring/ flush. Photograph George Smith.

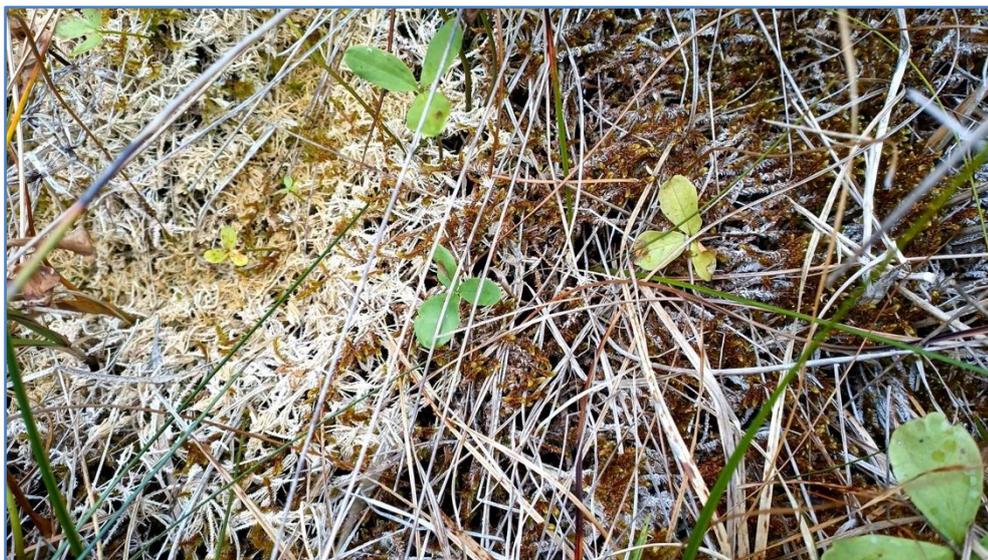
No. monitoring plots	3
% pass rate	0 %
Main criteria for failing S&F	Positive indicator species; phosphate; water flow; vegetation height

**Photograph 2** Paludal tufa on the moss *Scorpidium cossonii* in overgrown petrifying spring. Photograph George Smith.

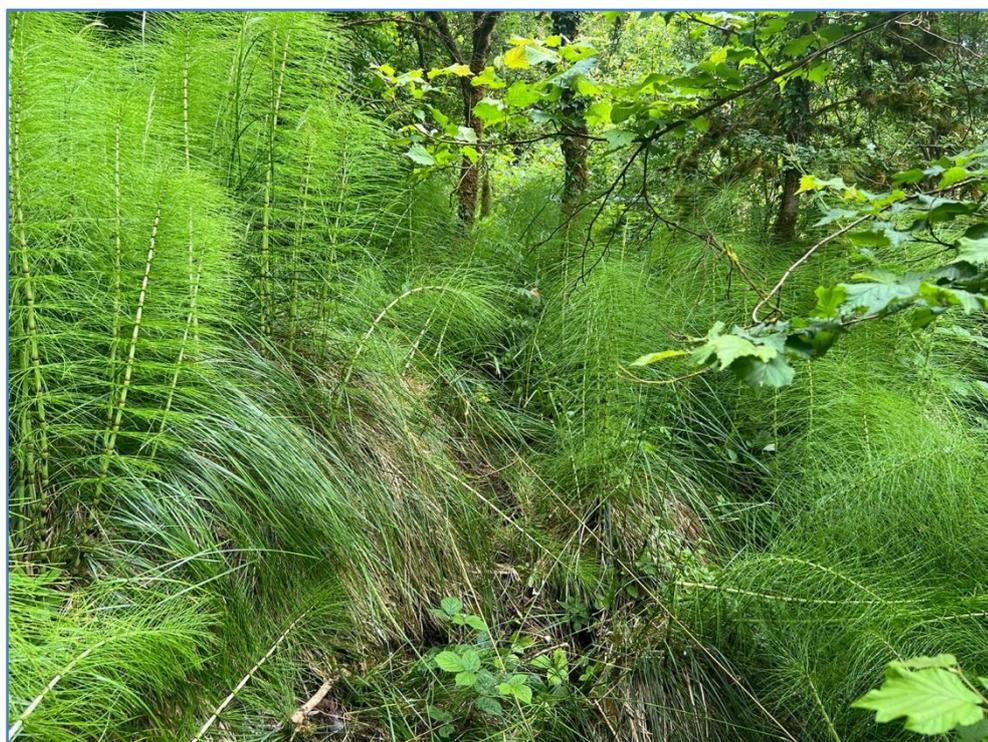
No. monitoring plots	1
% pass rate	100 %
Main criteria for failing S&F	Nitrate levels elevated, but all other criteria pass

**Photograph 1** Petrifying spring vegetation in woodland seepage, dominated by tall *Equisetum telmateia*. Photograph Joanne Denyer.

Site management	Avoid disturbance as some areas very wet and easily damaged by trampling
Survey	No further survey required in short-term
Hydrogeology	Investigate source of elevated nitrate

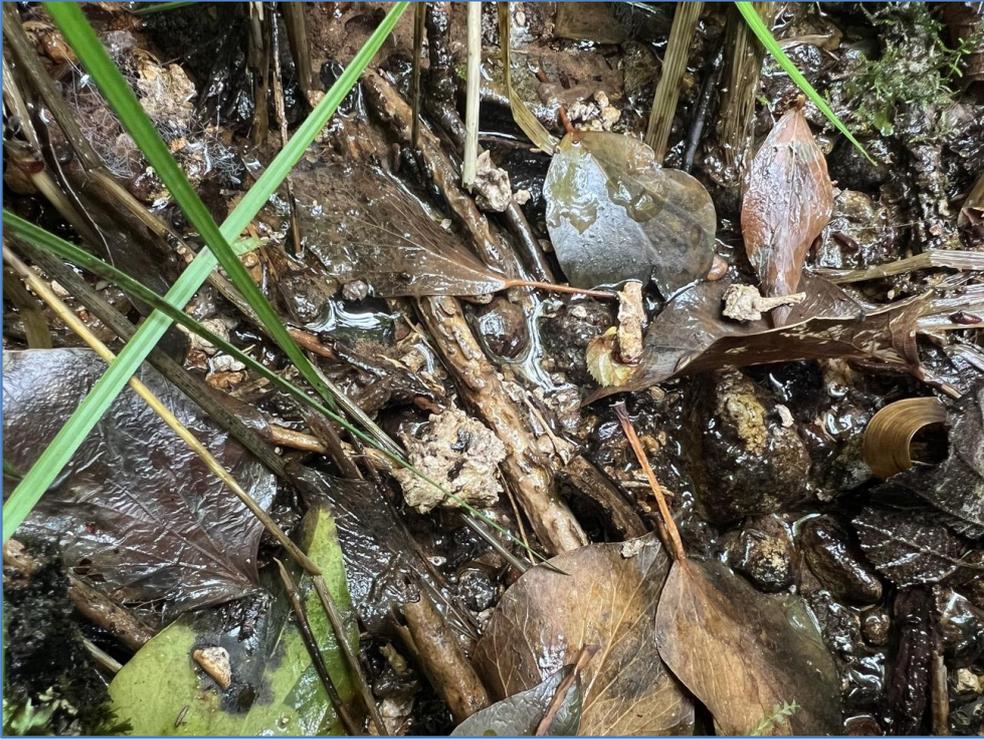
**Photograph 2** Sparse oncoids/ ooid tufa formation in petrifying spring. Photograph Joanne Denyer.

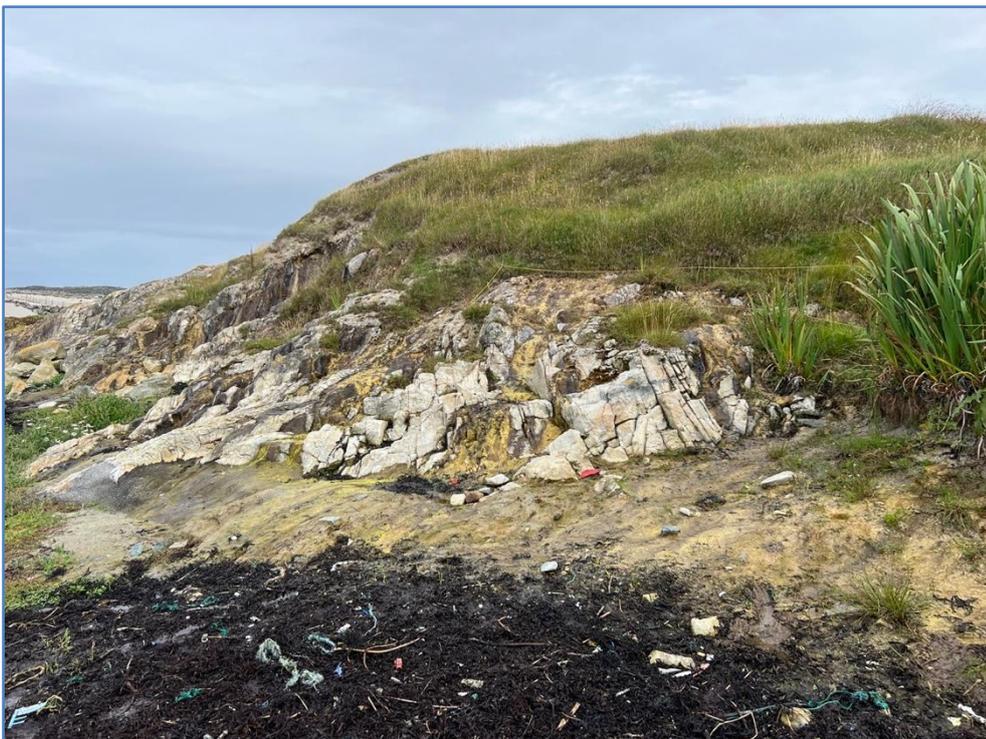
No. monitoring plots	4
% pass rate	100 %
Main criteria for failing S&F	Phosphate high but all other criteria pass and springs currently in good condition

**Photograph 1** Cascade tufa in seepage over coastal rocks with *Eucladium verticillatum*, *Didymodon tophaceus* and *Hymenostylium recurvirostrum* var. *recurvirostrum*. Photograph Joanne Denyer.

Site management	No change to current low levels of rabbit grazing
Survey	No further survey required in short-term
Hydrogeology	Investigate source of elevated phosphates

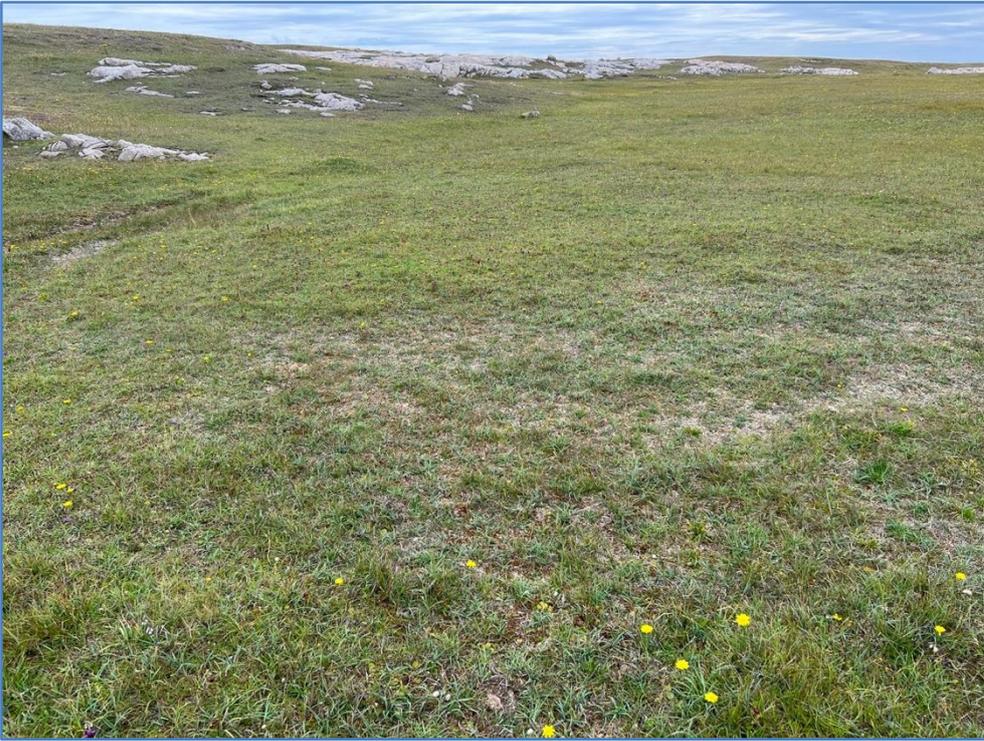
**Photograph 2** Small sedge petrifying spring vegetation in machair with paludal tufa abundant on *Scorpidium cossonii*. Photograph Joanne Denyer.

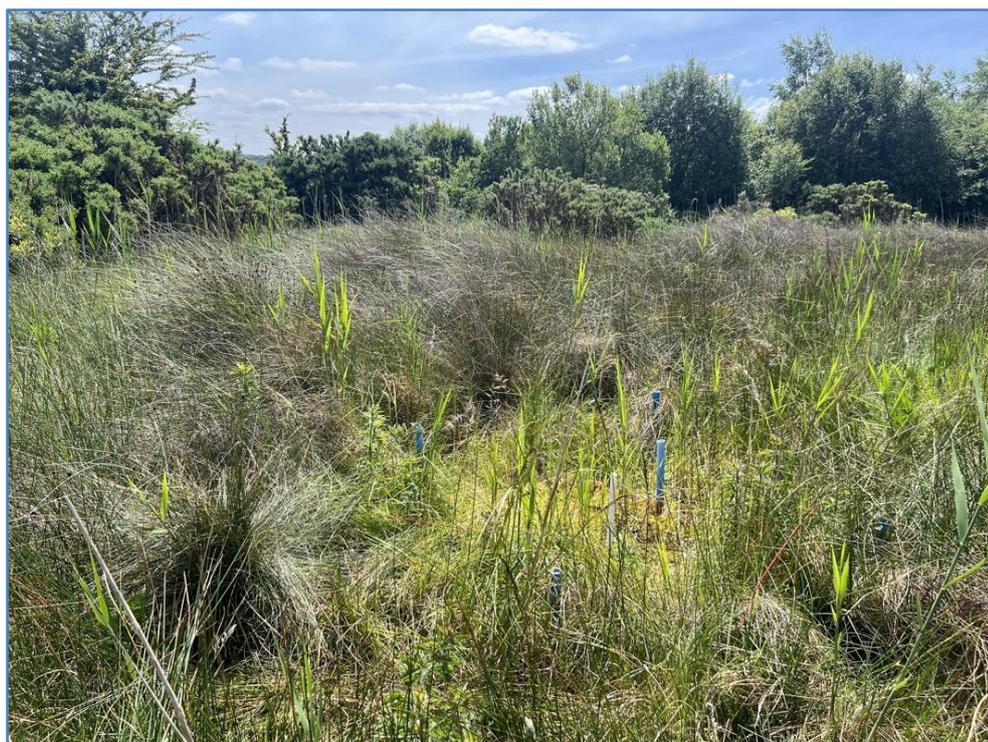
**Photograph 1** Petrifying spring springhead with strong paludal tufa in north west of site, grading to *Schoenus* fen around springhead. Photograph Joanne Denyer.

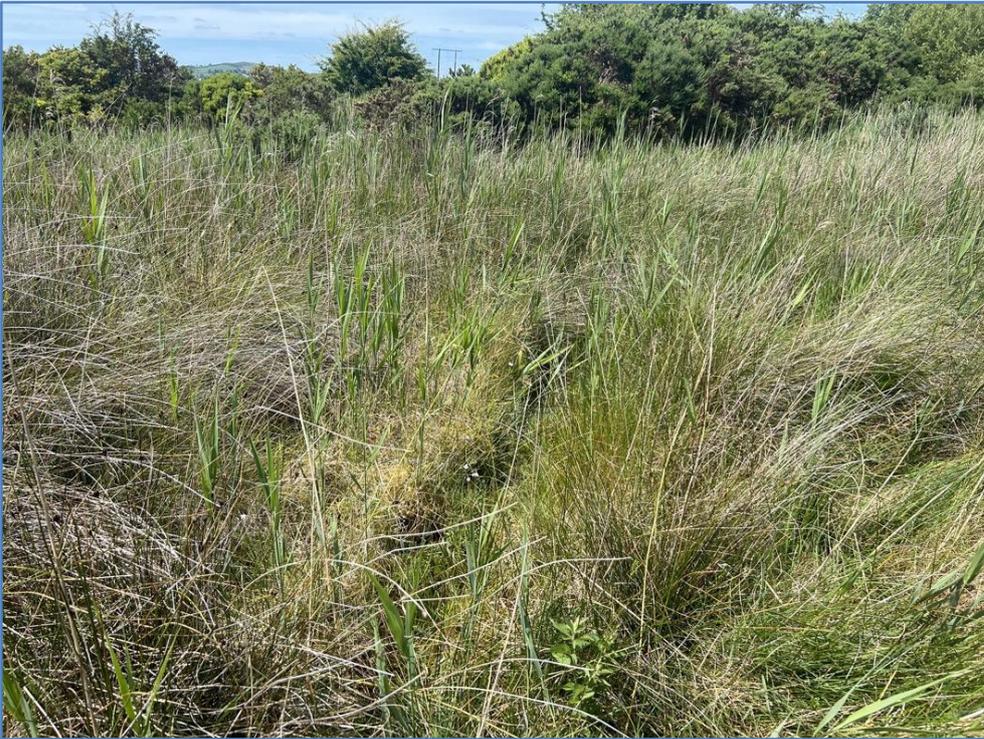
Plot M02 had a reduction in positive indicator species compared to the baseline survey from 2013. This has previously been described as Group 6 small sedge petrifying spring vegetation, but in 2024 was dominated by tall *Schoenus nigricans*. The high quality indicator species *Tomentypnum nitens* was recorded from this plot in 2013 but was not found in 2024 in the plot or adjacent area. Phosphate levels were elevated in 2024, but not in 2012. Plot M04 had an increase in positive indicator species from the baseline. Plot M05 had the same number of positive indicator species but *Tomentypnum nitens* was not recorded from this spring or adjacent areas where it had previously been present. The vegetation is very overgrown.

**Photograph 2** Overgrown petrifying spring springhead in north west of site, ground quaking and unstable underfoot around springhead. Photograph Joanne Denyer.

Site management	Reintroduction of grazing to reduce vegetation height and open vegetation
Survey	Survey of remaining area of SAC that was not surveyed in 2024
Hydrogeology	Investigate potential elevated phosphates in the south-west of the site. Reduce drainage/ abstraction from fen vegetation.

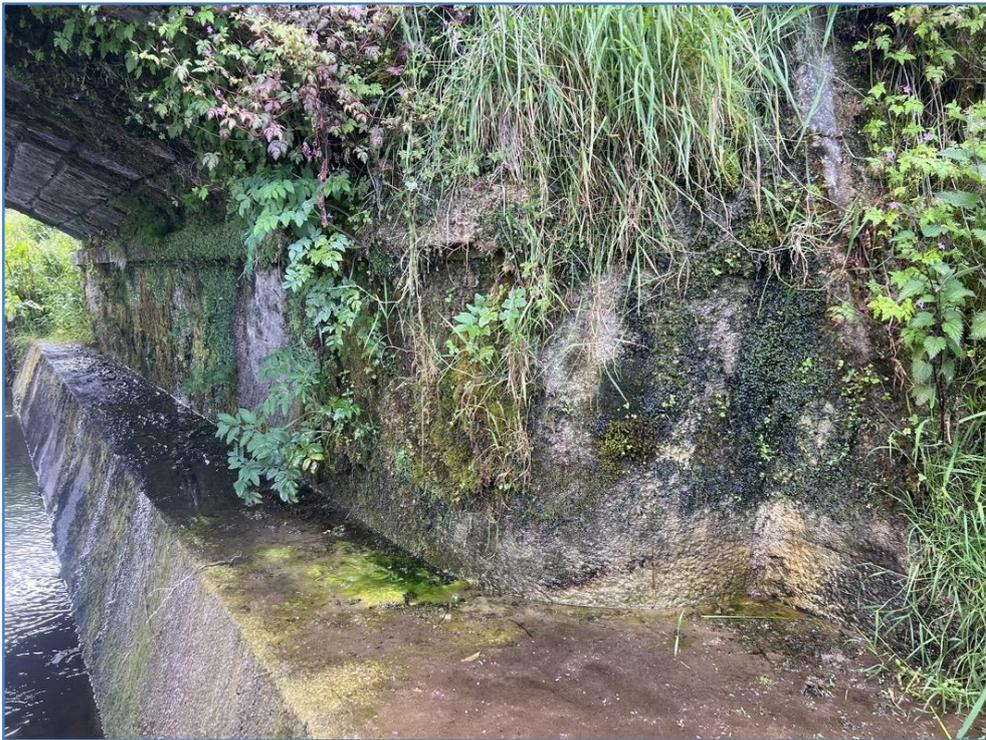
**Photograph 1** Cascade tufa and species-rich petrifying spring vegetation on Monasterevin Grand Canal / River Barrow aqueduct. Photograph Joanne Denyer.

Site management	Monasterevin – protect site from any re-pointing or similar works which could remove the tufa and vegetation
Survey	Survey of remaining area of SAC that was not surveyed in 2024
Hydrogeology	Investigate source of elevated phosphates and nitrates at Dysart site

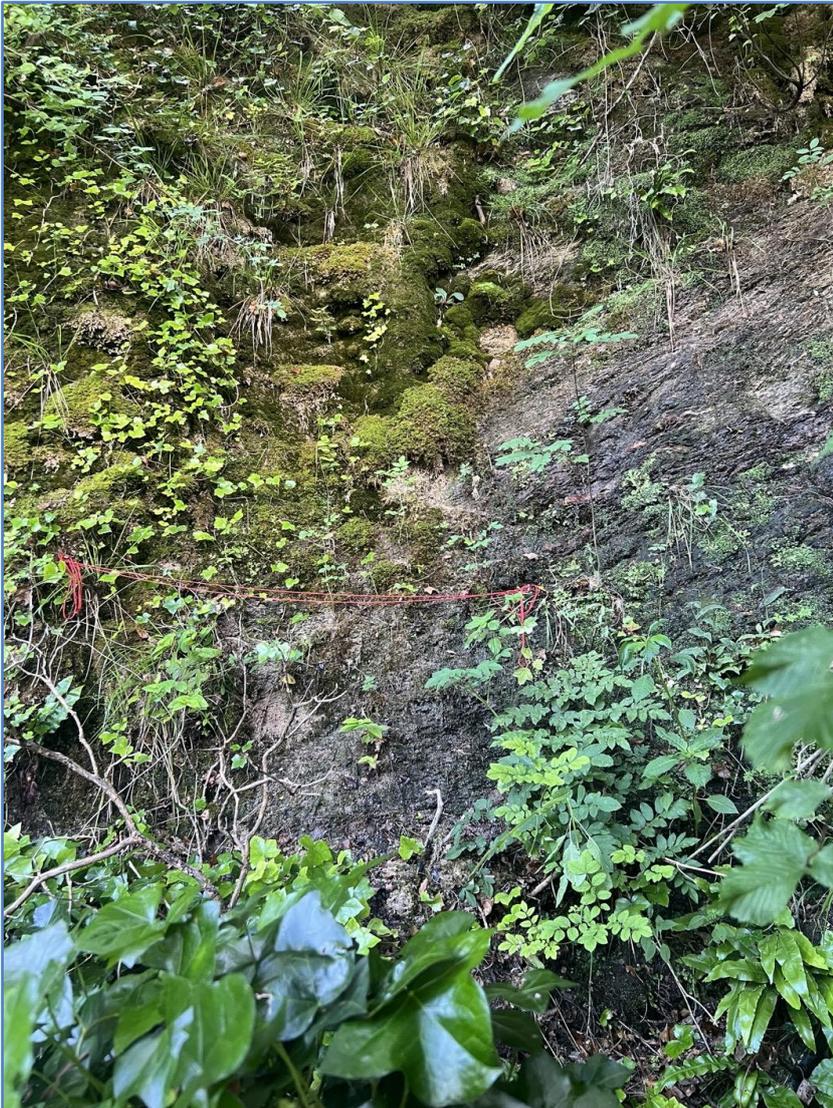
**Photograph 2** Cascade tufa with *Eucladium verticillatum* and *Palustriella commutata* on steep slope in wooded valley, Dysart. Photograph Joanne Denyer.

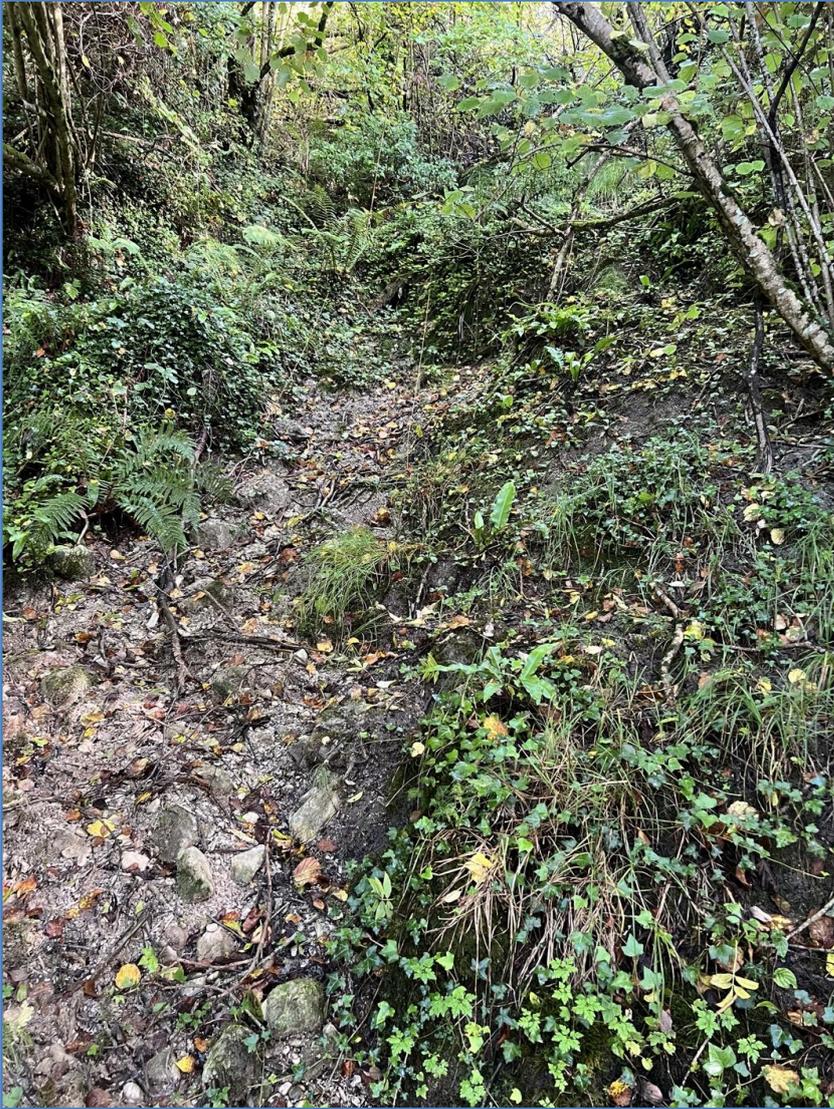
**Photograph 3** Petrifying spring tufa with sparse vegetation and abundant oncoids and ooids, wooded river valley, Dinin. Photograph Joanne Denyer.

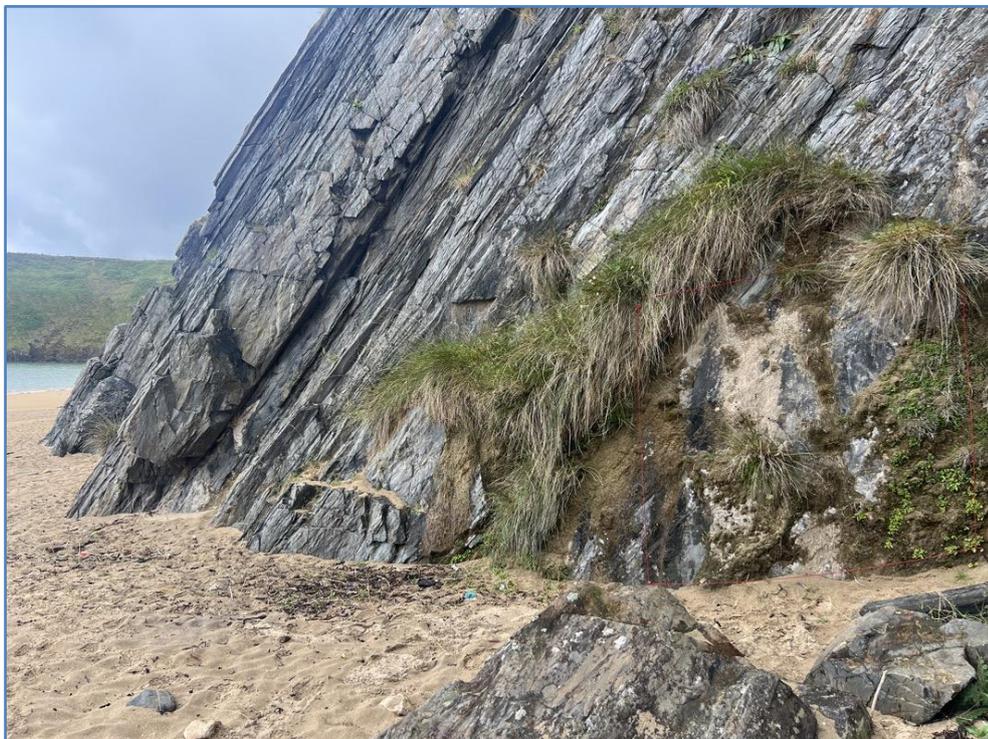
**Photograph 1** Cascade tufa on coastal rocks with *Adiantum capillus-veneris* and *Moerckia flotoviana* within petrifying spring. Photograph Joanne Denyer.
