# Monitoring and Assessment of EU Habitats Directive Annex I Priority Habitat Petrifying Springs, 2025

## Irish Wildlife Manuals 160

## **Monitoring and Assessment of EU Habitats Directive Annex I Priority Habitat Petrifying Springs, 2025**

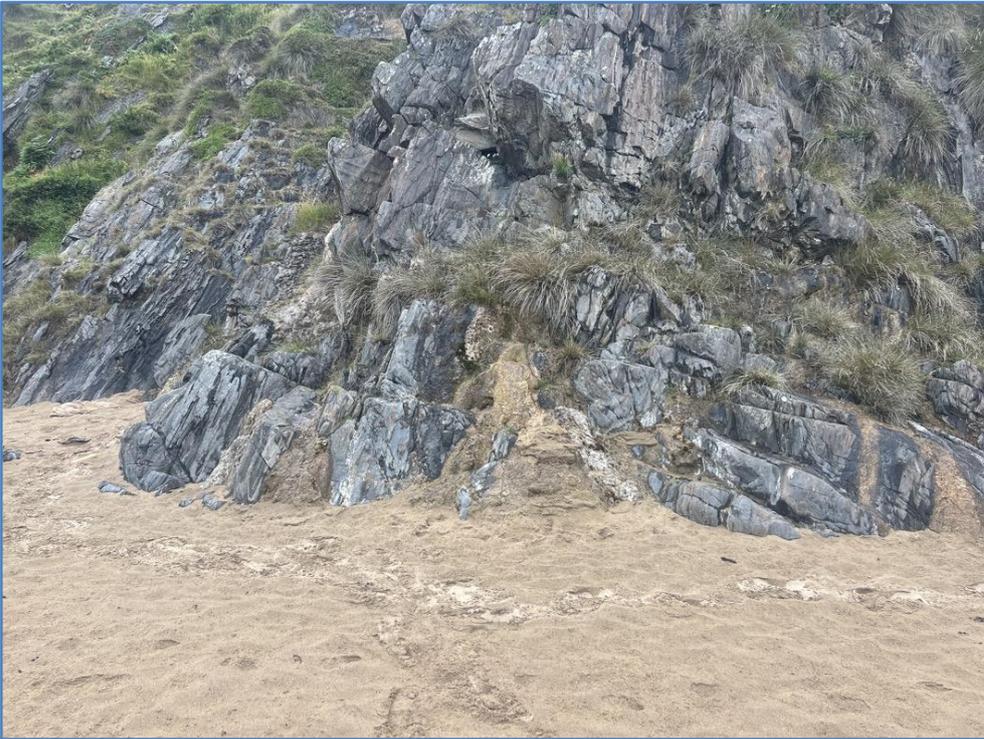
**Photograph 2** Cascade tufa on coastal rocks with *Moerckia flotoviana* and abundant *Didymodon tophaceus* within petrifying spring. Photograph Joanne Denyer.

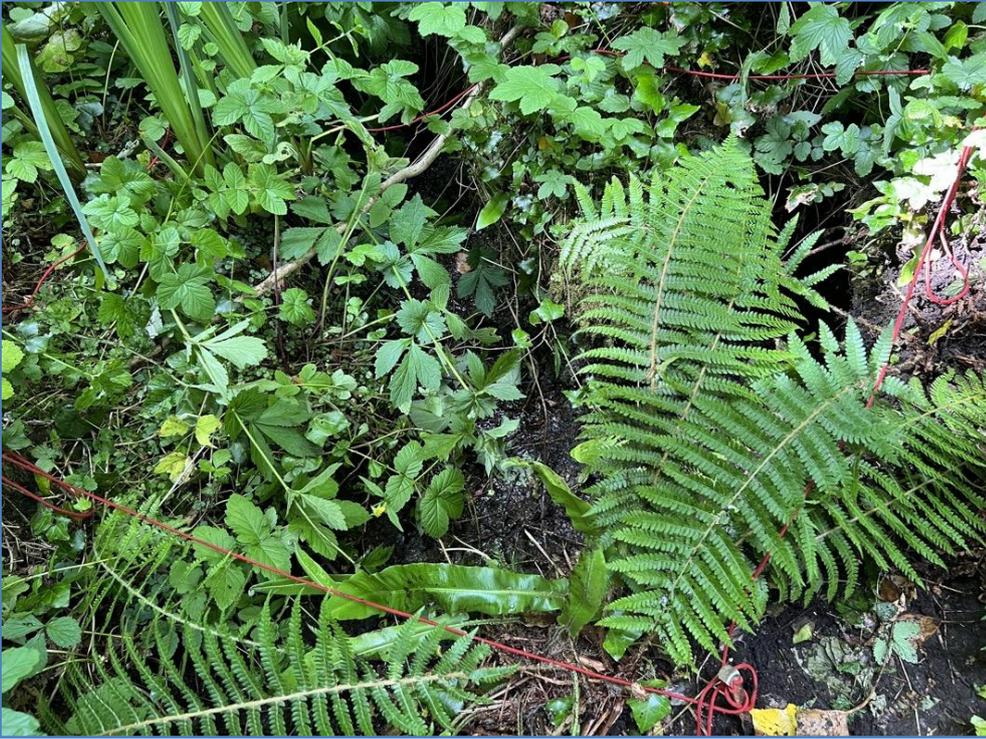
**Photograph 2** Shaded petrifying spring vegetation in spring with small amounts of cascade tufa. Photograph Joanne Denyer.

Site management	Currently used as an occasional access path which causes some trampling damage. Consider fencing/ brush piles, to discourage access through this small valley.
Survey	No further survey required in short-term
Hydrogeology	Investigate impacts of pipes and other potential impacts to hydrology of the spring area.

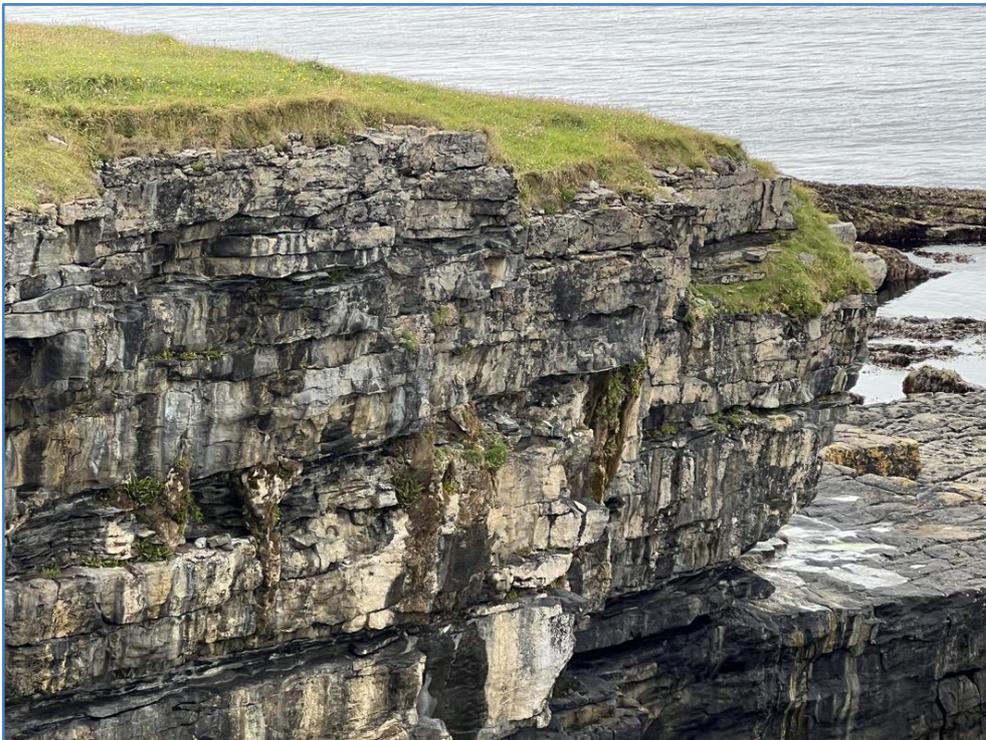
**Photograph 1** Massive cascade tufa with petrifying spring vegetation on high inaccessible cliffs in south-west of SAC. Photograph Joanne Denyer.

Site management	n/a
Survey	Survey petrifying springs on coastal cliffs in south-west of site (may require climbing equipment)
Hydrogeology	None

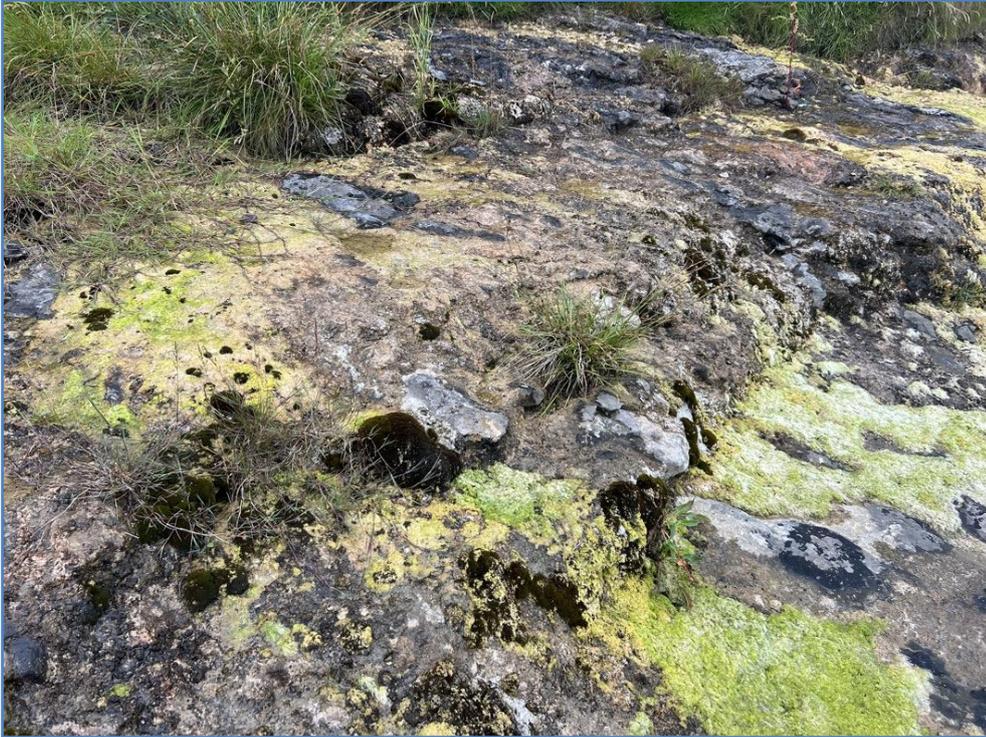
**Photograph 2** Cascade tufa over rocks on northern beach shoreline with abundant *Didymodon tophaceus*, *Eucladium verticillatum* and *Schoenus nigricans*. Photograph Joanne Denyer.

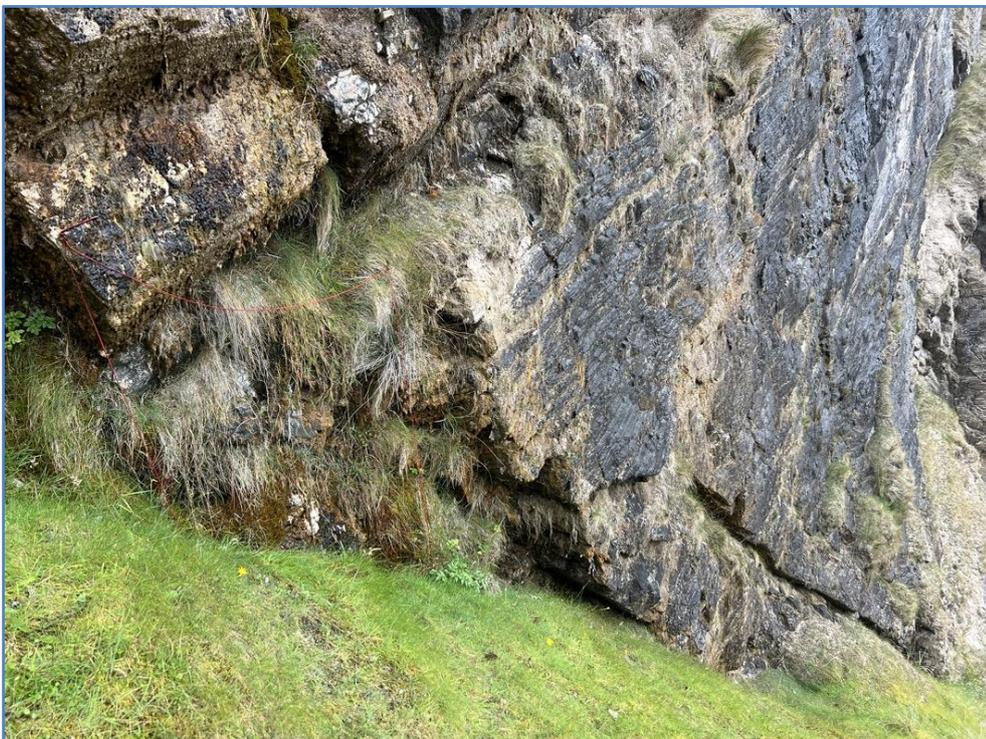
**Photograph 1** Cascade tufa and soft tufa bound sand on rocks with petrifying spring vegetation up steep slope from beach. Photograph Joanne Denyer.

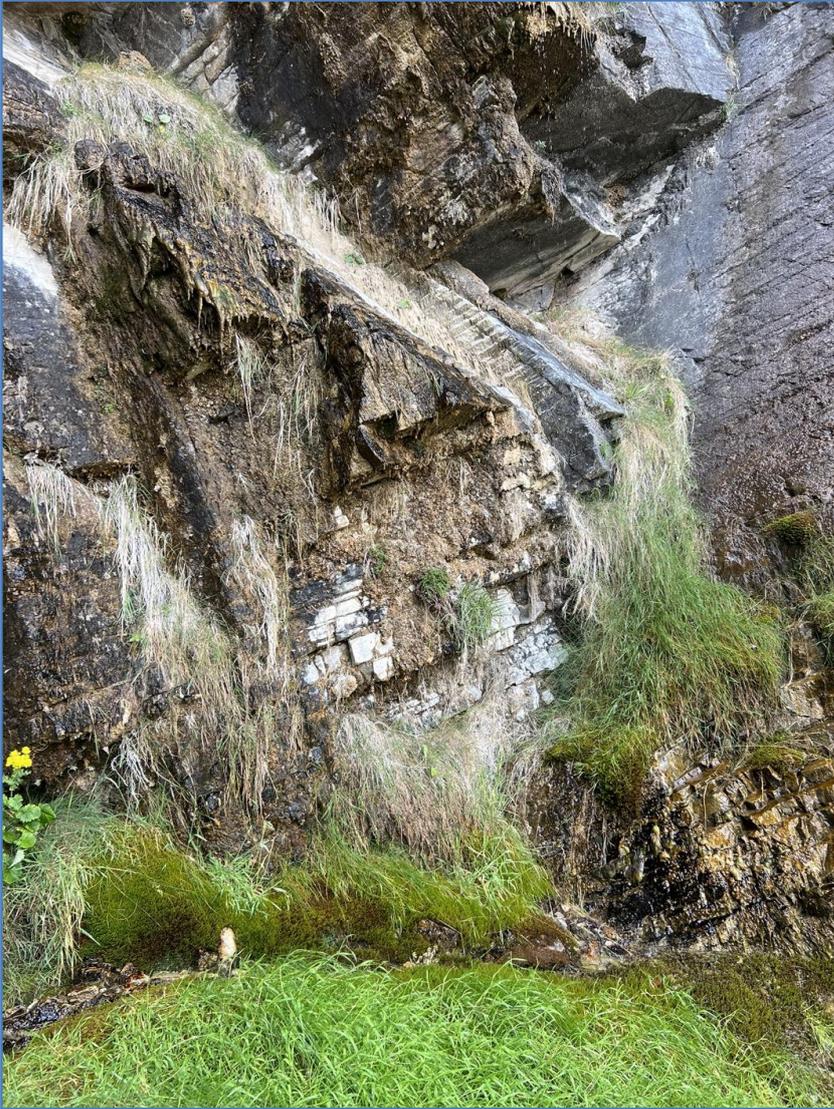
**Photograph 2** Part of seepage line with cascade tufa near large cave entrance, up slope from beach. *Palustriella commutata* abundant with soft tufa bound sand, but also some harder more typical tufa. Photograph Joanne Denyer.
