**TEICNIUIL-PRIORY CONSULTING
ENGINEERS Ltd**

Structural Report and Condition Survey

Location: Whispering Pines, Coolick, Killarney. Co. Kerry, V93 E9P5

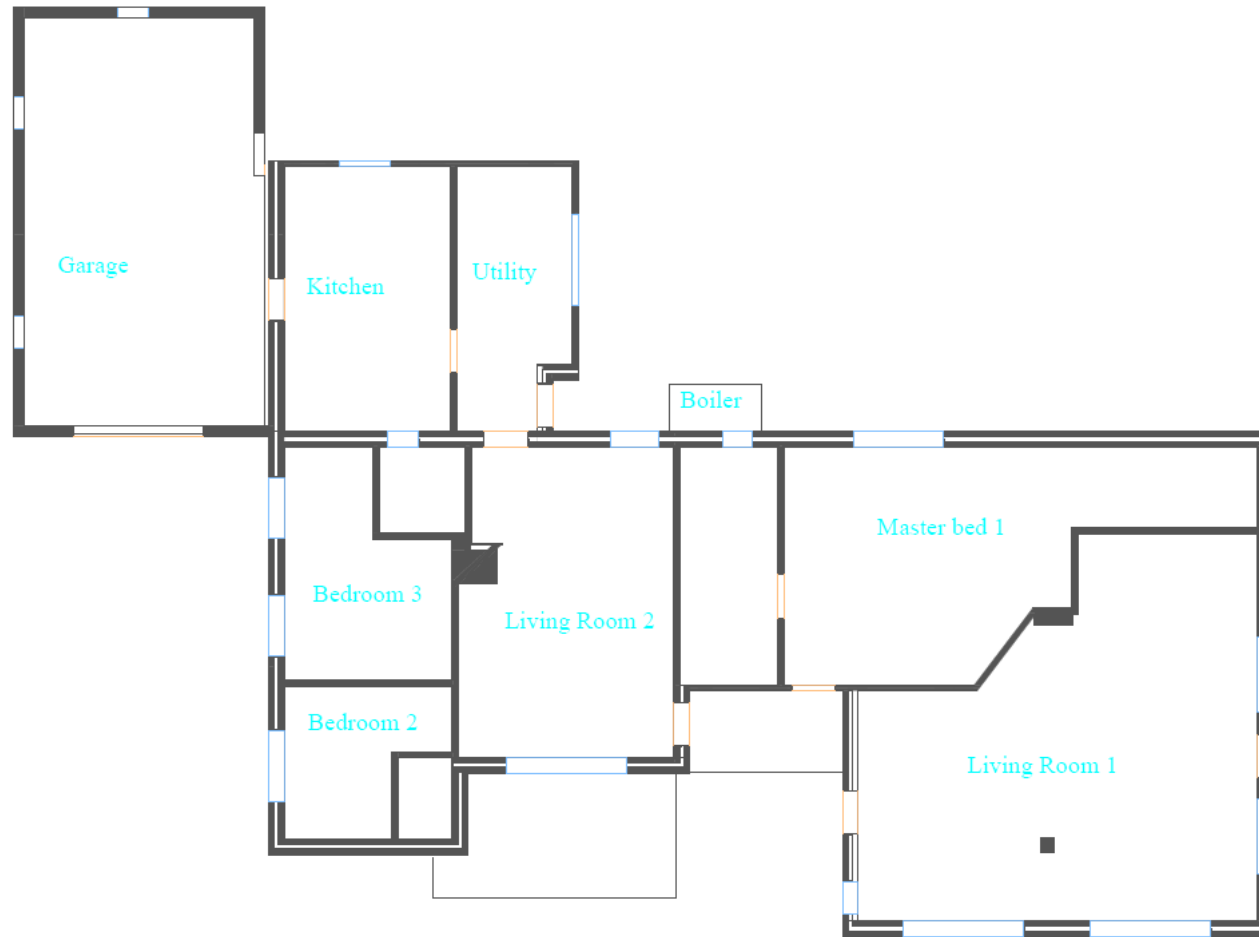
(note: drawings for schematic purposes ONLY for the purposes of this report)

Appendix 1 – Floor Plan
