# BAT DEROGATION LICENCE APPLICATION – MENLOUGH CASTLE

| Project Reference | 191204 |
| Subject | Menlough Castle Phase 6 - Derogation License |

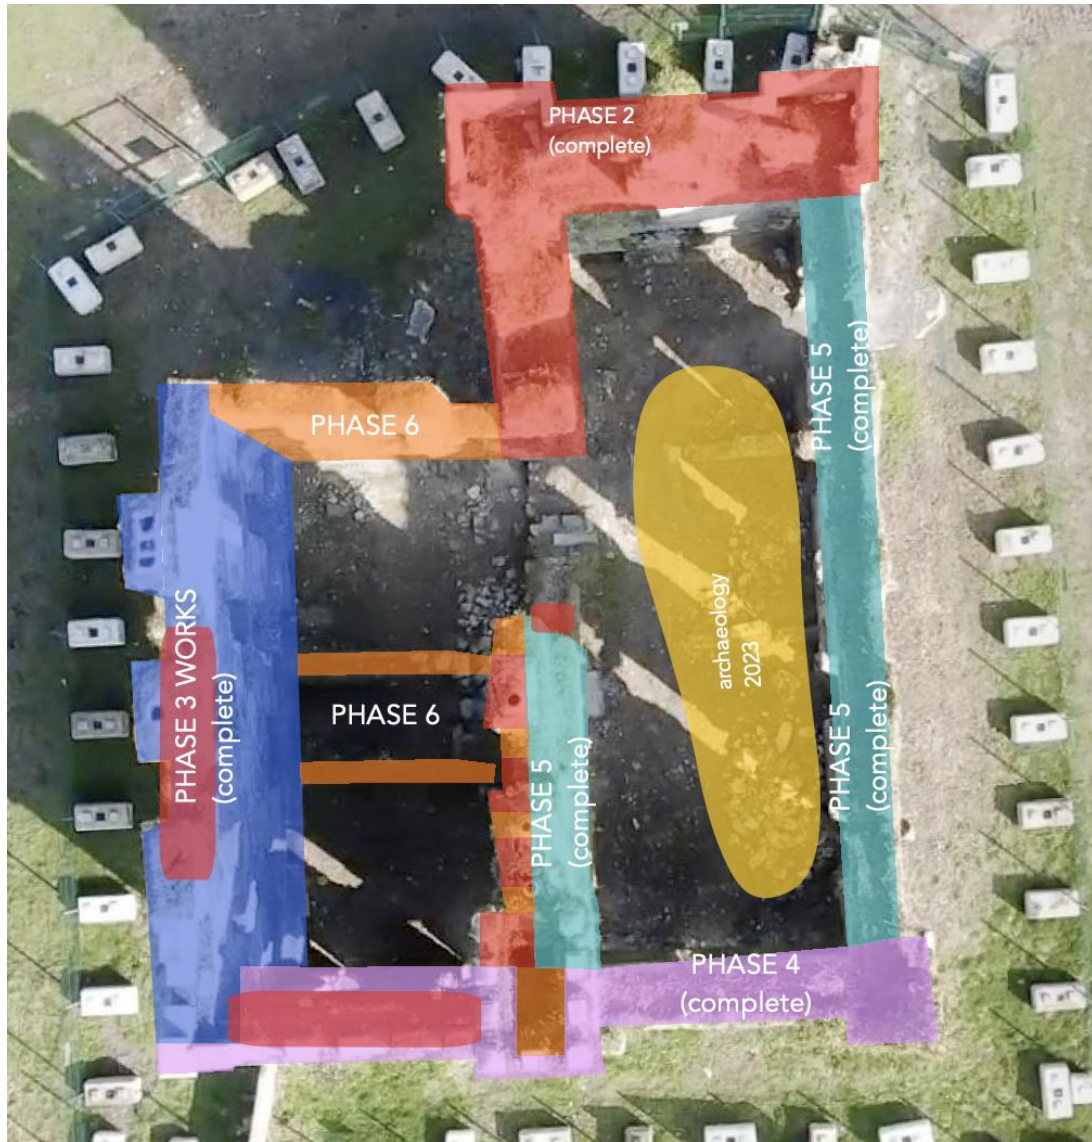
*Figure 1 – Completed and proposed Phased works of Menlo Castle*

The proposed works aim to support the stabilisation and conservation of Menlough Castle. The proposed Phase 6 works will run over an approximate 8-week programme from June 2026 onward and will focus on the west side of the spine wall, the northern wall on the western side, and interior ground floor areas not completed in previous phases (Figures 1 & 2).

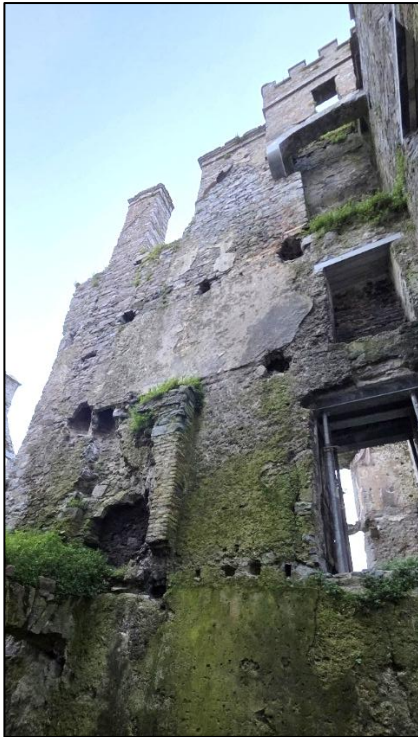
*Plate 1: West side of internal spine wall to be repaired as part of Phase 6*

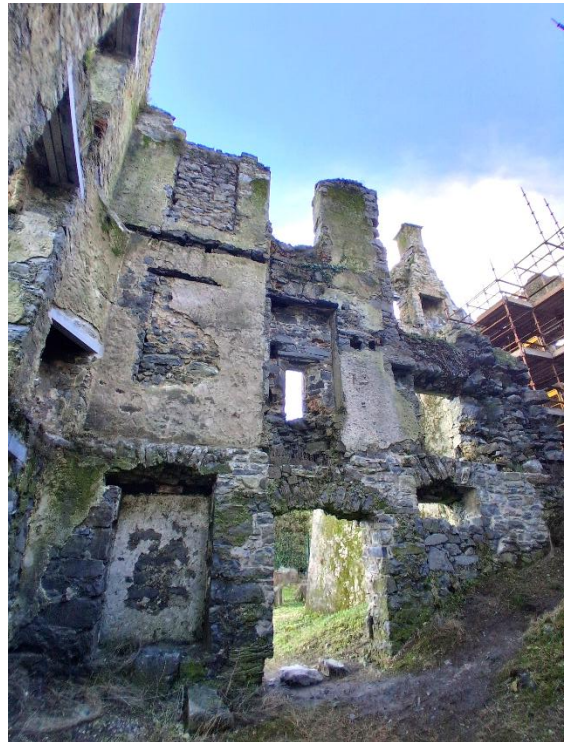
*Plate 2 Internal elevation of northern wall on west side to be repaired as part of Phase 6*

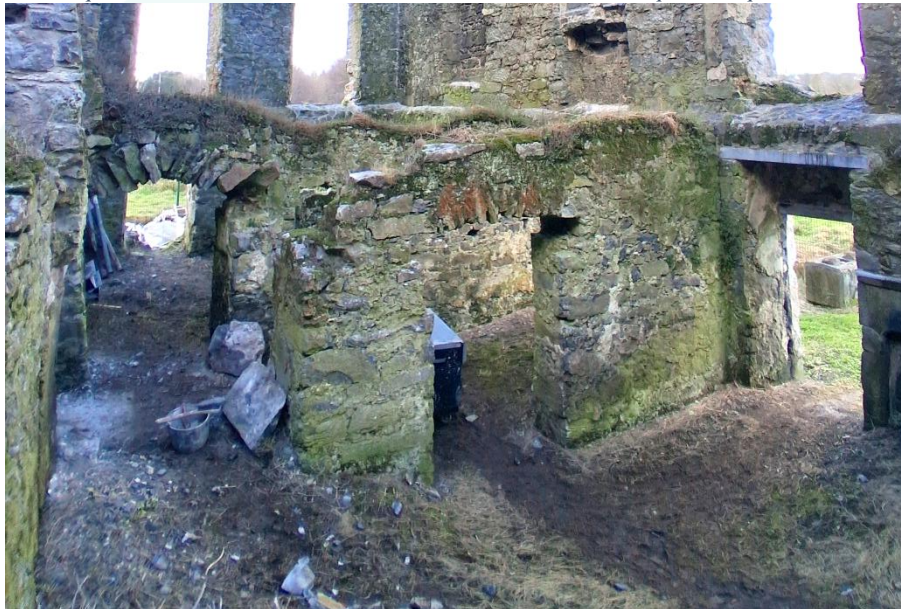
*Plate 3: Internal ground level walls in the west area of the castle to be repaired as part of Phase 6*

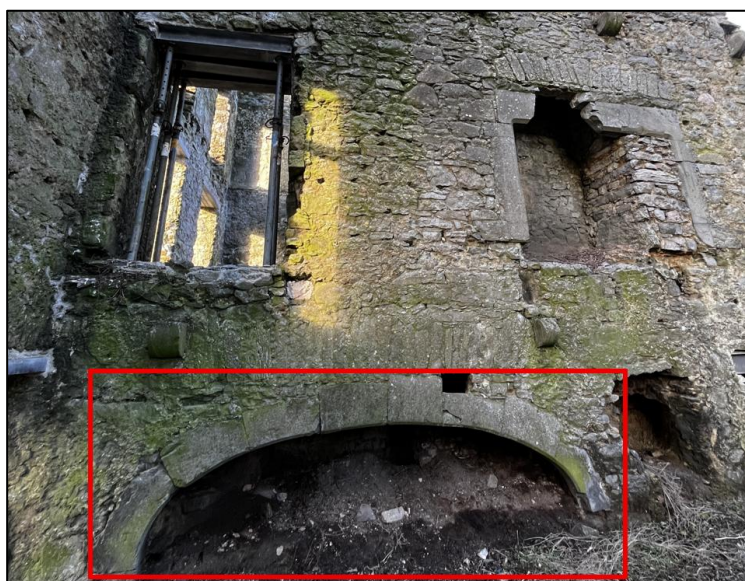
*Plate 4: Fireplace on the eastern side of the central spine wall where the Lesser horseshoe were recorded emerging.*

The dusk emergence survey confirmed emergence activity of lesser horseshoe bat, with 62 observations of LHB emerging from the chimney during the survey (Plate 4). However, 23 re-entrances were also recorded. Based on the emergence/re-entry activity, the estimated population size is approx. 39 bats. Other behaviour at the roost entrance included 12 recordings of LHB emerging briefly and re-entering straight away. From previous surveys carried out at the site, this behaviour is typical for this population.

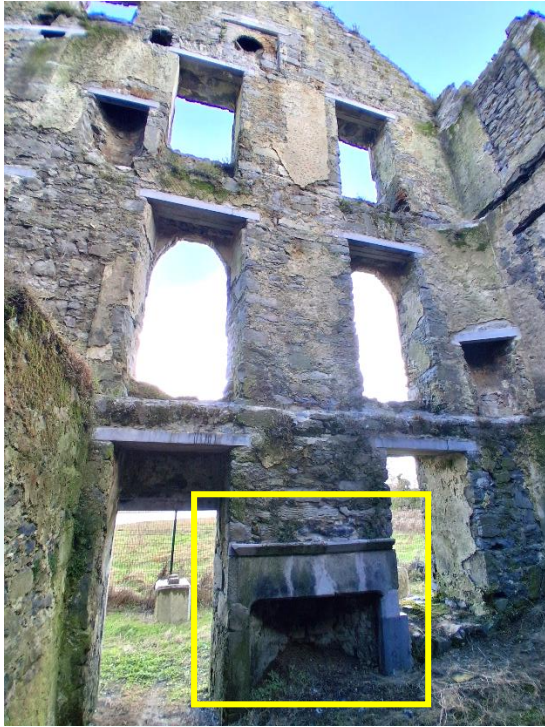
Plate 5: Fireplace on western internal elevation used as night roost by an individual LHB

They were also recorded utilising other chimney cavities within the castle but outside the works area as night roosts during the survey (Plates 5 & 6). These included chimney cavities on the western wall elevation at ground floor level.

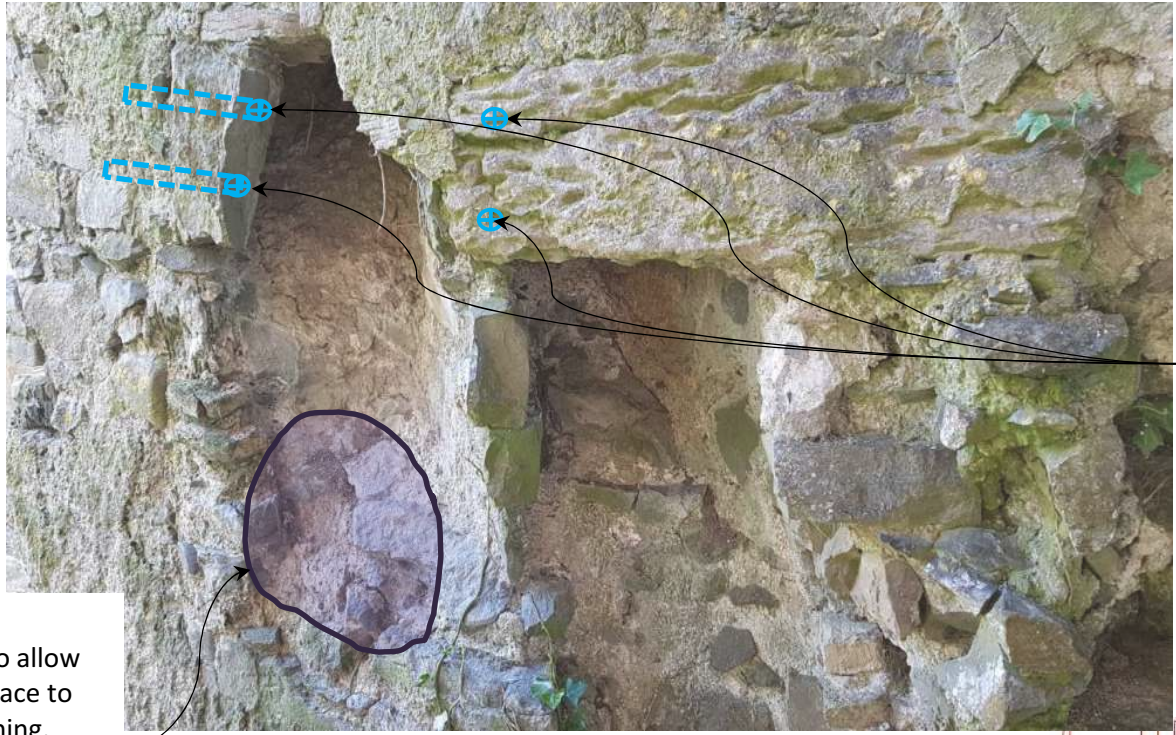
Area to be flaunched to allow the top surface to be self draining. Note stone pinning's maybe required.

Void to be infilled with salvaged stone to match the existing, bedded in lime mortar to match the existing. Infill to be recessed by 150mm at the location of the existing timber floor beams. Base of the pocket to be flaunched to allow rainwater run off.

Allow for temporary propping the existing lintel over the fireplace. Allow for the stone to be fixed back to the wall with two number M10 sock fix anchors per stone. Sock fix anchors approximately 400mm long. Location and size of the sock fix anchors to be reviewed when access is arranged. Head of the sock fix anchor to be concealed with a stone indent or mortar repair to match the surrounding stone.

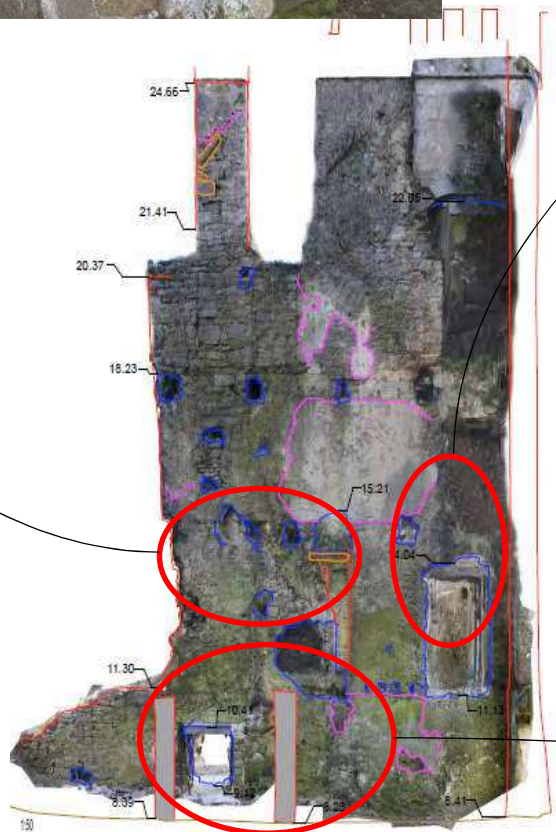
INTERNAL WALL LOOKING EAST

Refer to CORA drawing SK5023 for the number of lintels. Dry pack between the new lintels and the wall over.

Area to be flaunched to allow the top surface to be self draining. Note stone pinning's maybe required.

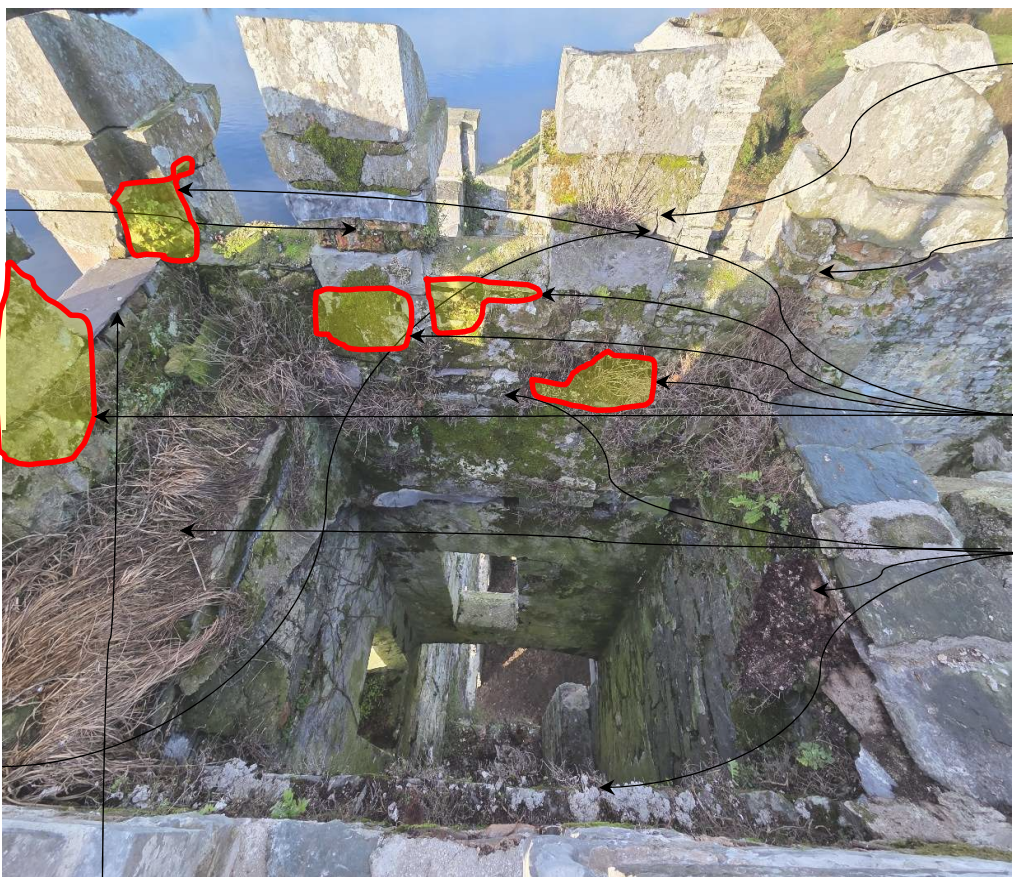
INTERNAL WALL LOOKING SOUTH & WEST

Existing slate to be carefully lifted and reseated in lime mortar.

Lime wash to be applied to the face of the red bricks.

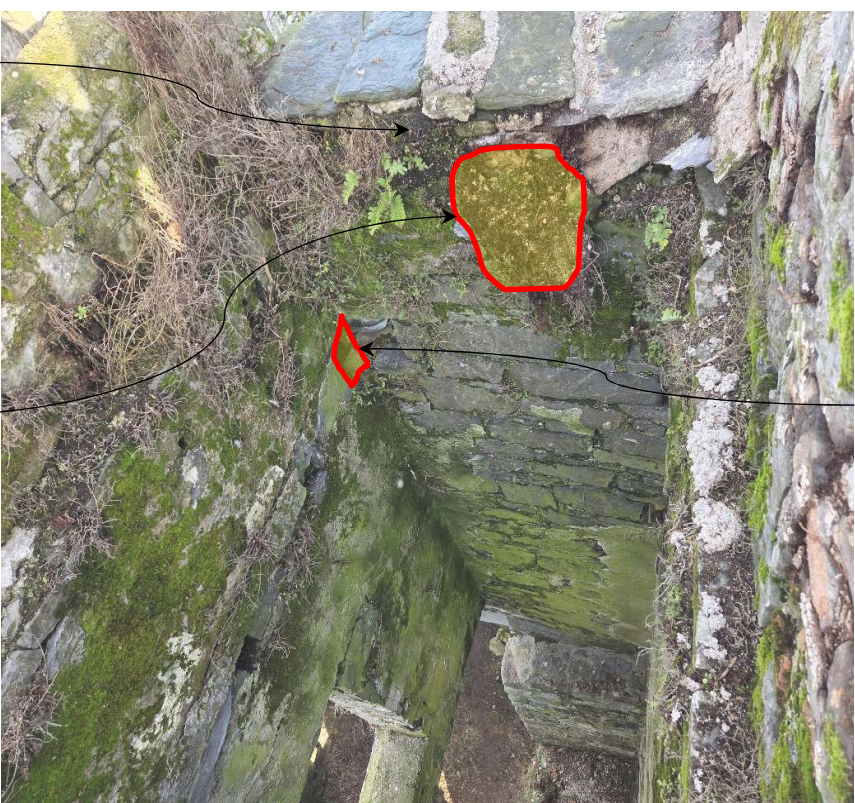
INTERNAL WALL LOOKING NORTH

Allow for localised rebuilding in new or salvaged stone to match the existing in lime mortar at the location of the existing rainwater outlet. The extend of the rebuild is to be agreed on site when the scaffolding is erected.

Carefully remove all the vegetation growing from the wall and rake out any loose mortar. Repoint the wall with lime mortar where required.

Any loose render to be consolidated with lime mortar or the loose render is to be removed, to be reviewed on site when the scaffolding is erected.

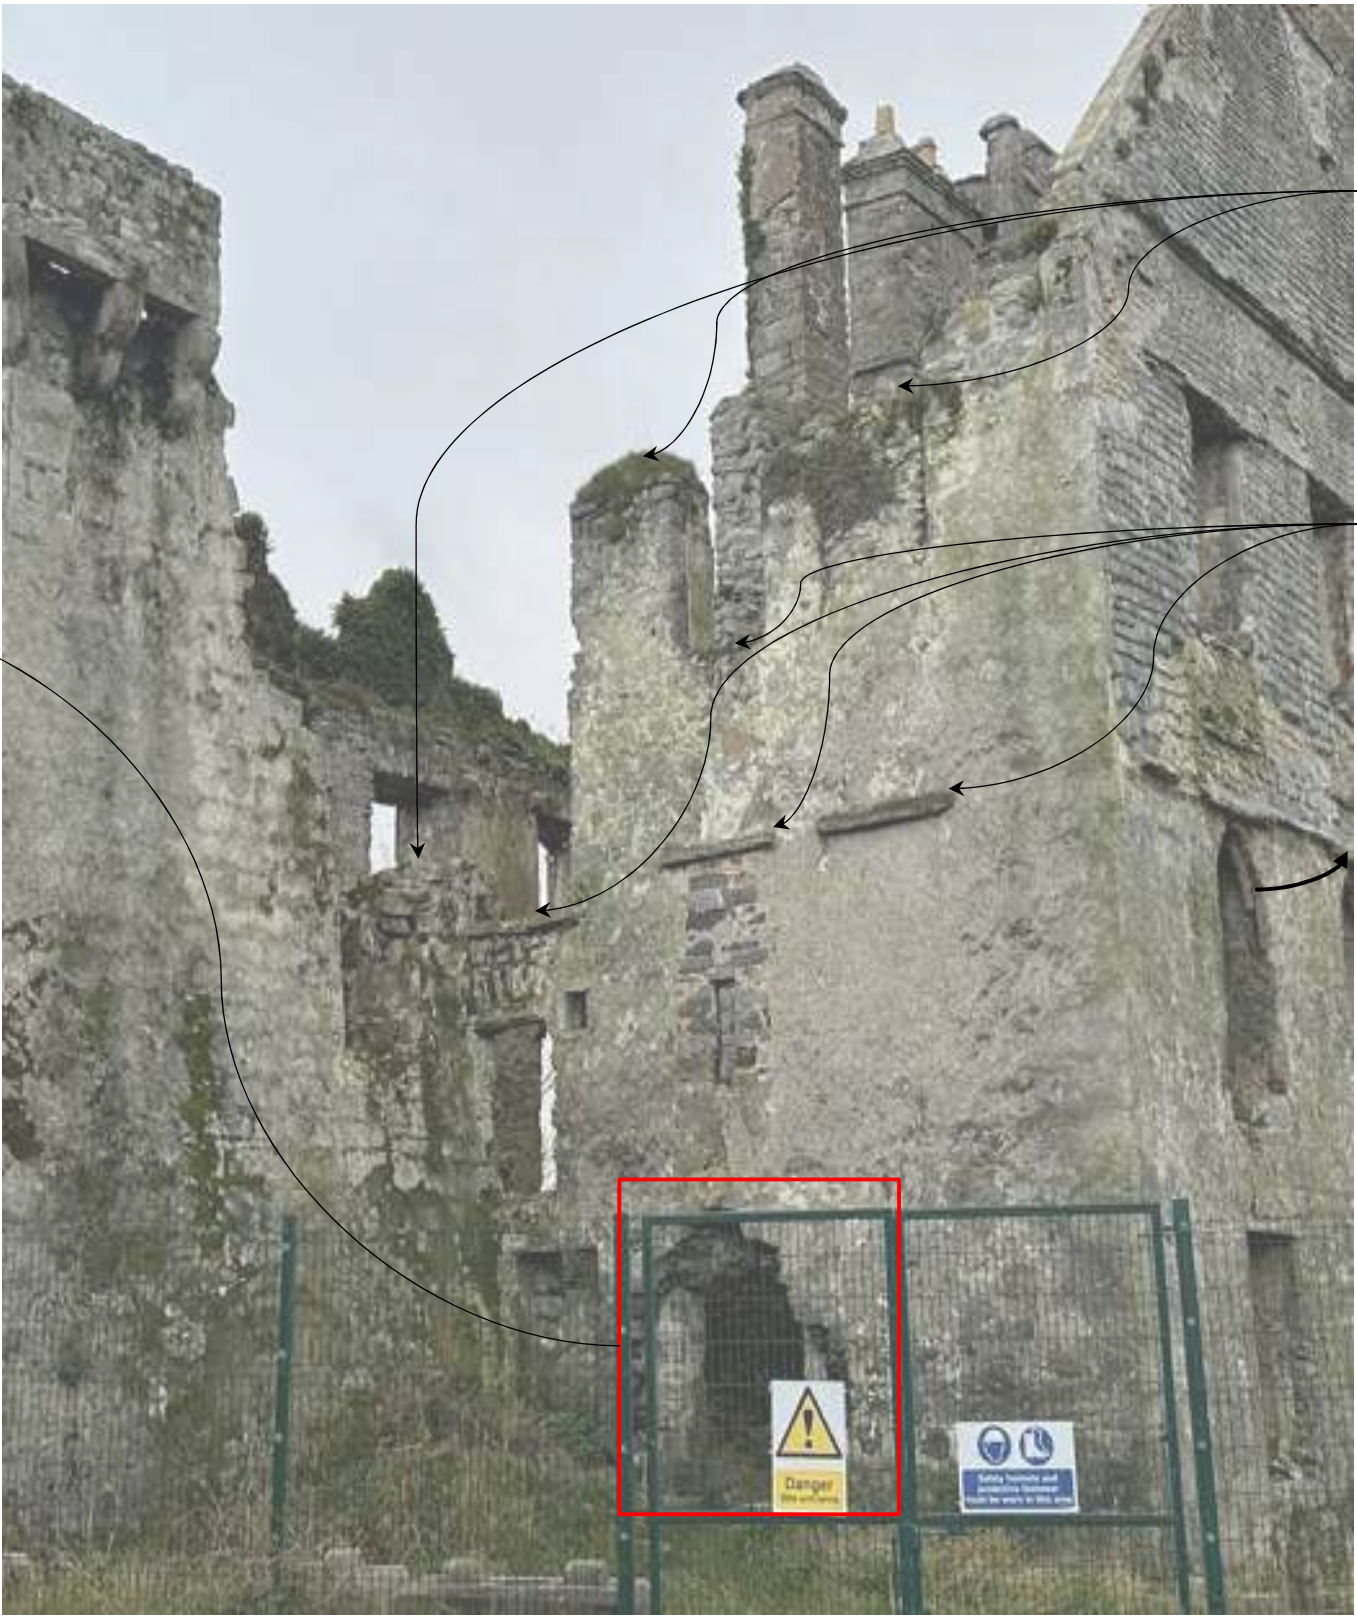
Rebuild the door reveals and stone arch over the door with new stone keyed into the existing stone and lime mortar. The face of the new stone to be recessed by 25mm from the face of the existing stone.

Spray all of the vegetation growing from the wall tops.  
Fully record all stones in the top 200-300mm of the wall.  
Carefully rake out loose mortar.  
Arrange for inspection.  
Allow for careful dismantling and rebuilding of the top 200-300mm of the wall top exactly as is now but with adjustments to give a top surface that is self draining. Repoint the wall, refer to specifications.

Cill to be flanchued to allow rainwater to self

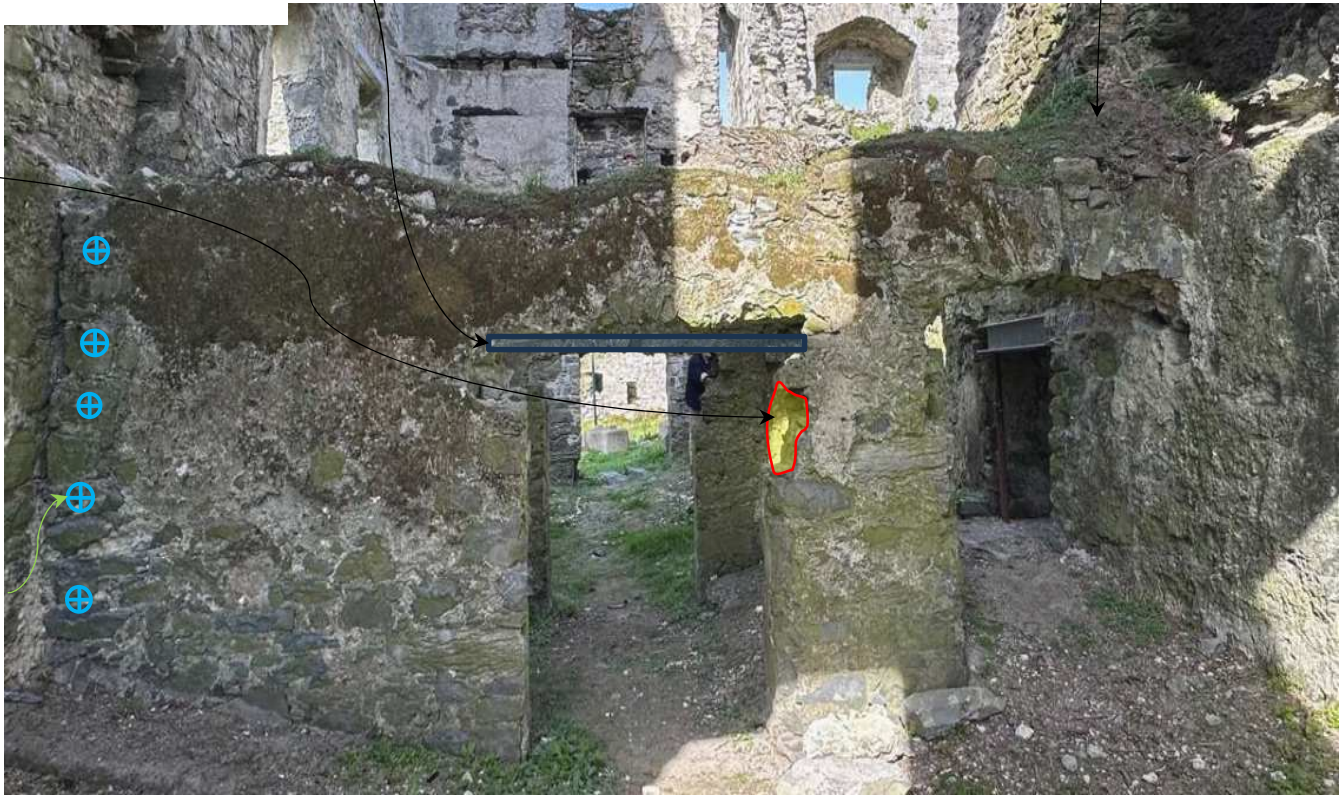
INTERNAL WALL 1 - LOOKING NORTH

Spray all of the vegetation growing from the wall tops. Fully record all stones in the top 200-300mm of the wall. Carefully rake out loose mortar. Arrange for inspection. Allow for careful dismantling and rebuilding of the top 200-300mm of the wall top exactly as is now but with adjustments to give a top surface that is self draining. Repoint the wall, refer to specifications.

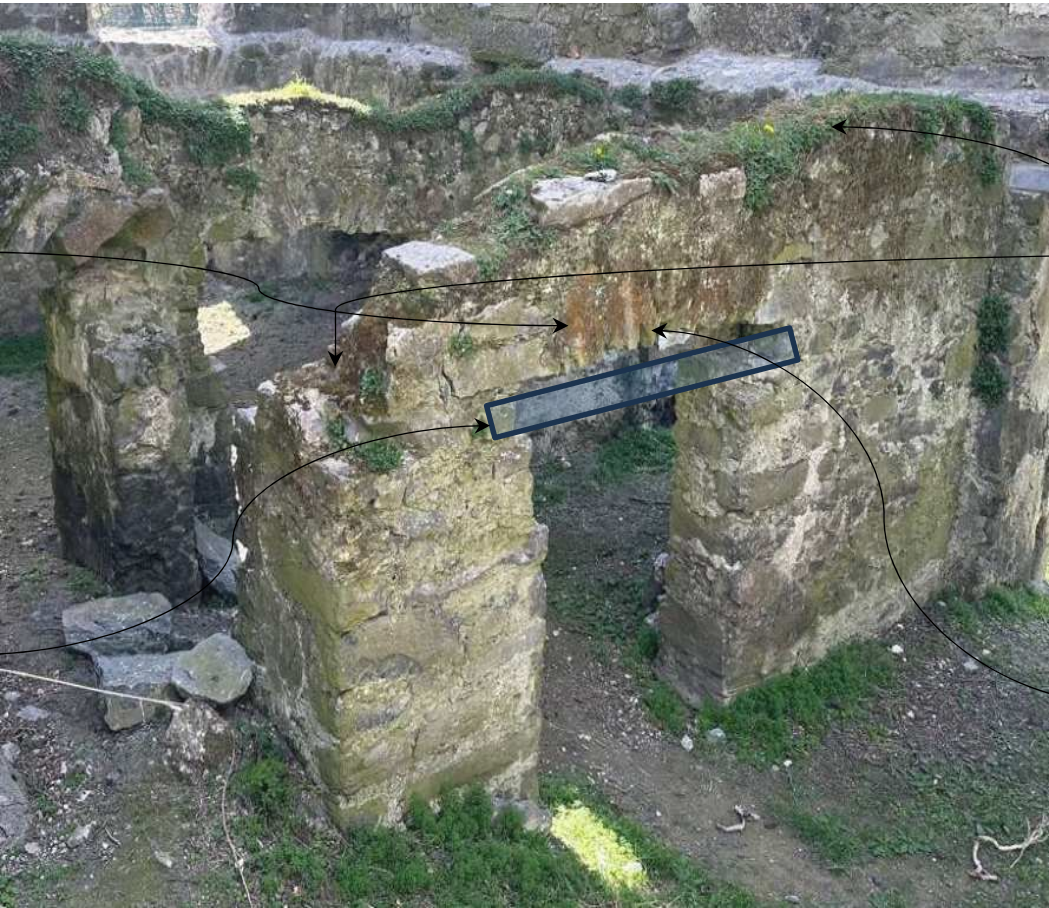
INTERNAL WALL 2 - LOOKING SOUTH

Spray all of the vegetation growing from the wall tops. Fully record all stones in the top 200-300mm of the wall. Carefully rake out loose mortar. Arrange for inspection. Allow for careful dismantling and rebuilding of the top 200-300mm of the wall top exactly as is now but with adjustments to give a top surface that is self draining. Repoint the wall, refer to specifications.

Allow for consolidation of the underside of the stone arch. Note deep repointing may be required with pieces of slate.
