St. John's Church of Ireland, Kill, Nass, Co. Kildare – Derogation Licence Supporting Information

Project Name & Location: St. John's Church of Ireland, Kill, Naas, Co. Kildare.

The following is a letter supporting the application for Derogation under the European Communities (Birds and Natural Habitats) Regulations 2011-2021.

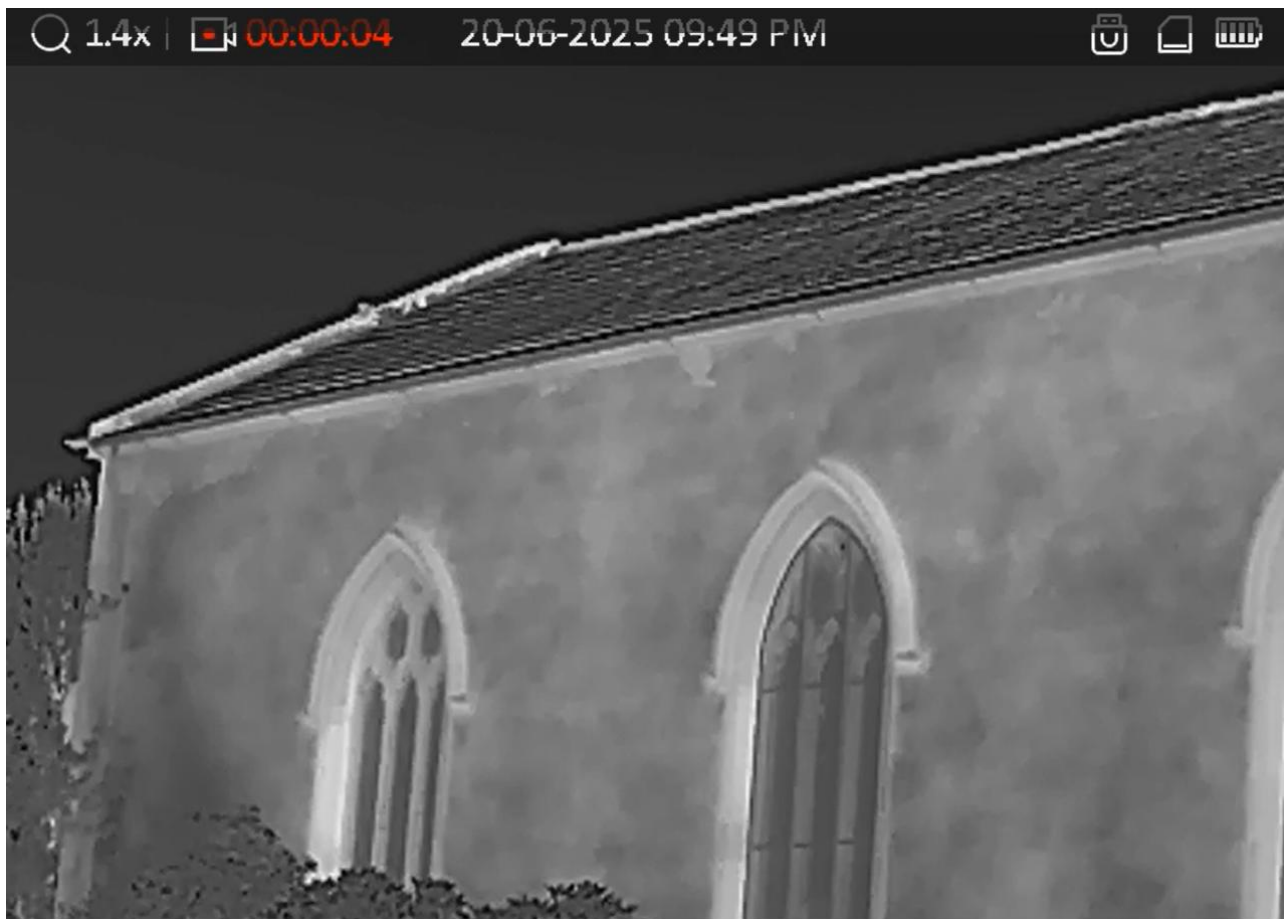
Figure 4b: Thermal image screenshot of Scope 1 of St. John's Church, Kill, Naas, Co. Kildare.

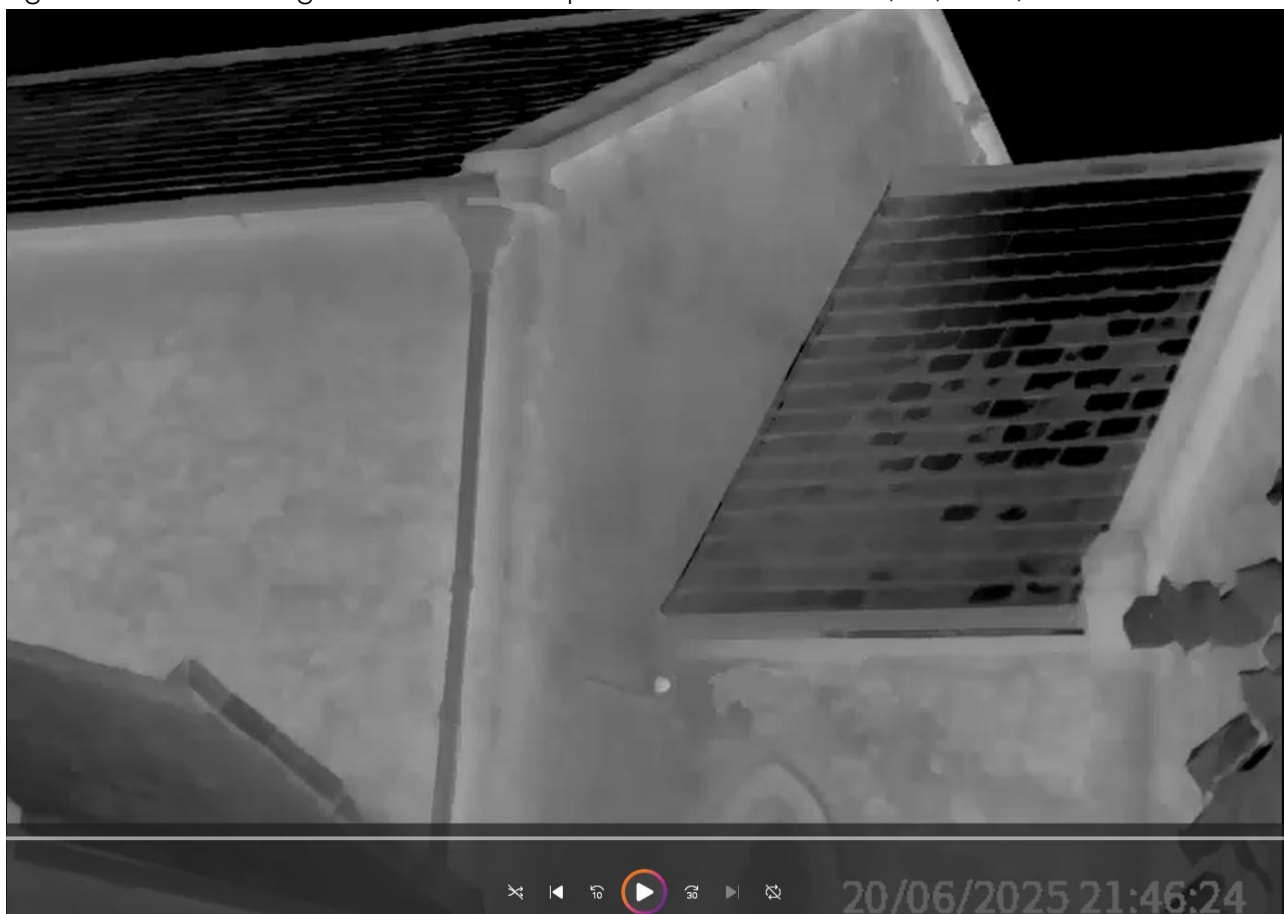
Figure 4c: Thermal image screenshot of Scope 2 of St. John's Church, Kill, Naas, Co. Kildare.

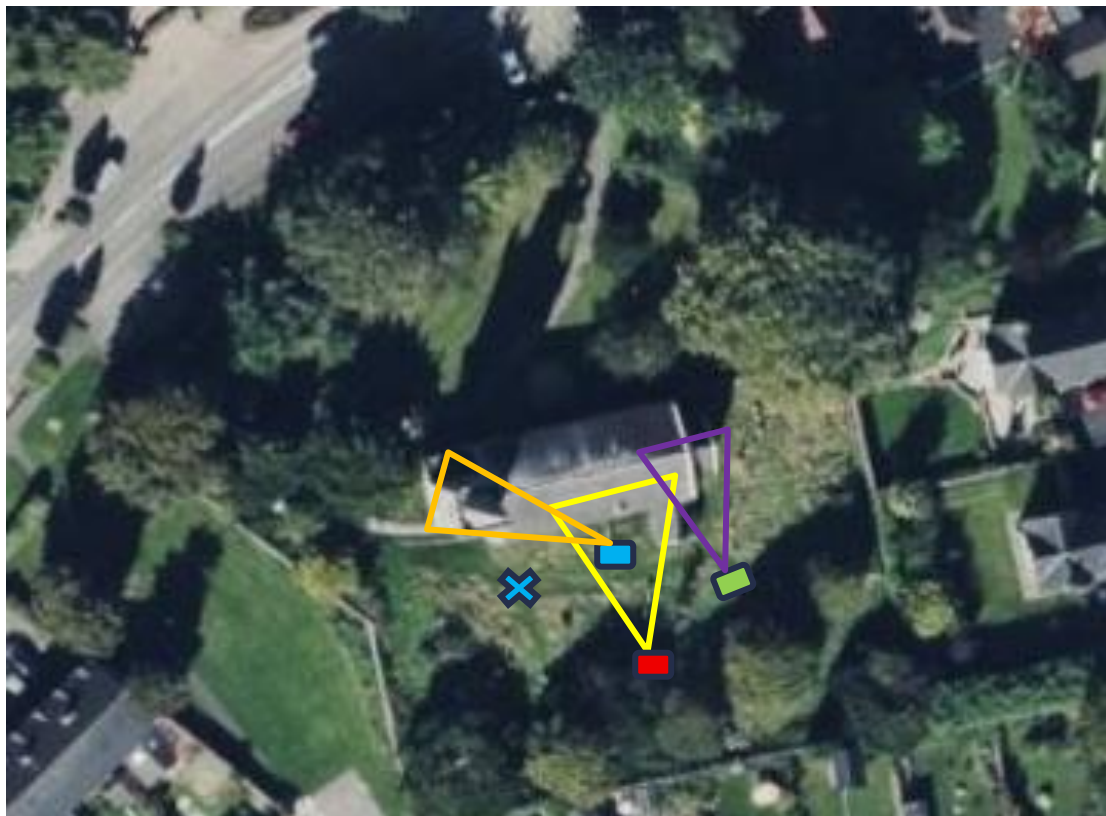
During the second dusk survey (20th June 2025, weather conditions: full cloud cover, 13oC, calm and dry), due to the fact that brown long-eared bat activity was recorded at the rear of the church during the first dusk survey. Filming and surveying were concentrated in this area. The thermal imagery scopes were positioned as presented below on Figure 4d (Scope 1: Red Rectangle with triangle showing area of coverage & Scope 2: Blue Rectangle with triangle showing area of coverage and Scope 3: Green Rectangle with triangle showing area of coverage), while Surveyor 2 was located at Blue X on Figure 4d. As a consequence of this survey, three exit points were recorded for the brown long-eared bat roost.

Figure 4d: Aerial of St. John's Church, Kill, Naas, Co. Kildare.

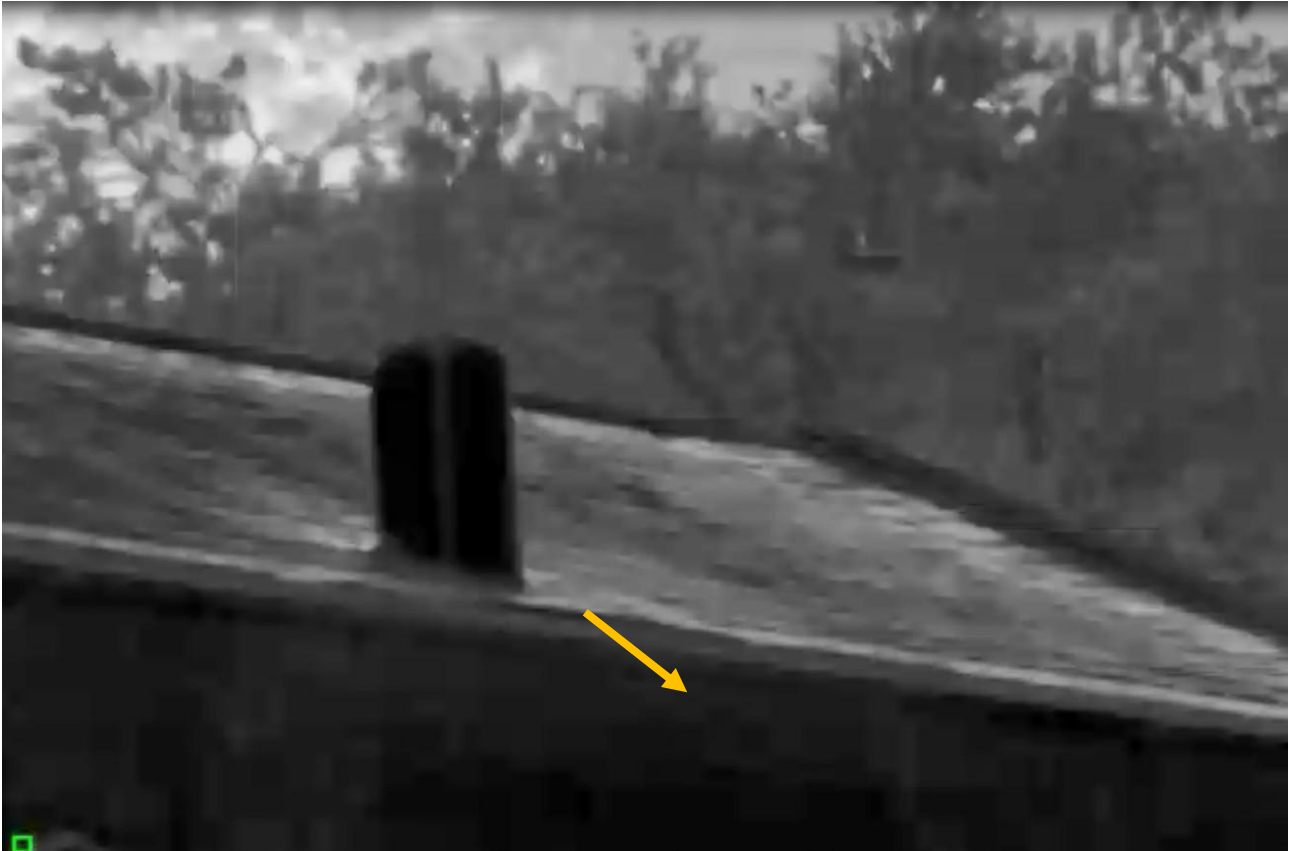
Figure 4e: Thermal image screenshot of Scope 1 of St. John's Church, Kill, Naas, Co. Kildare – Exit Point 1 (main roof space).

The survey results recorded a maternity roost for brown long-eared bats (42 individuals – this includes juveniles) in the roof space of the church with two exit points: Exit Point 1 - bell tower (louvre window) and Exit Point 2 - gap at wall plate of main roof to rear of church.

The exact exit points are indicated on Figure 4e (22 bats – Exit Point 1), Figure 4f (19 bats – Exit Point 2) and Figure 4g (1 bat – Exit Point 3).

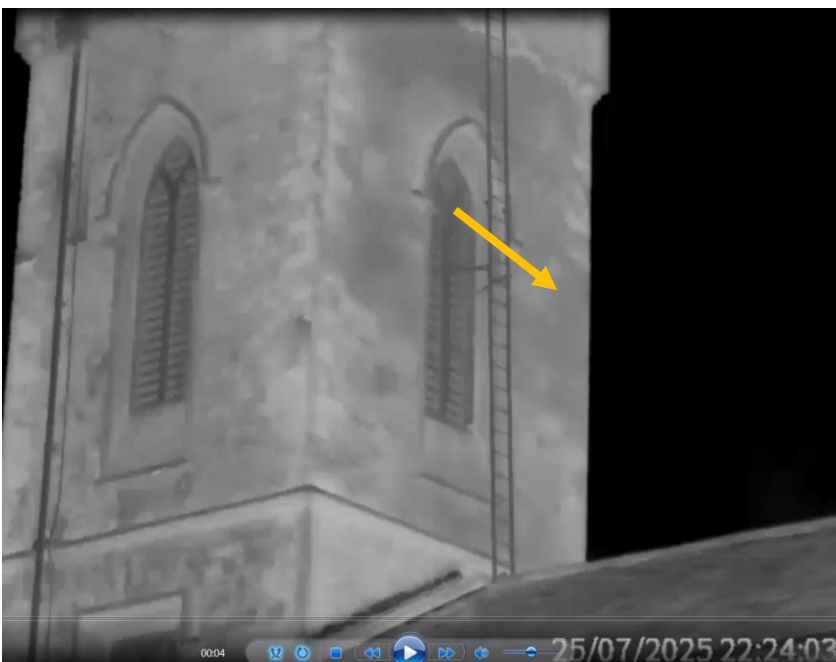
Figure 4f: Thermal image screenshot of Scope 2 of St. John's Church, Kill, Naas, Co. Kildare – Exit Point 2 bell tower.

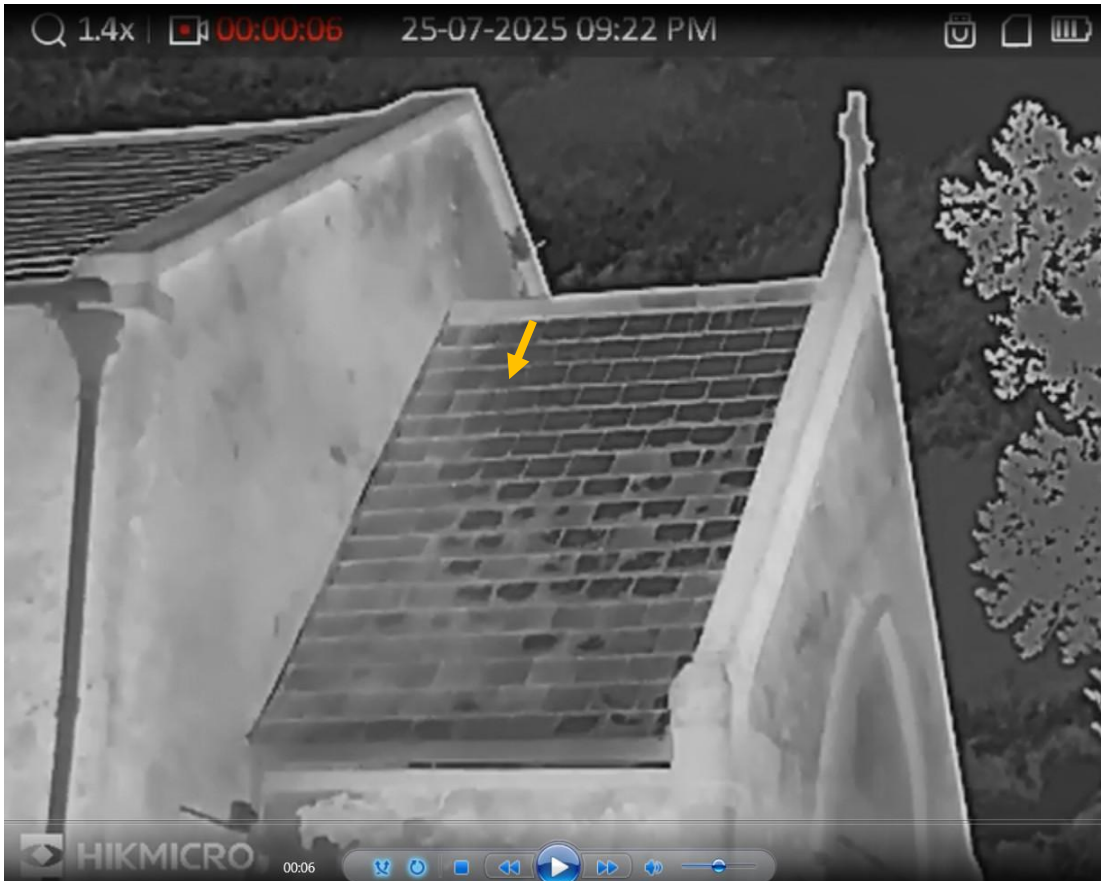
Figure 4g: Thermal image screenshot of Scope 3 of St. John's Church, Kill, Naas, Co. Kildare – Exit Point 3 2nd roof space (no works are proposed for this section of the roof).

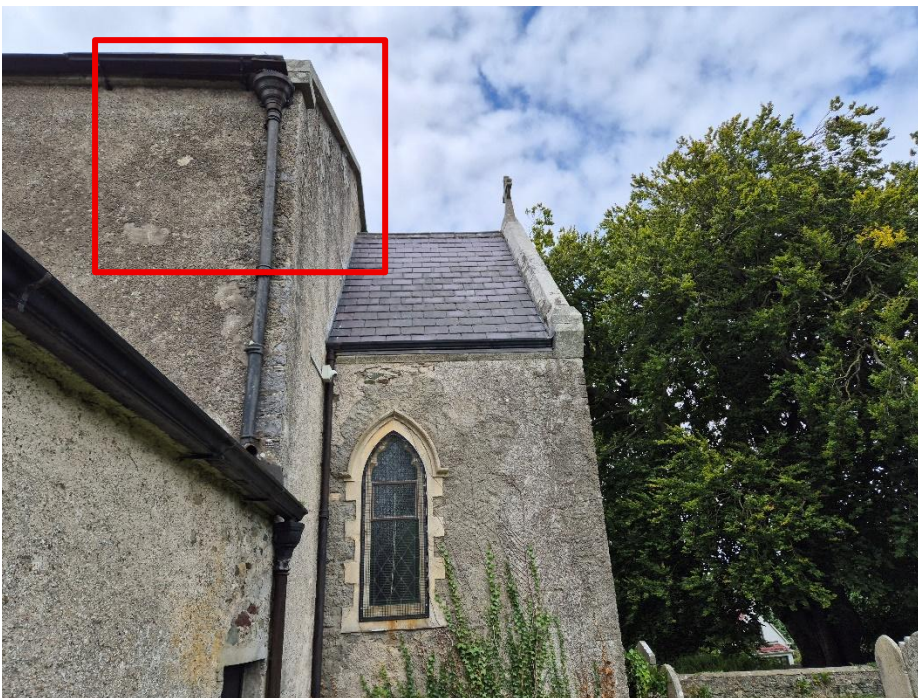
A daytime inspection was undertaken on 1st August 2025 and the colony of bats was recorded roosting at the gable end of the church furthest from the bell tower.

Plate 1: Location of colony during internal inspection of St. John's Church, Kill, Naas, Co. Kildare.

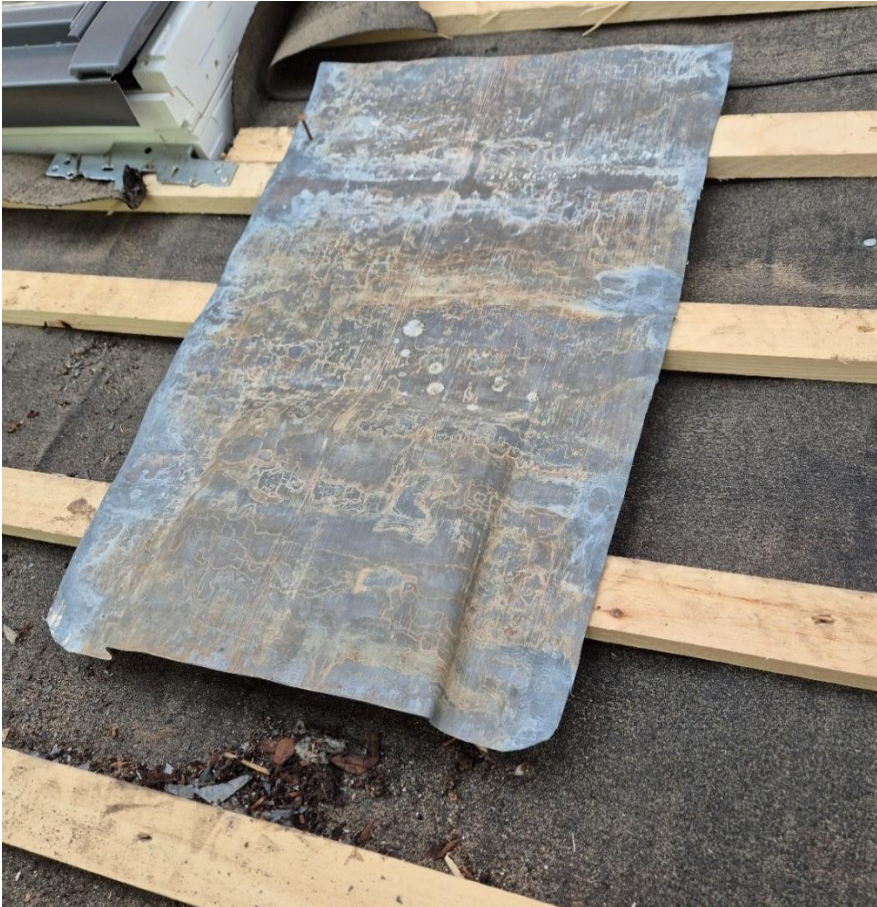
Plate 2a: Construction of bat slates for inspection by bat specialist at Coole Park Visitor Centre, Gort, Co. Galway.

The roof space of this building was identified as a maternity roost for brown long-eared bats. A new roof was installed in April 2025 with bat slates inserted as shown in the series of photographs below. These have provided new exit points for the brown long-eared bat colony.

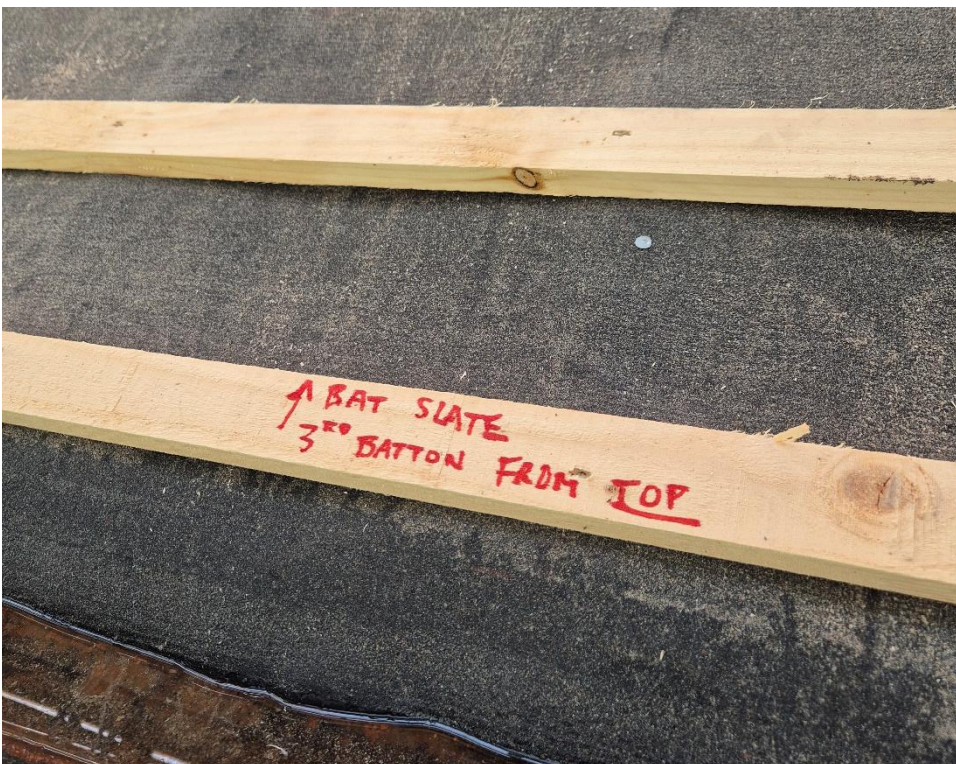
Plate 2b: bat specialist marked up where bat slates (x5) are to be positioned in consultation with NPWS – Coole Park Visitor Centre, Gort Co. Galway.

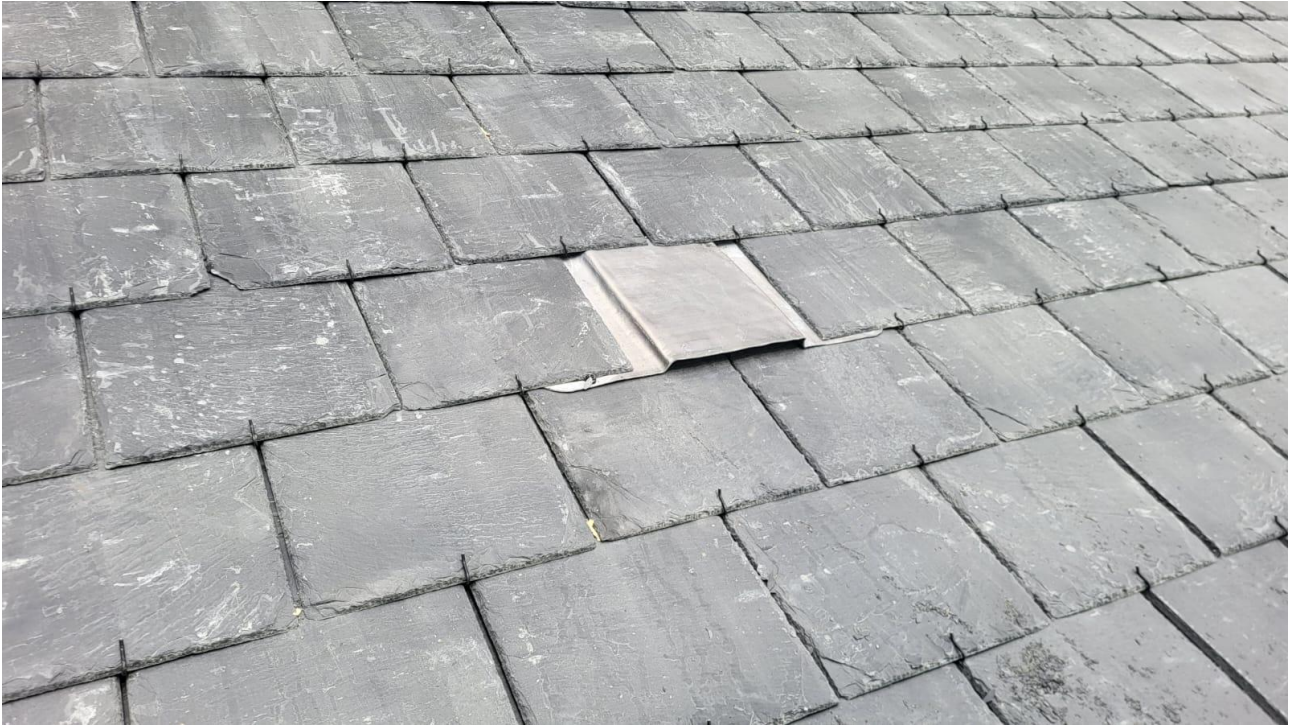
Plate 2c: Bat slate in new roof (29.4.2025) of Coole Park Visitor Centre, Gort, Co Galway.
