# Derogation Licence Application and Bat Survey Report

## Ballinacurra Mills LRD, Co. Cork.

Project: Proposed Large-scale Residential Development (LRD) at Ballinacurra Mills, Co. Cork.

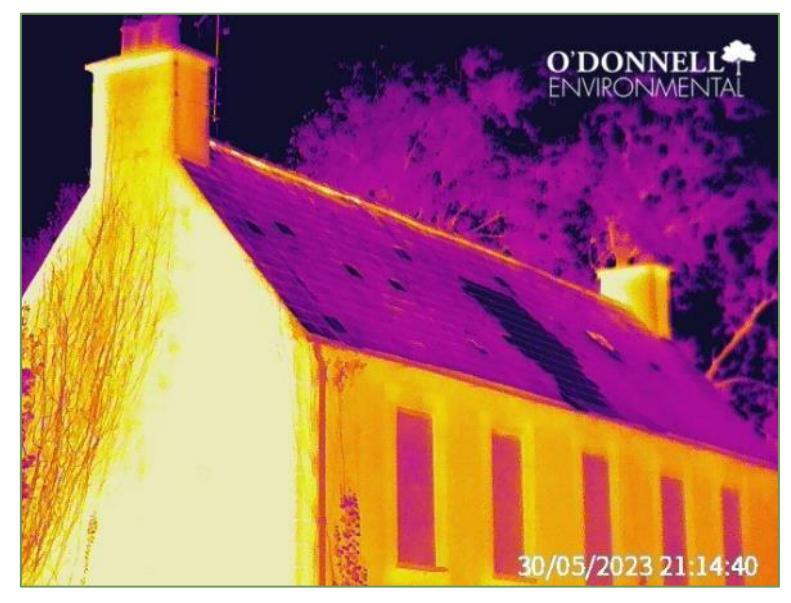
Plate 2.1 Example image from thermal camera covering the front/eastern aspect of Roseville House.

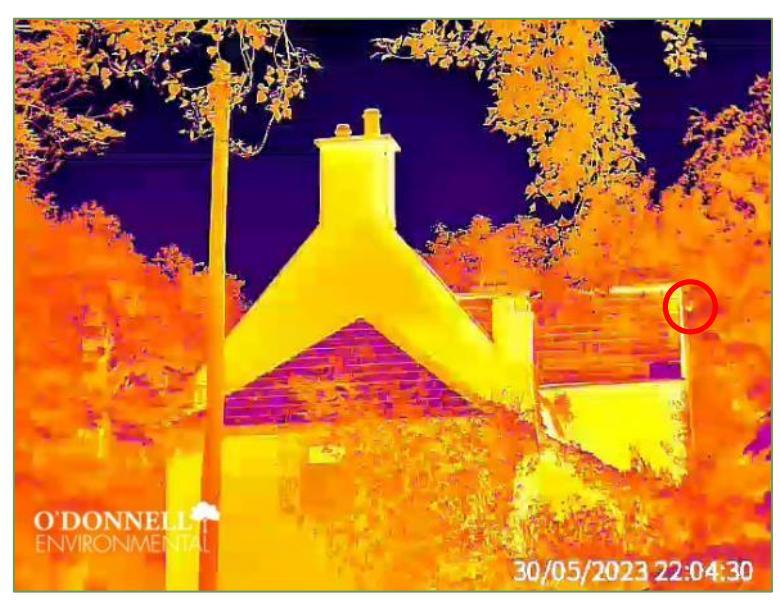
Plate 2.2 Example image from thermal camera covering the northern aspect of Roseville House with Soprano Pipistrelle emerging (red).

Roseville House displays 'high' suitability for roosting bats and has been confirmed as a bat roost for Soprano Pipistrelle (see **Plate 2.1** and **2.2**). It should be noted that Rosehill House display a wide variety of PRFs and that while only Soprano Pipistrelle was observed roosting individually the possibility of other species roosting within the structure in larger numbers in the future cannot be discounted.

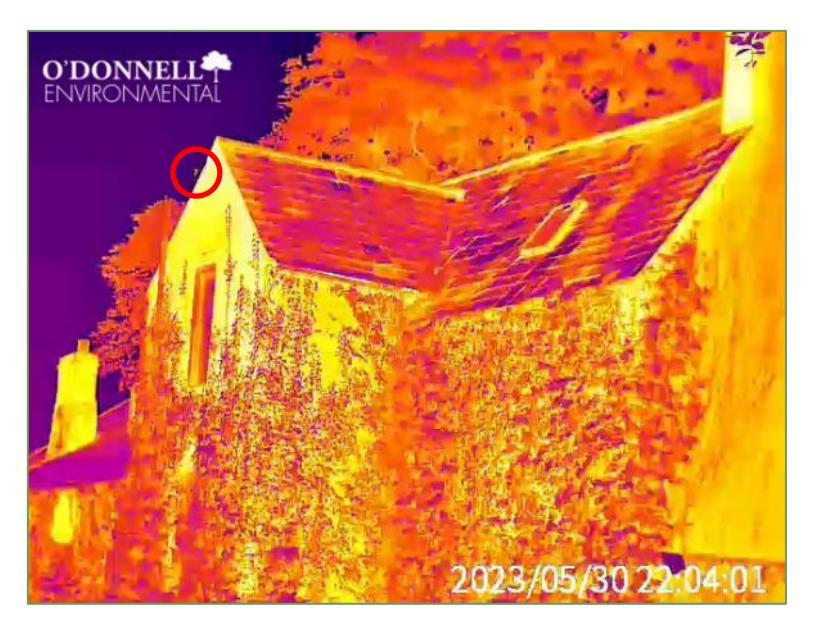
Plate 2.3 Example image from thermal camera covering the rear/western aspect of Roseville House with Soprano Pipistrelle emerging (red).

Additionally, activity levels remain are consistent throughout the night, with the majority of activity present around sunset and sunrise (see **Figure 3.2**). The number of registrations then decline but become stable throughout the night, indicating the survey area is of moderate value for foraging bats. The earliest registrations of bats appear approximately 20 minutes before sunset and consist entirely of Common and Soprano Pipistrelle, suggesting the presence of bats roosting within the locality of the proposed site. This aligns with the results of bat activity surveys, whereby Soprano Pipistrelle was observed roosting within Rosehill House (see **Plate 2.2** and **2.3**).

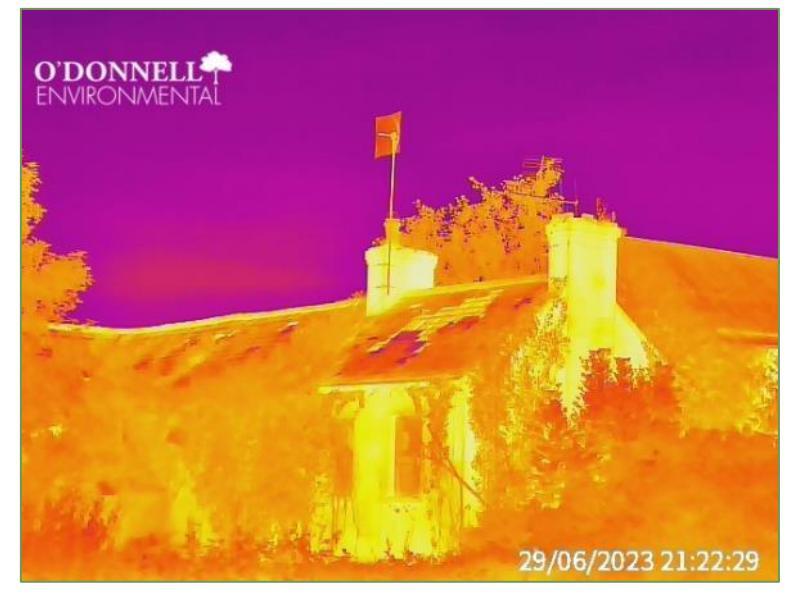
Plate 2.4 Example image from thermal camera covering the western aspect of Eastville House.

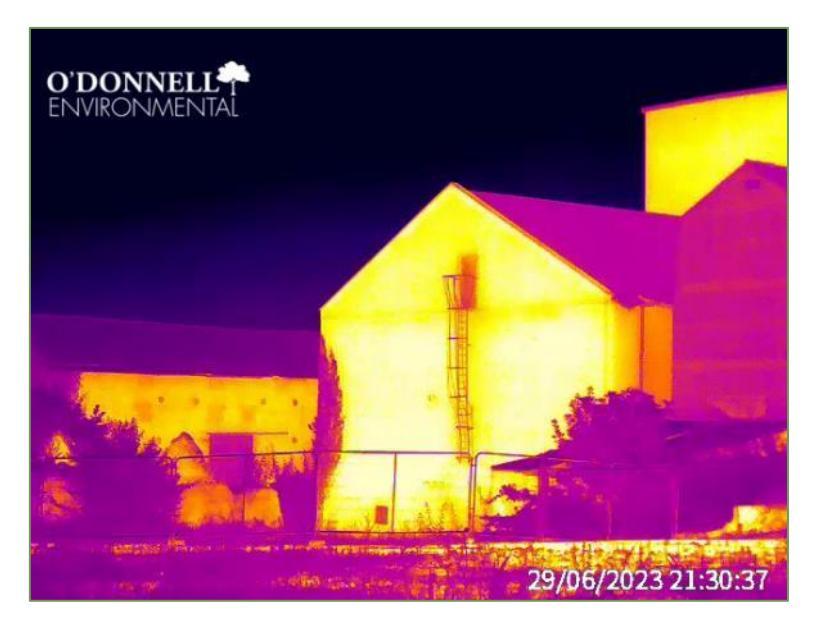
Plate 2.5 Example image from thermal camera covering the western aspect of the former mill buildings complex.

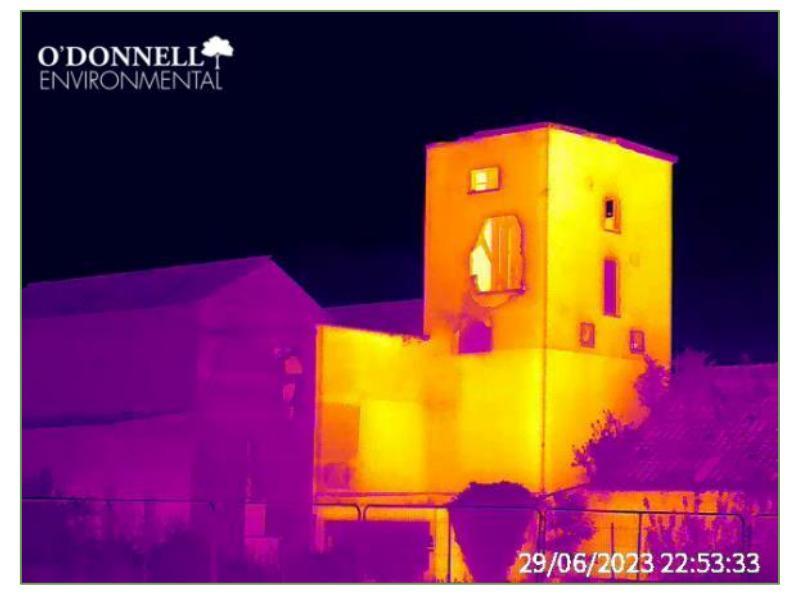
Plate 2.6 Example image from thermal camera covering the eastern aspect of the former mill buildings complex.

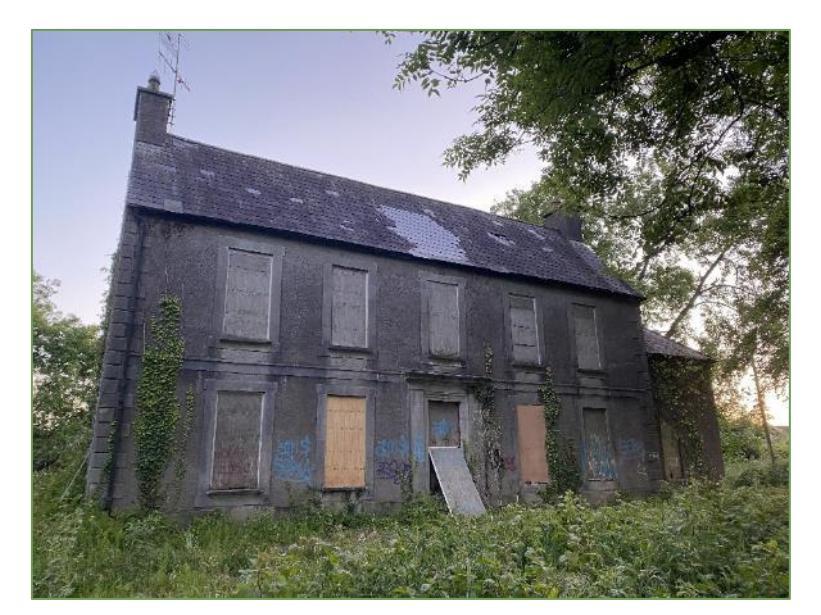
Plate 3.2.1 View overlooking the eastern/front aspect of Roseville House.

Portions of the roof have been repaired with modern slate equivalent, and slates are missing in portions which provides clear access/egress points for roosting bats. Additionally, some windows are currently uncovered or have been left open, notably the skylight on the western aspect of the roof and uncovered second storey window to the north. The western aspect of the house is covered in dense ivy growth.

Access was limited to the ground floor only due to the lack of safe access to the upper floors. The interior spaces were noted as being in an advanced state of dereliction. No evidence of roosting bats was identified during interior inspection although it was noted to possess a wide variety of PRFs stemming from the dilapidated interior. A single storey outbuilding is associated with the structure and is currently in a state of advanced disrepair with missing slates and damage caused from vigorous growth of adjacent tree saplings.

While no evidence of significant (i.e. maternity) roosting was identified within Rosehill House, the structure in its current form provides a wide range of roosting features for bat species. As noted previously, the upper floors of Rosehill House were not safely accessible due to significant dilapidation and winter roosting cannot therefore be entirely discounted from this structure. As such, no structural/demolition works will take place on Rosehill House during the core winter months of December to March inclusive.

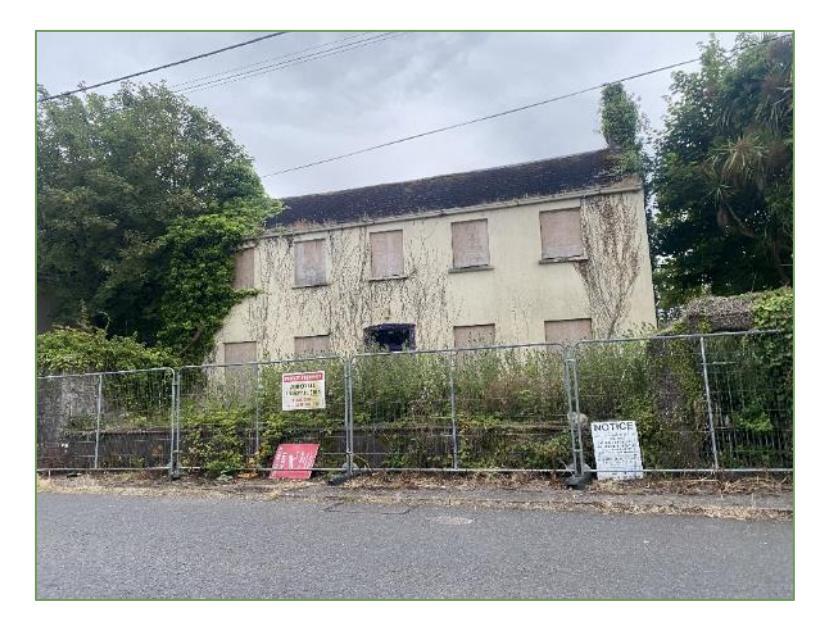
Plate 3.2.2 View overlooking the northern/front aspect of Eastville House from the adjacent roadway (L3625).

The interior of Eastville House is considerably degraded as a result of water ingress, with portions of the upper flooring rotten and not safely accessible. No discrete attic space exists, with the upper floors showing exposed roofing slate atop timber framing with no underlying bitumen felt. A single Brown Long-eared Bat was identified day-roosting within the upper floor directly within the eaves of the timber framing on 30<sup>th</sup> May 2023 (see **Plate 3.2.3**). Subsequent interior inspections did not reveal Brown Long-eared Bat day-roosting. Additionally, Swallow nests were identified within the ground floor.

Eastville House displays 'high' suitability for roosting bats and has been confirmed as a bat roost for Brown Long-eared Bat. It should be noted that Eastville House display a wide variety of PRFs and that while only Brown Long-eared Bat was observed roosting individually the possibility of other species roosting within the structure in larger numbers in the future cannot be discounted.

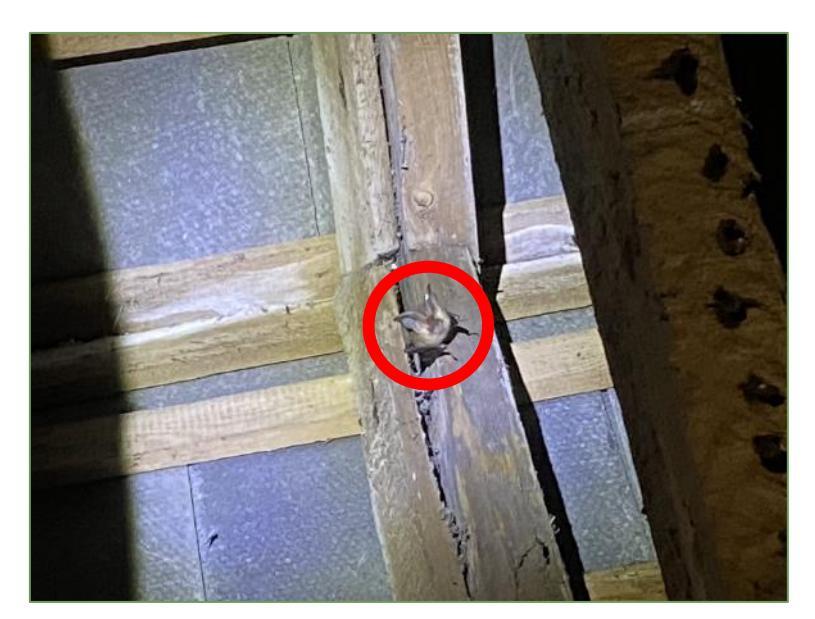
Plate 3.2.3 Brown Long-eared Bat (red) present within upper floor of Eastville House during survey on 30<sup>th</sup> May 2023. (Photo by T. O'Donnell, NPWS License Ref. 39 / 2022).

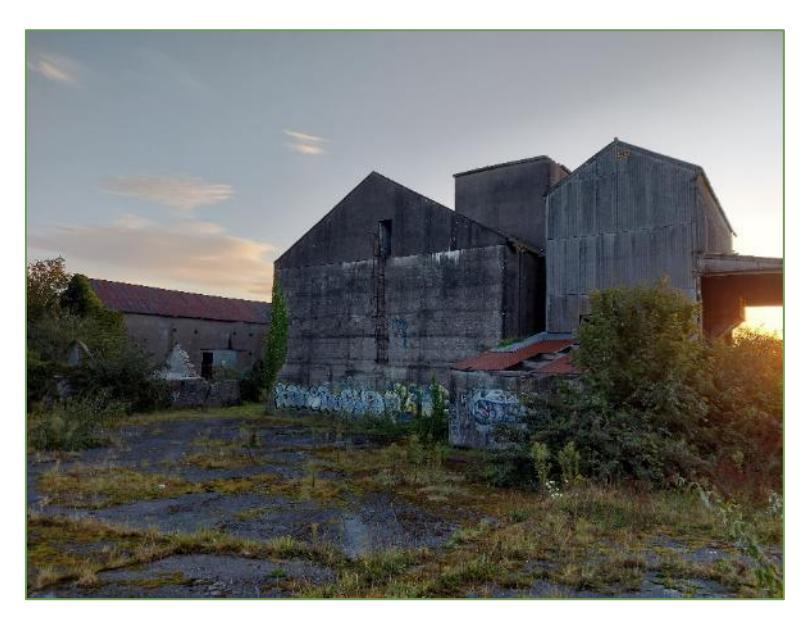
The mill buildings complex comprises an extensive series of interconnected structures composed of block built, stonework and metal structures (see **Plate 3.2.4**). The building complex has experienced extensive fire damage both historically and recently which has left large portions without a roof and thus drastically reduces its suitability for roosting bats (see **Figure 1.1** for extent; **Appendix A1**). The intact portions of the complex comprise the stonework storage barn at the west adjacent to the L3625 (see **Appendix A3**) and the concrete tower located centrally (see **Plate 2.7**; **Appendix A4**).

Plate 3.2.4 View overlooking the western aspect of the mill buildings complex.

Due to the extent of the mill complex, a wide array of roosting opportunities are present for individual crevice dwelling bats such as in the form of gaps in the stonework and loose

plasterwork, but by the nature of their construction, the buildings likely do not represent optimal roosting conditions.

The mill buildings complex in its entirety presents 'low' suitability for roosting bats, based on available evidence. The service tunnel was noted to possess suitable winter hibernating roosting spaces for bat species. No bats were identified roosting within the structures during the course of surveys.

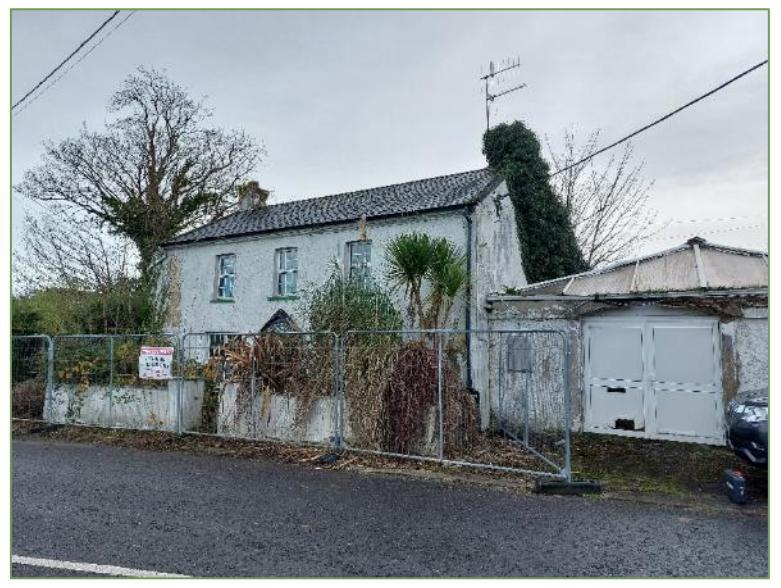
The former residence located at the northwest boundary of the proposed development is a twostorey stonework structure with modern external render, attic section and modern slate roof (see **Plate 3.2.5**). The derelict building is in structurally sound condition with no evidence of dilapidation. No access/egress points were identifiable upon external inspection, roof tiles were intact and flush, and all windows were secure. This structure is located adjacent to a roadway which experiences considerable light disturbance which limits bat roosting suitability on the northern aspect.

Heavy cobwebs were present throughout the interior spaces of the structure, particularly along the stairway between floors, indicating the lack of recent bat roosting. Two instances of possible feeding remains of bats were identified, although these are likely as a result of a single instance of occupation and not as a result of regular roosting by bats. Inspection of the attic space revealed a heavily cobwebbed space with a single window facing east allowing considerable light ingress (see **Appendix A14**). No evidence of bat roosting was identified within the attic space.

Plate 3.2.5 View overlooking the northern aspect of the former residence.

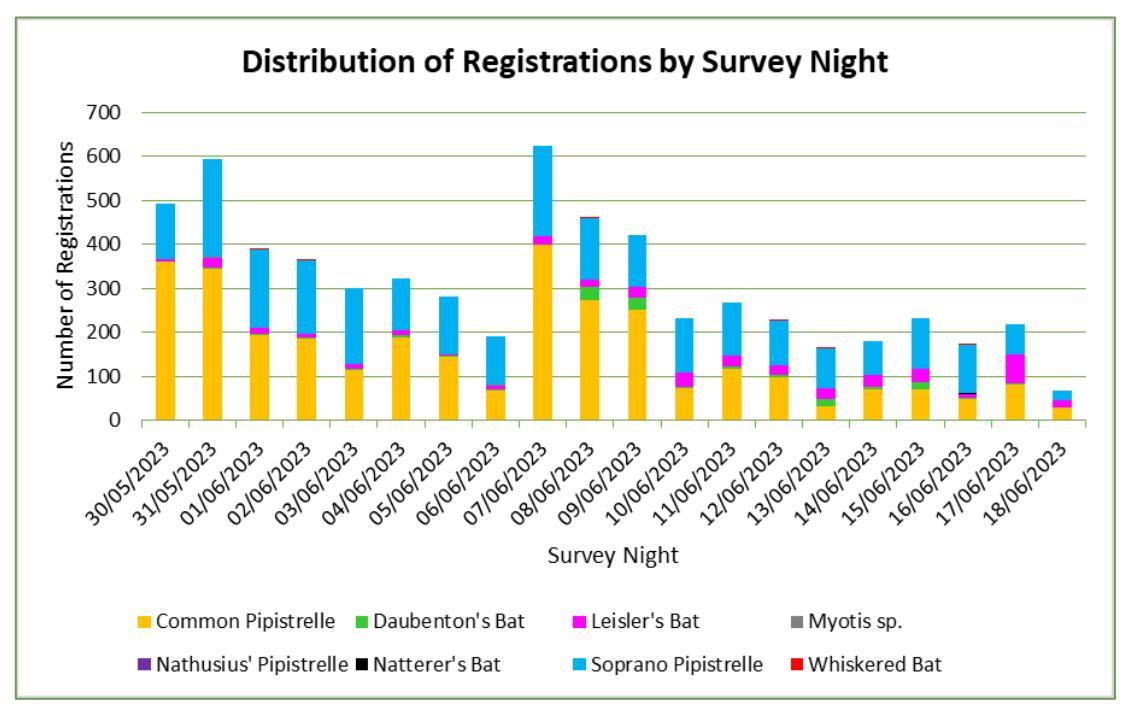
The distribution of registrations recorded are shown in **Figure 3.1** and **Figure 3.2**. Median sunset and sunrise time was 21:49 and 05:14 respectively throughout the survey period. Activity patterns can be seen as relatively consistent throughout the survey period, indicating the survey area is of high value for its bat assemblage due to the presence of mature broadleaf woodland within the site boundary.

Figure 3.1 - Distribution of all bat registrations recorded by survey night and species.

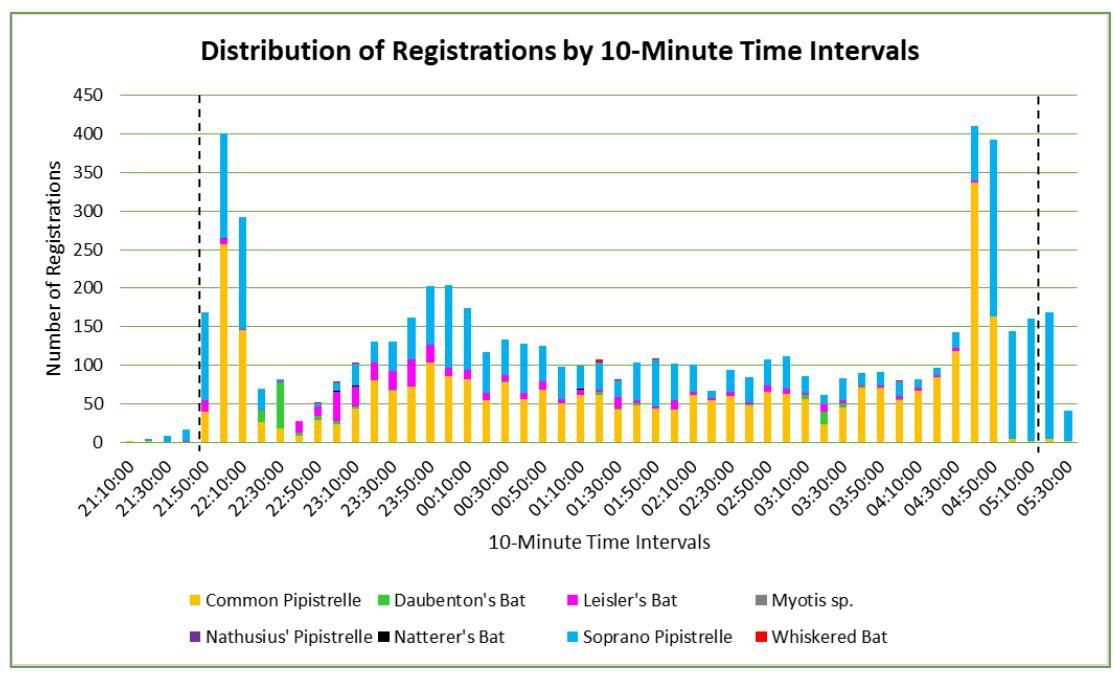
**Figure 3.2** - Distribution of all bat registrations recorded by 10-minute time intervals and species (median sunset and sunrise times were 21:49 and 05:14 respectively – indicated by black dashed lines).

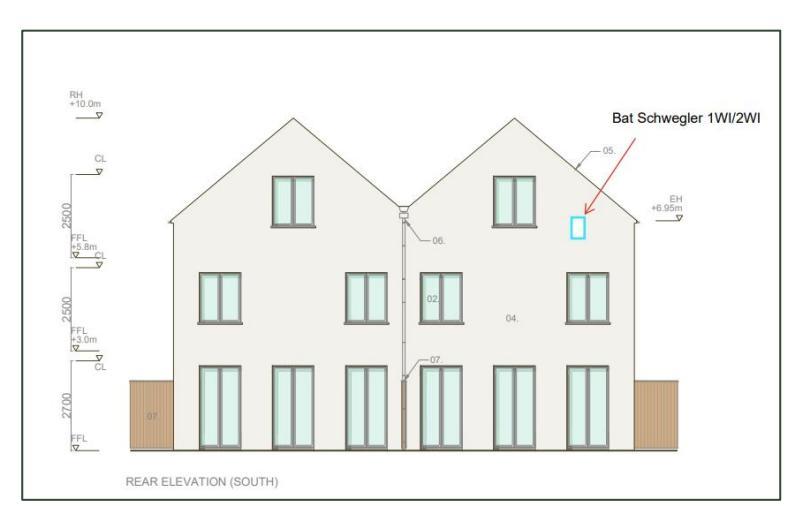
Plate 5.1 - Example of location of externally mounted bat box on structures (blue). Adapted from Drawing No. 02.04 (Fourem Architects).

In order to mitigate the loss of non-maternity roosting locations in structures, 11 artificial bat boxes will be incorporated into structures throughout the site. A mixture of **Schwegler Bat Winter Roost 1WI** and **Schwegler Bat Winter Roost 2WI** bat boxes will be mounted externally on structures (see 'Bat and Bird Box Location' drawing in **Appendix B** for locations; Fourem, 2024). A bat-licensed Ecologist will supervise the installation of bat boxes, in order to verify correct placement and installation. No ongoing maintenance is necessary for this design of artificial bat box. These bat boxes will be placed a minimum of 3m from ground level, roost entrance not illuminated from proximal lighting and is placed in an area with connectivity to the surrounding landscape in the form of vegetation. A mixture of northern and southern aspects will be utilised to provide a range of roosting environments for bat species. See **Plate 5.1** for example location of bat boxes on structures.

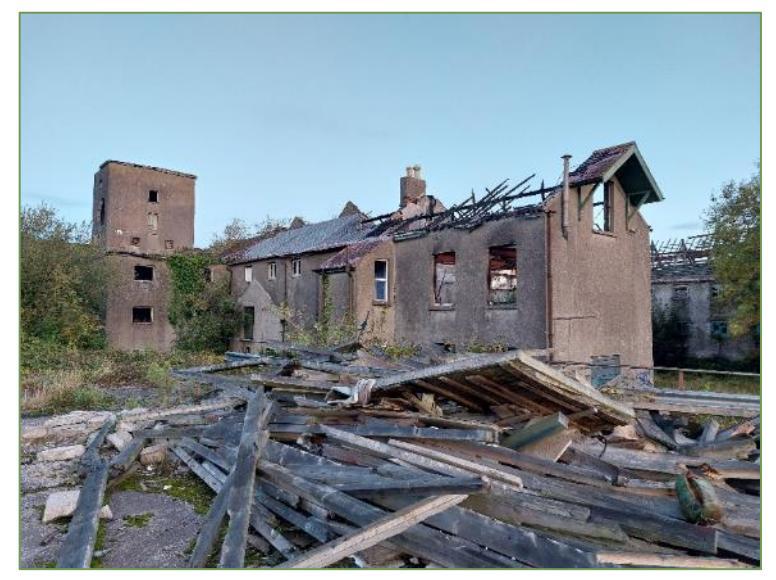
A1. View of southeastern portion of the mills complex showing extensive fire damage of the building.

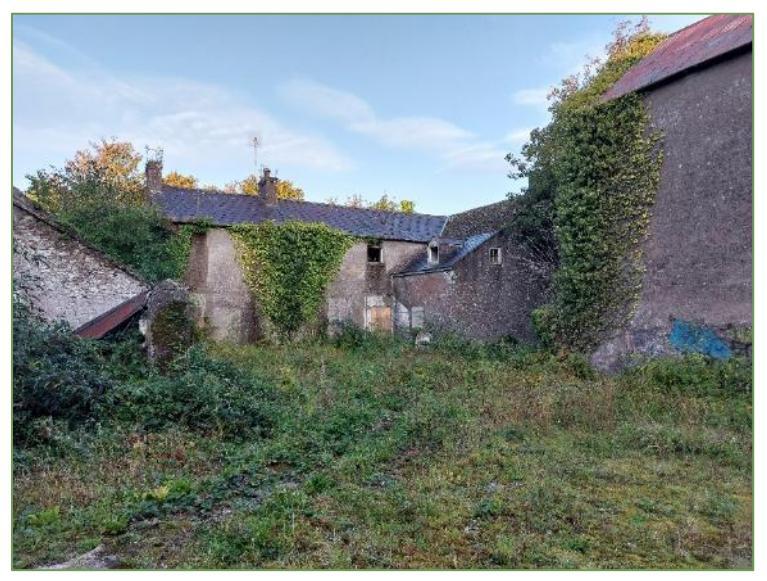
A2. View of the eastern aspect of Eastville House.

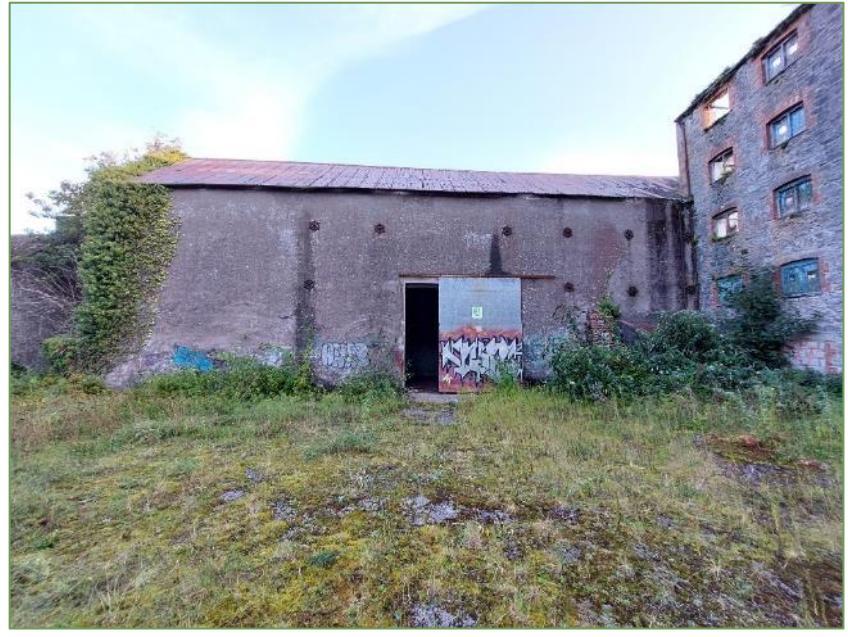
**A3.** View of the stonework grain store within the mills complex.

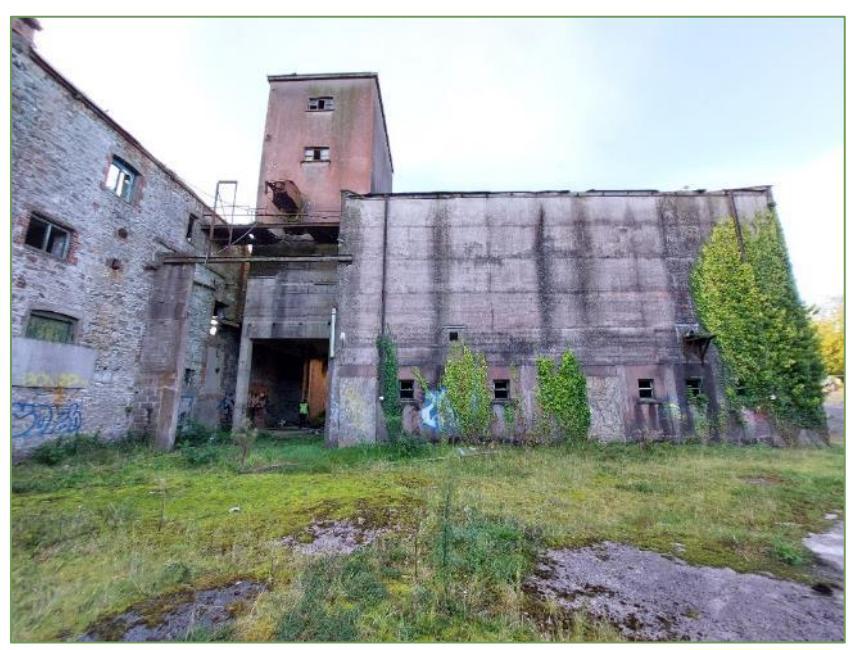
A4. View of the northern aspect of the concrete tower and associated concrete structures.

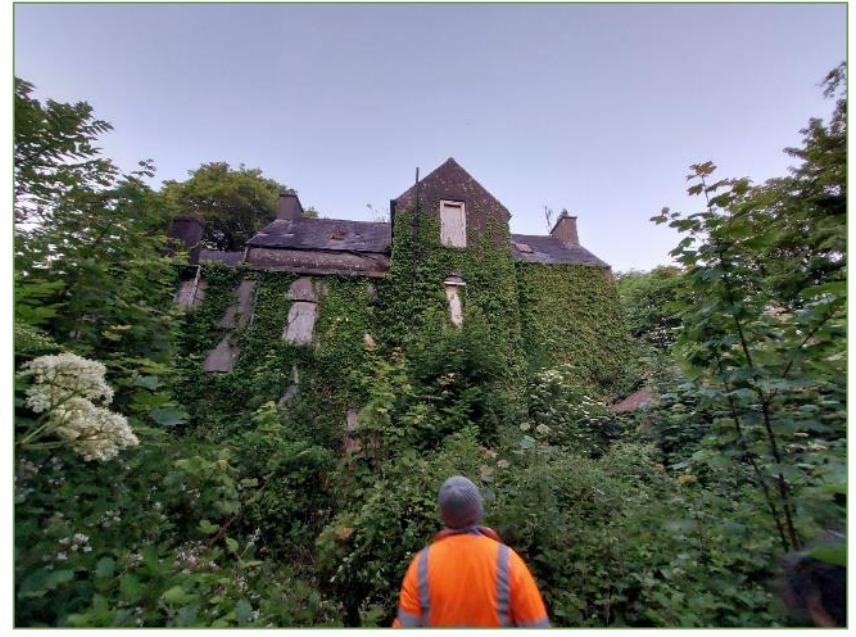
A5. View of the western aspect of Rosehill House.

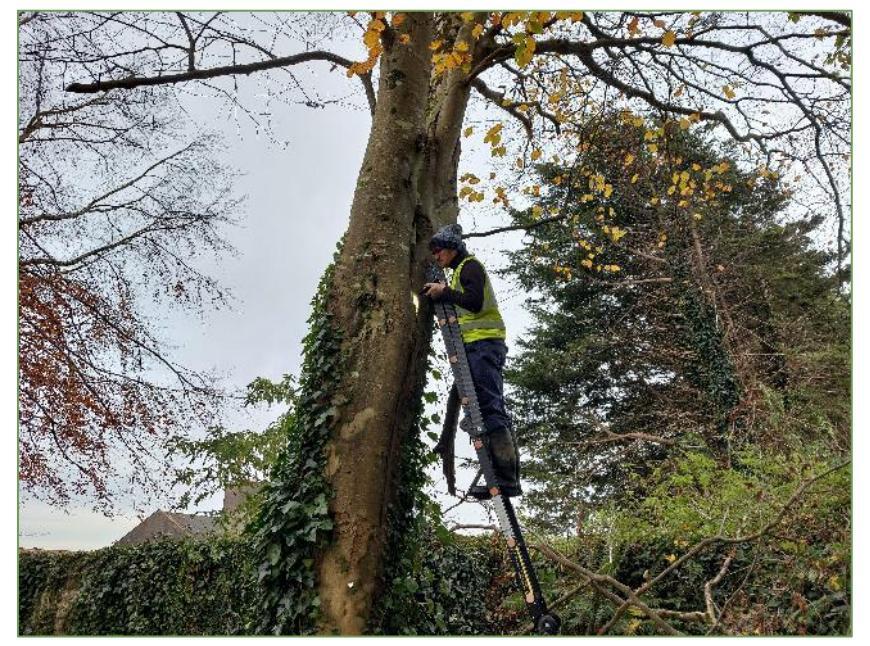
A6. Survey at height using ladder and endoscope of identified vertical fissure displaying PRF-M suitability for bat roosting (Tag no. 2652).

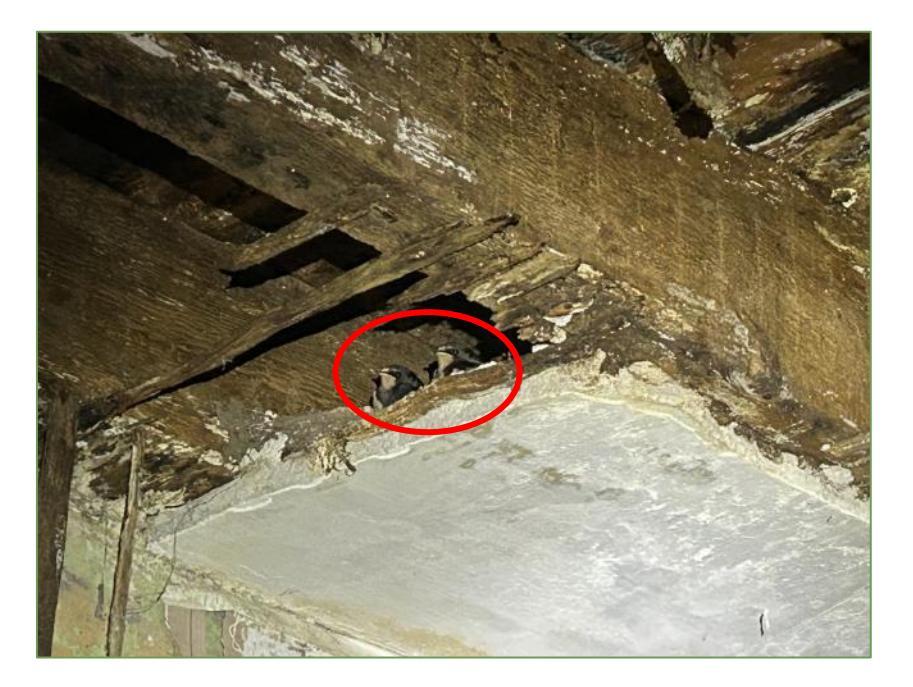
A8. Barn swallow nest (red) within the ground floor ceiling of Eastville House.

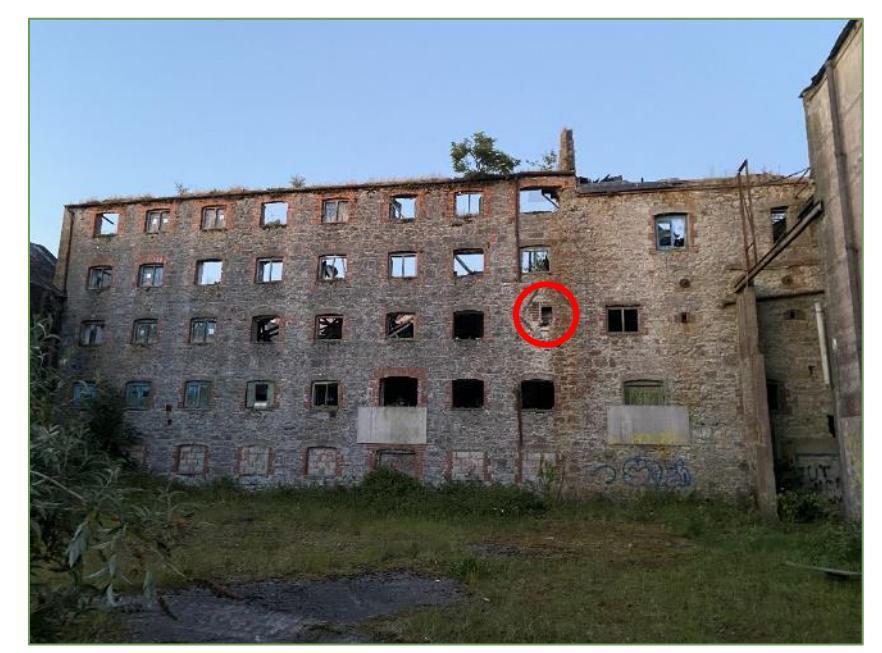
A12. View of the western aspect of the mills building complex, with location of Kestrel nesting site within old fireplace (red circle).

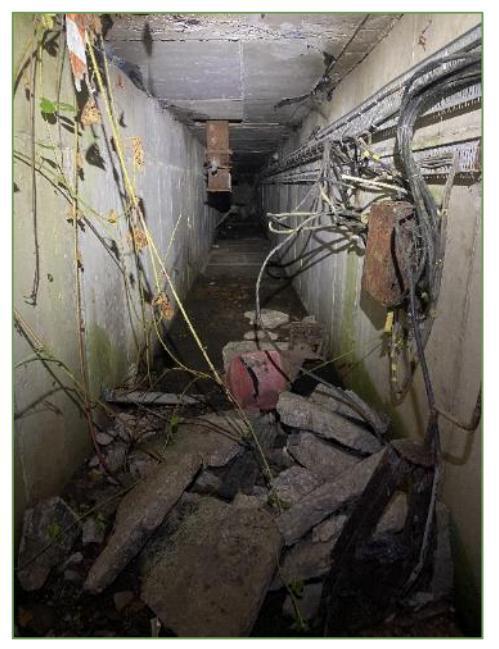
A13. View of the underground tunnel network within the development site.

There exists a former service tunnel associated with the former mills building complex at the southern portion of the site which extends a considerable distance underground (see **Figure 1.1; Appendix A13**). Daytime inspection of this space for bat species during summer 2023 revealed no individuals at the time but was noted to possess cool, stable temperatures alongside minimal wind and light ingress. The service tunnel possesses suitable winter hibernating spaces for bat species.

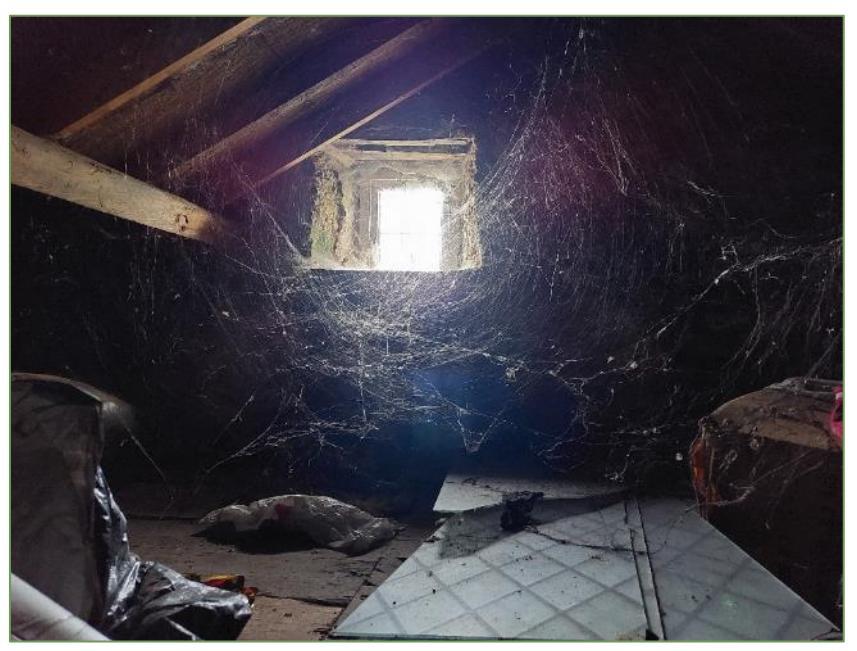
A14. View of the attic of the former residence showing heavily cobwebbed interior and light ingress.
