# **Bat Mitigation Strategy**

Derelict Structures at Rathellen, Finisklin, Sligo

24 January 2025

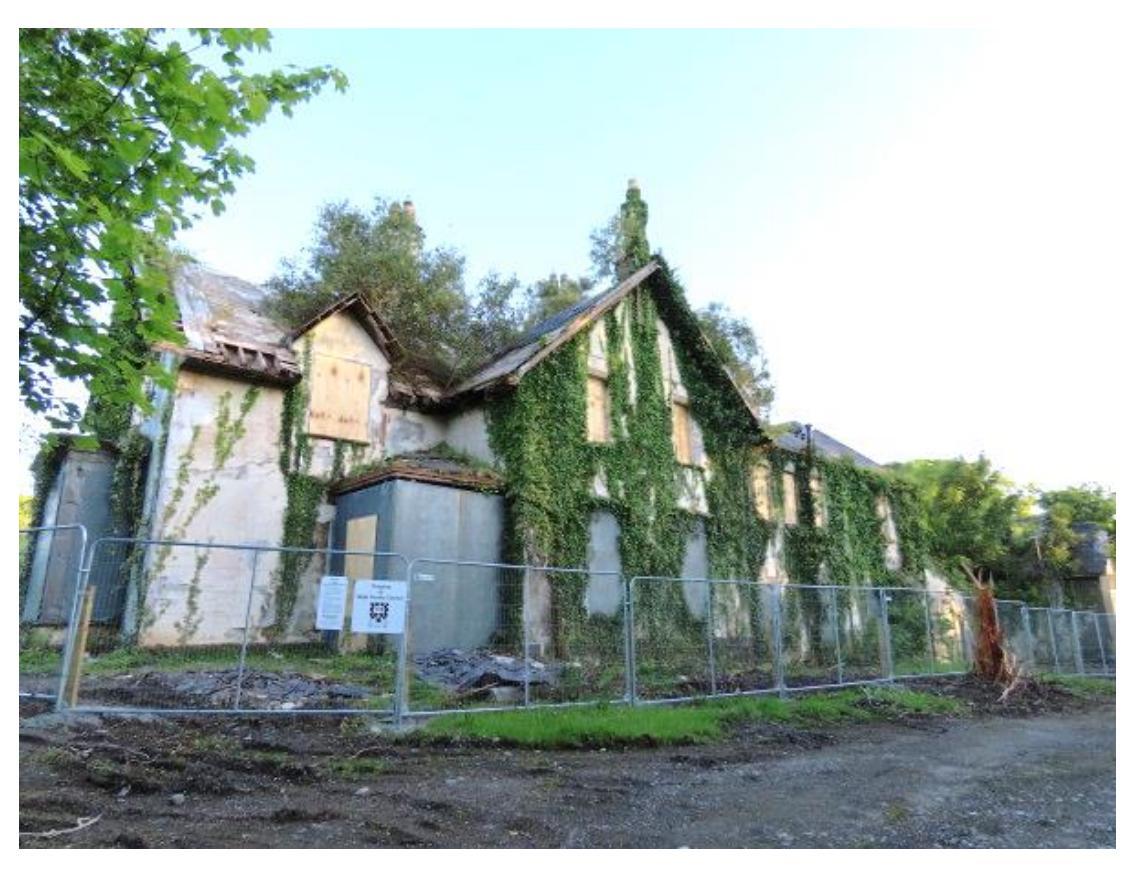
The site contains a derelict historical building known as Rathellen House. In the Landed Estates database it is described as follows: "*McTernan writes that Rathellen was built at the beginning of the nineteenth century as a dower house for the Wood of Woodville estate. It was purchased by Henry Lyons in 1860 and remained in the Lyons family until the 1940s"*. It is a large two-storey house with a slate roof, parts of which have collapsed, revealing rotting wooden joists. The exterior of the building is no longer weathertight, and the interior has been vandalised. Doors and windows have been boarded up to prevent further damage. The exterior of Rathellen House is shown in Figure 2.

Figure 2. Exterior of Rathellen House in May 2021

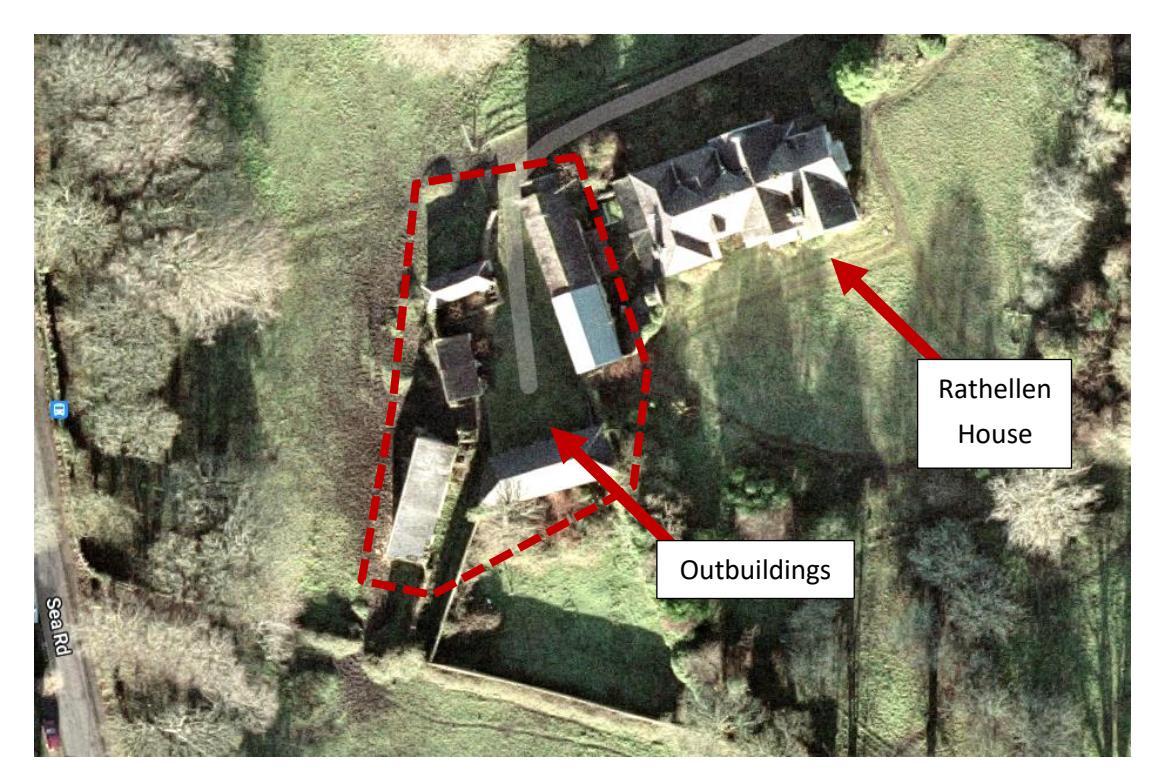
A number of outbuildings are associated with Rathellen House (Figure 3), which may previously have been stables, storage buildings and / or servants' quarters. They are one or two storeys in height and of masonry construction. One structure has an intact roof of corrugated metal (Figure 4), but the roofs of all other structures have collapsed (Figure 5). There are trees growing through a number of the buildings (Figure 4).

Figure 3. Layout of buildings

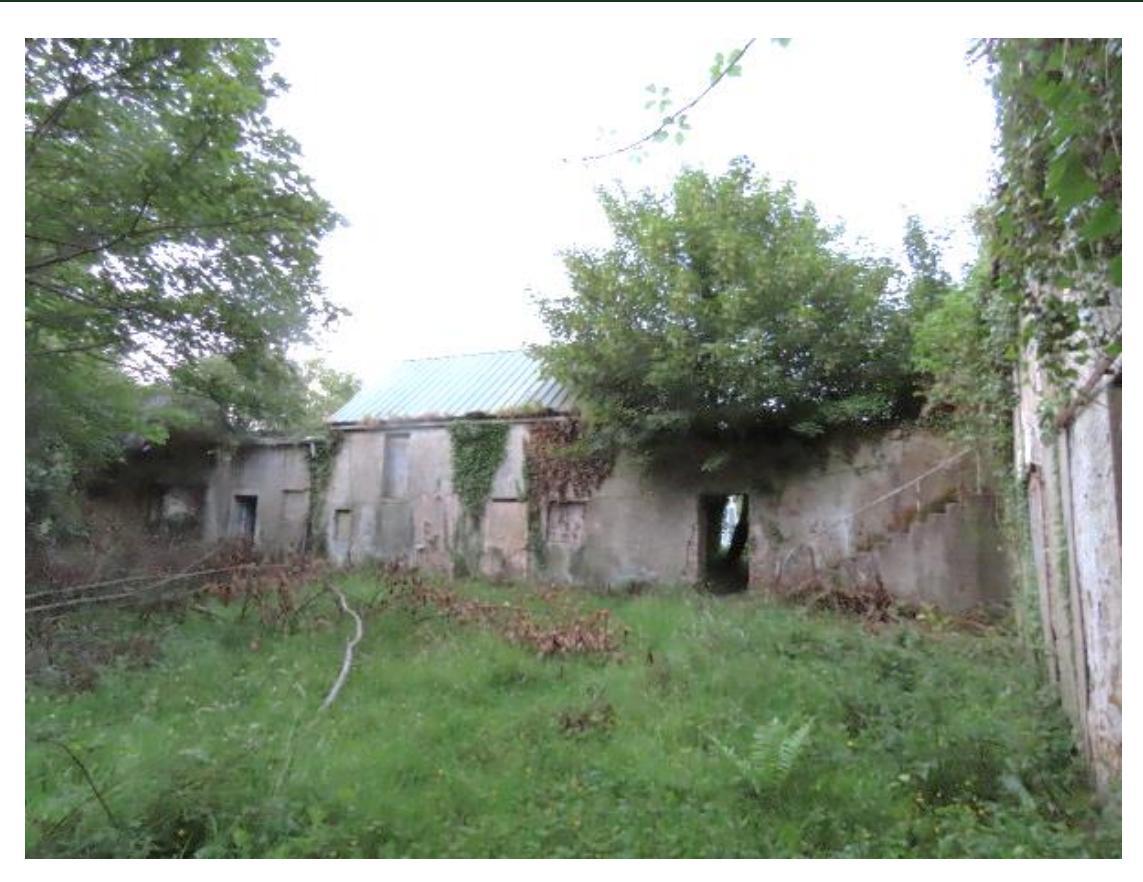
Figure 4. Exterior of outbuildings, showing the only structure with an intact roof

The walls of the outbuildings have a number of shallow cracks and crevices that would be suitable for small numbers of bats. The roofs of most buildings have collapsed, which reduces their suitability. One building still has a roof, but it is constructed of corrugated metal, a material which is typically avoided by bats. Therefore, the outbuildings are considered to have low to moderate roost suitability.

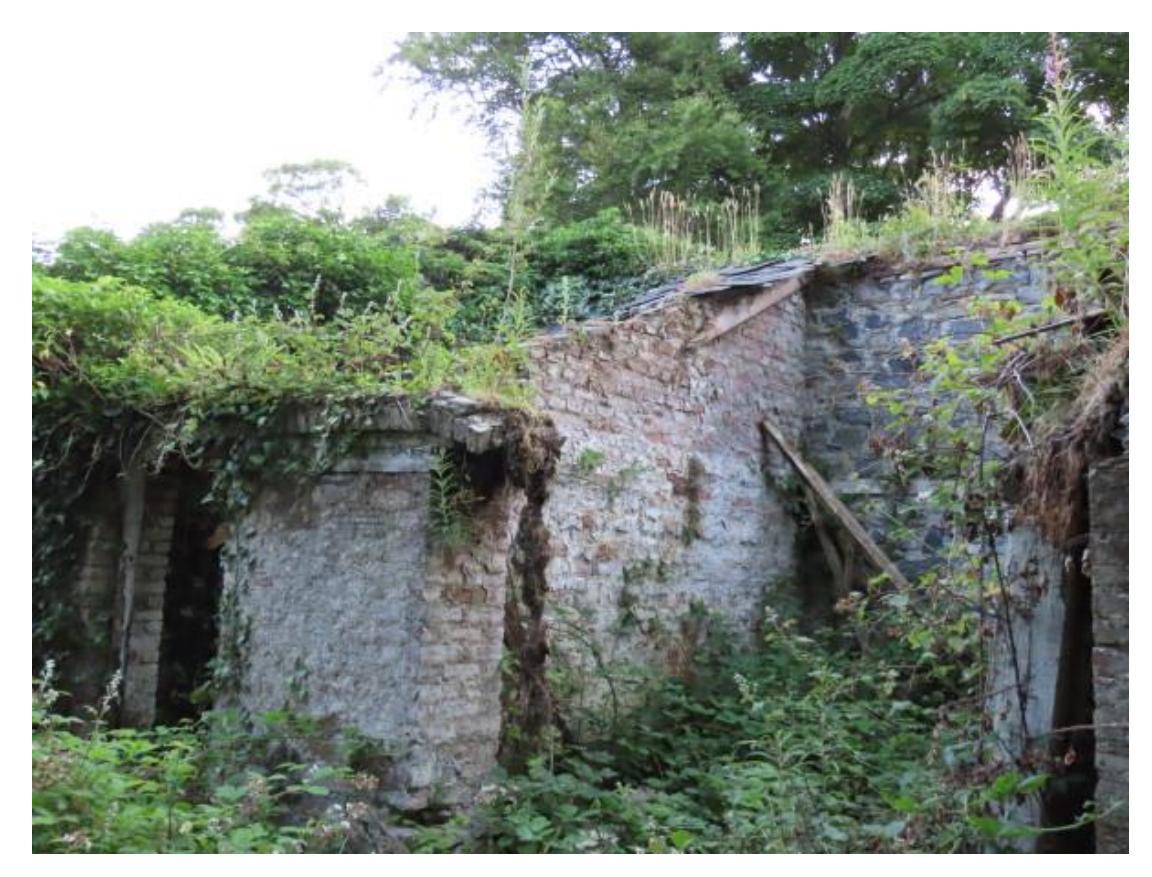
Figure 5. Ruined outbuilding with collapsed roof

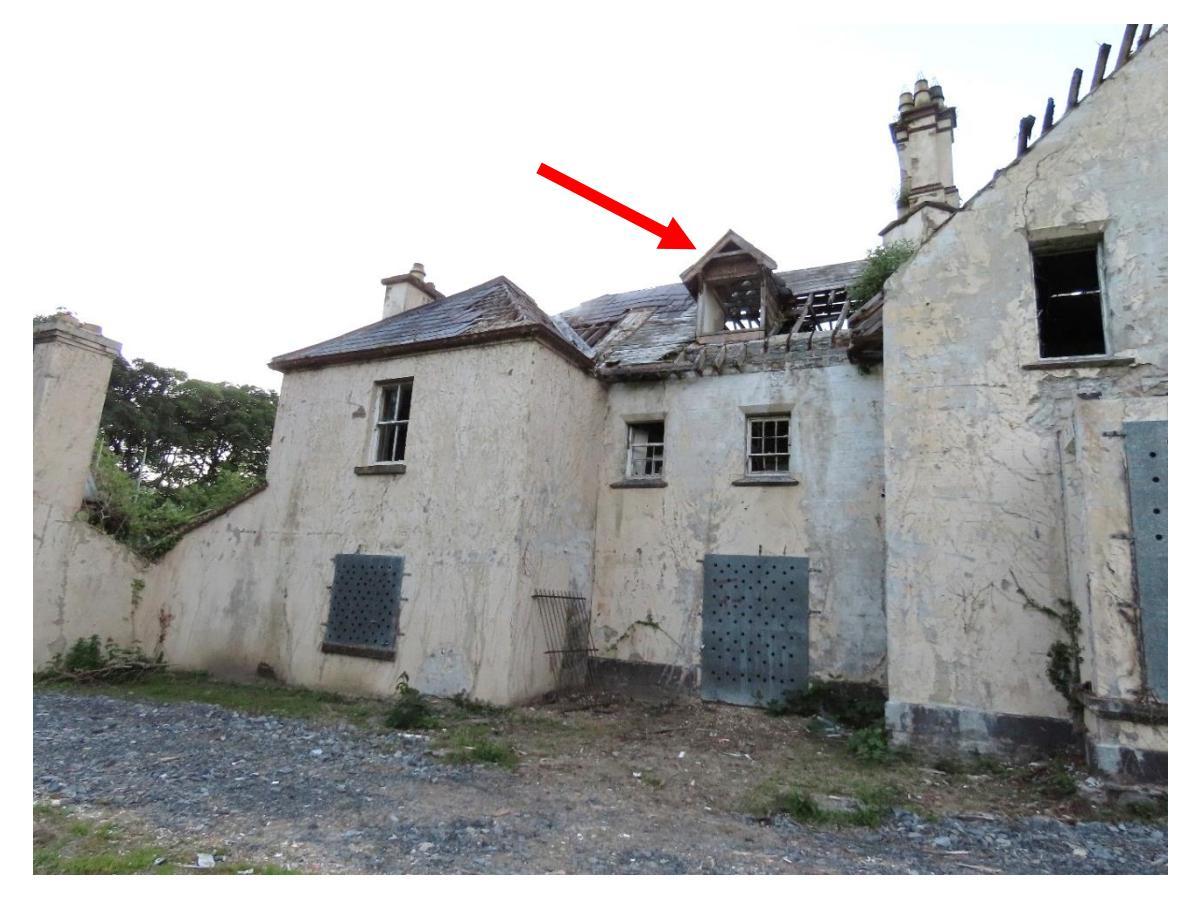
One soprano pipistrelle was recorded emerging from a crevice on the rear (southern) side of the building. The emergence point is shown in Figure 6.

Figure 6. A single soprano pipistrelle bat emerged from a dormer window on the southern side of Rathellen house

• One soprano pipistrelle above the dormer window on the southern side of Rathellen House

When the roosting location has been identified, measures will be taken to exclude bats from the structure, e.g. using a one-way exclusion tubs at the emergence point. Any crevices that do not contain bats (to be confirmed using an endoscope) will be blocked. The surveyor will then wait one night to allow bats to leave their roosts, and will resurvey the structure the following day.

When the exclusion process is complete, the ecologist will supervise the demolition of all structures, including the removal by hand of building materials around the roosting sites. If any bats are uncovered during this process they will be transferred to a cotton holding bag and placed in one of the bat boxes. Once all potential roost sites identified by the ecologist have been removed, the remainder of the structures can be demolished without further supervision.

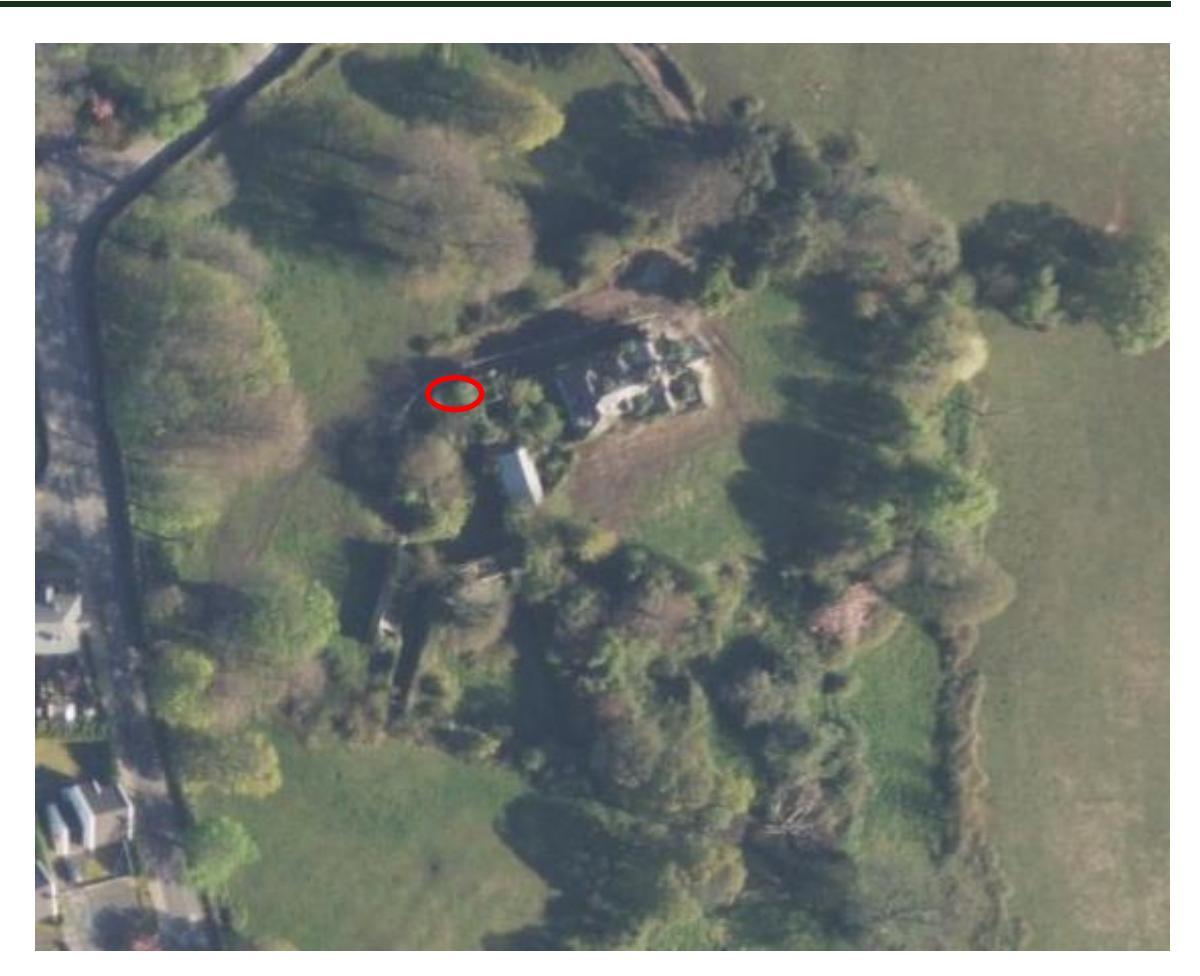
A single whiskered bat was recorded emerging from a small stone outbuilding to the west of Rathellen House (Figure 7). It circled within the structure for approx. one minute before leaving to forage.

Figure 7. Location of outbuilding used by whiskered bat

- Approx. four brown long-eared bats roosting at an unknown location within Rathellen House
- A whiskered bat roosting within one of the outbuildings to the west of Rathellen House
