Ballyduff Bog (SAC 000641), Co. Tipperary

Executive Summary

Site identification

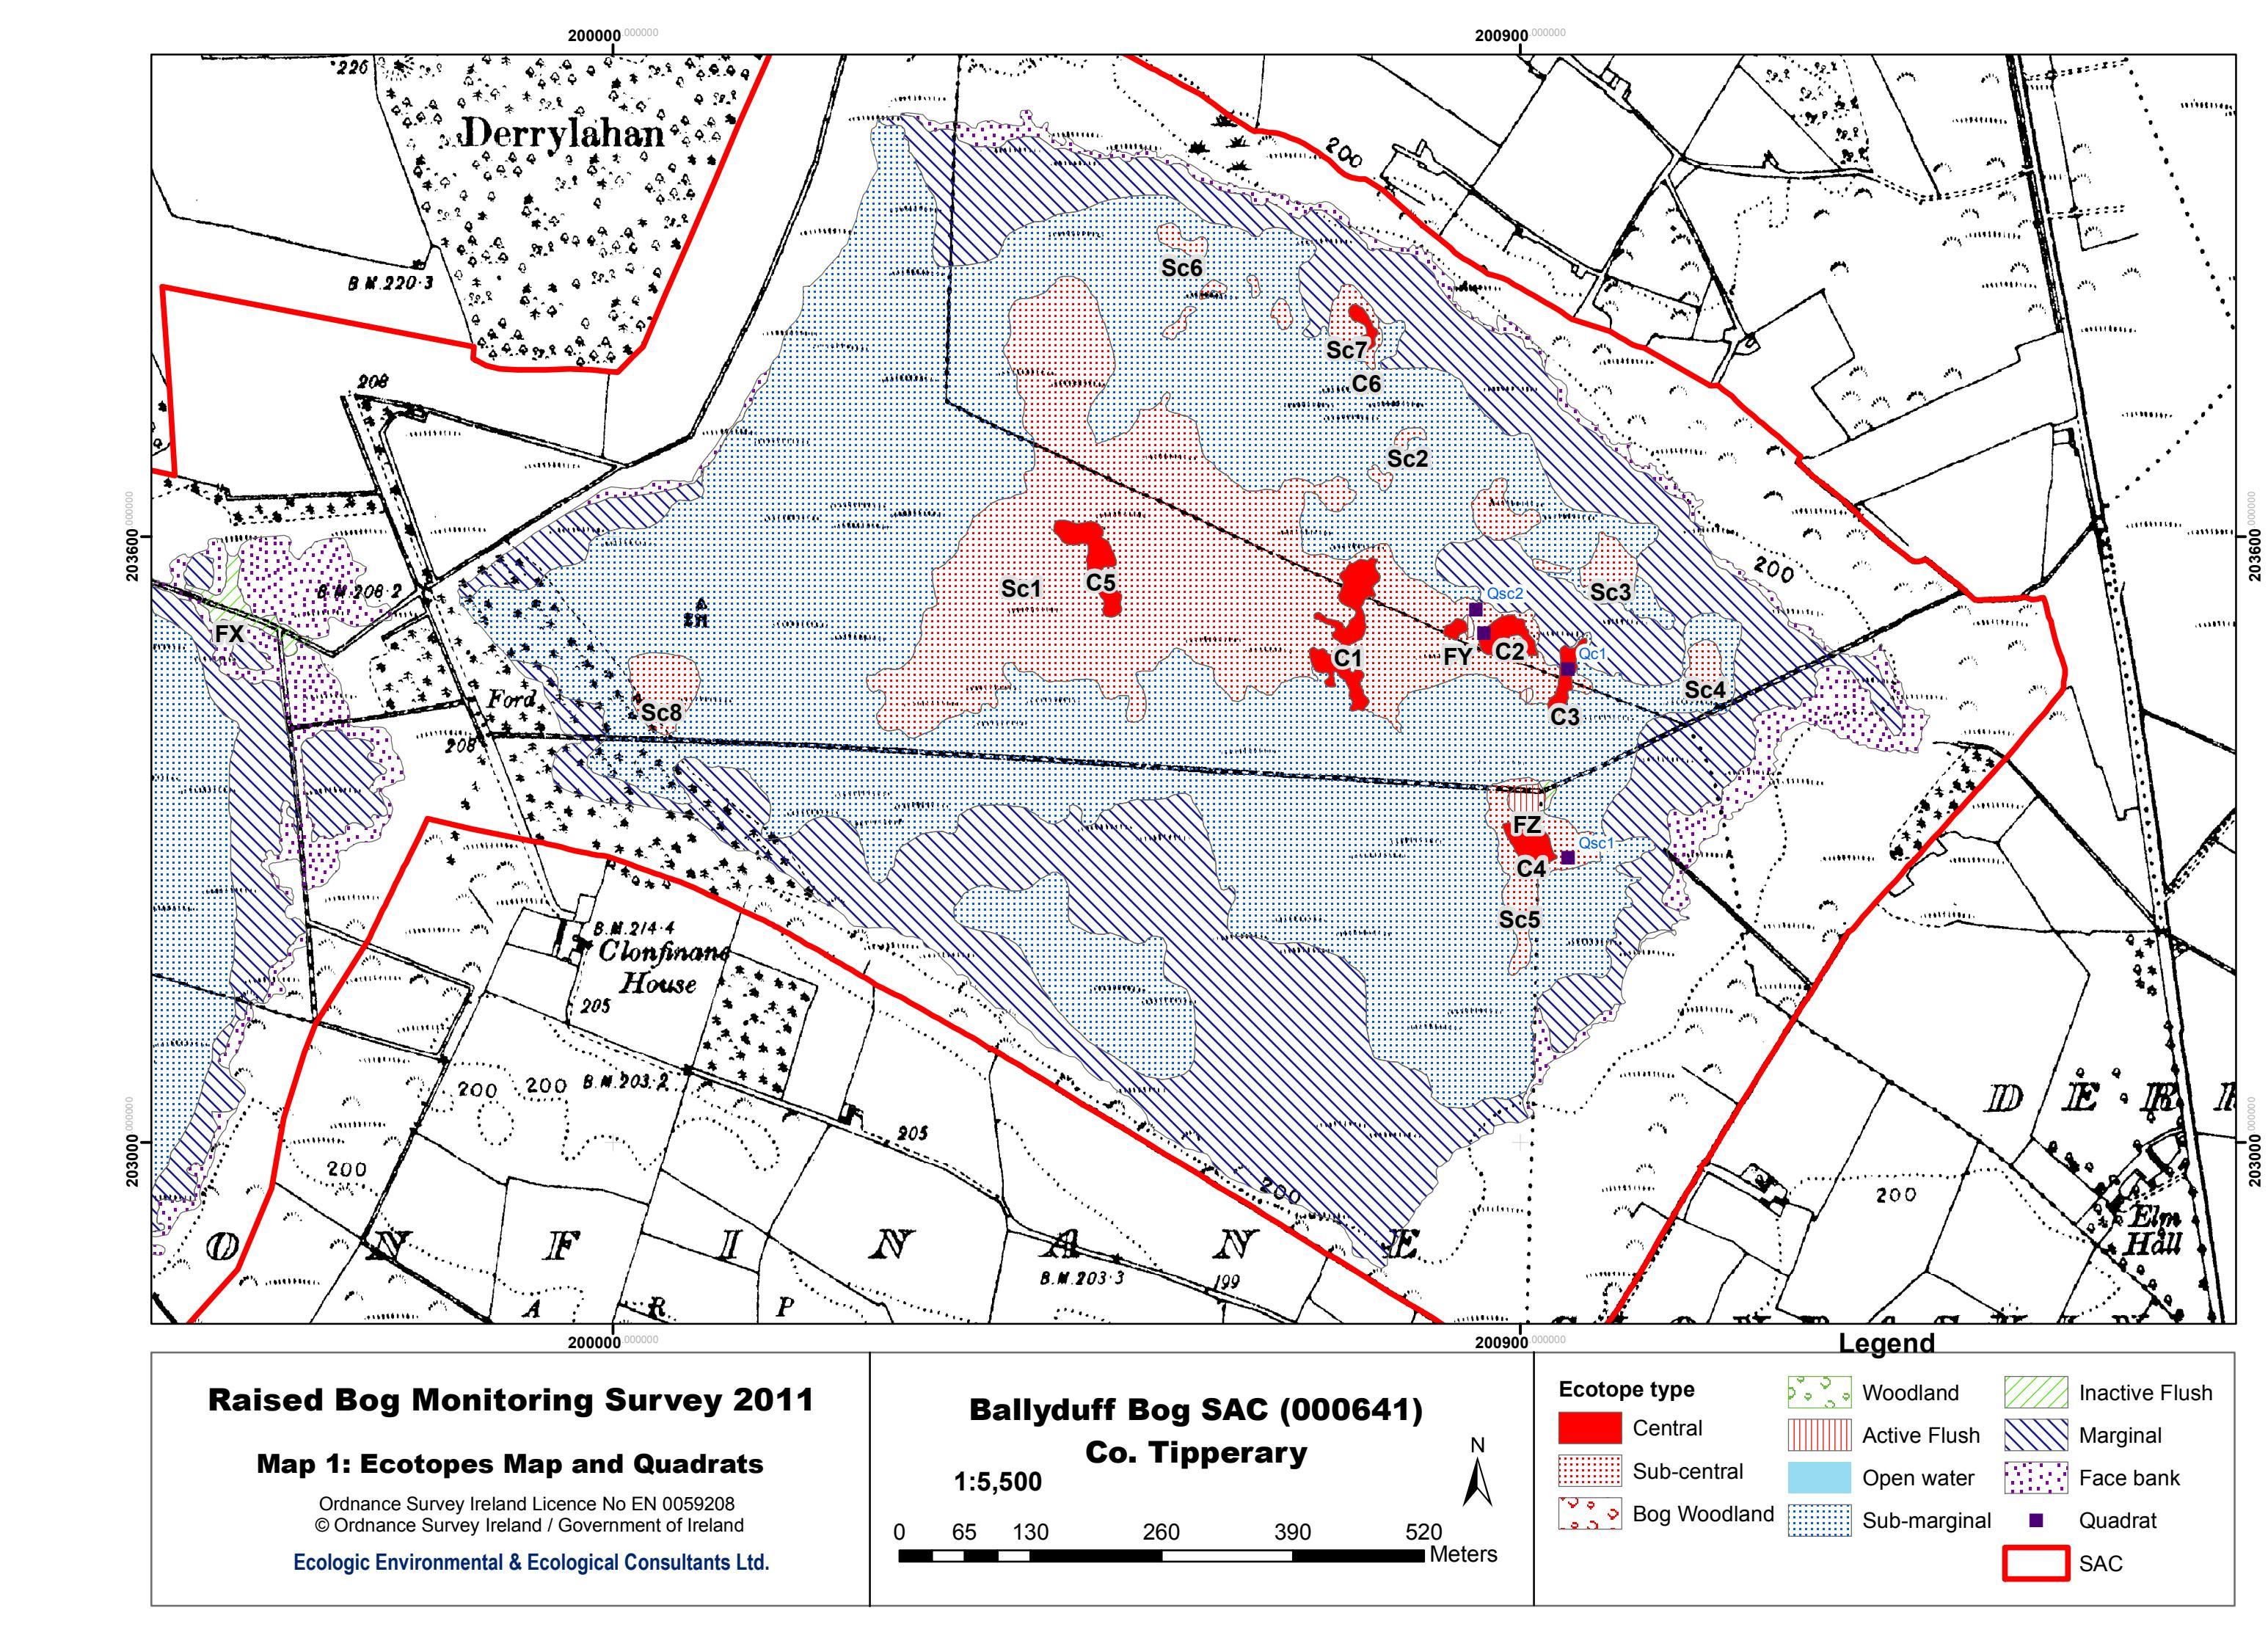
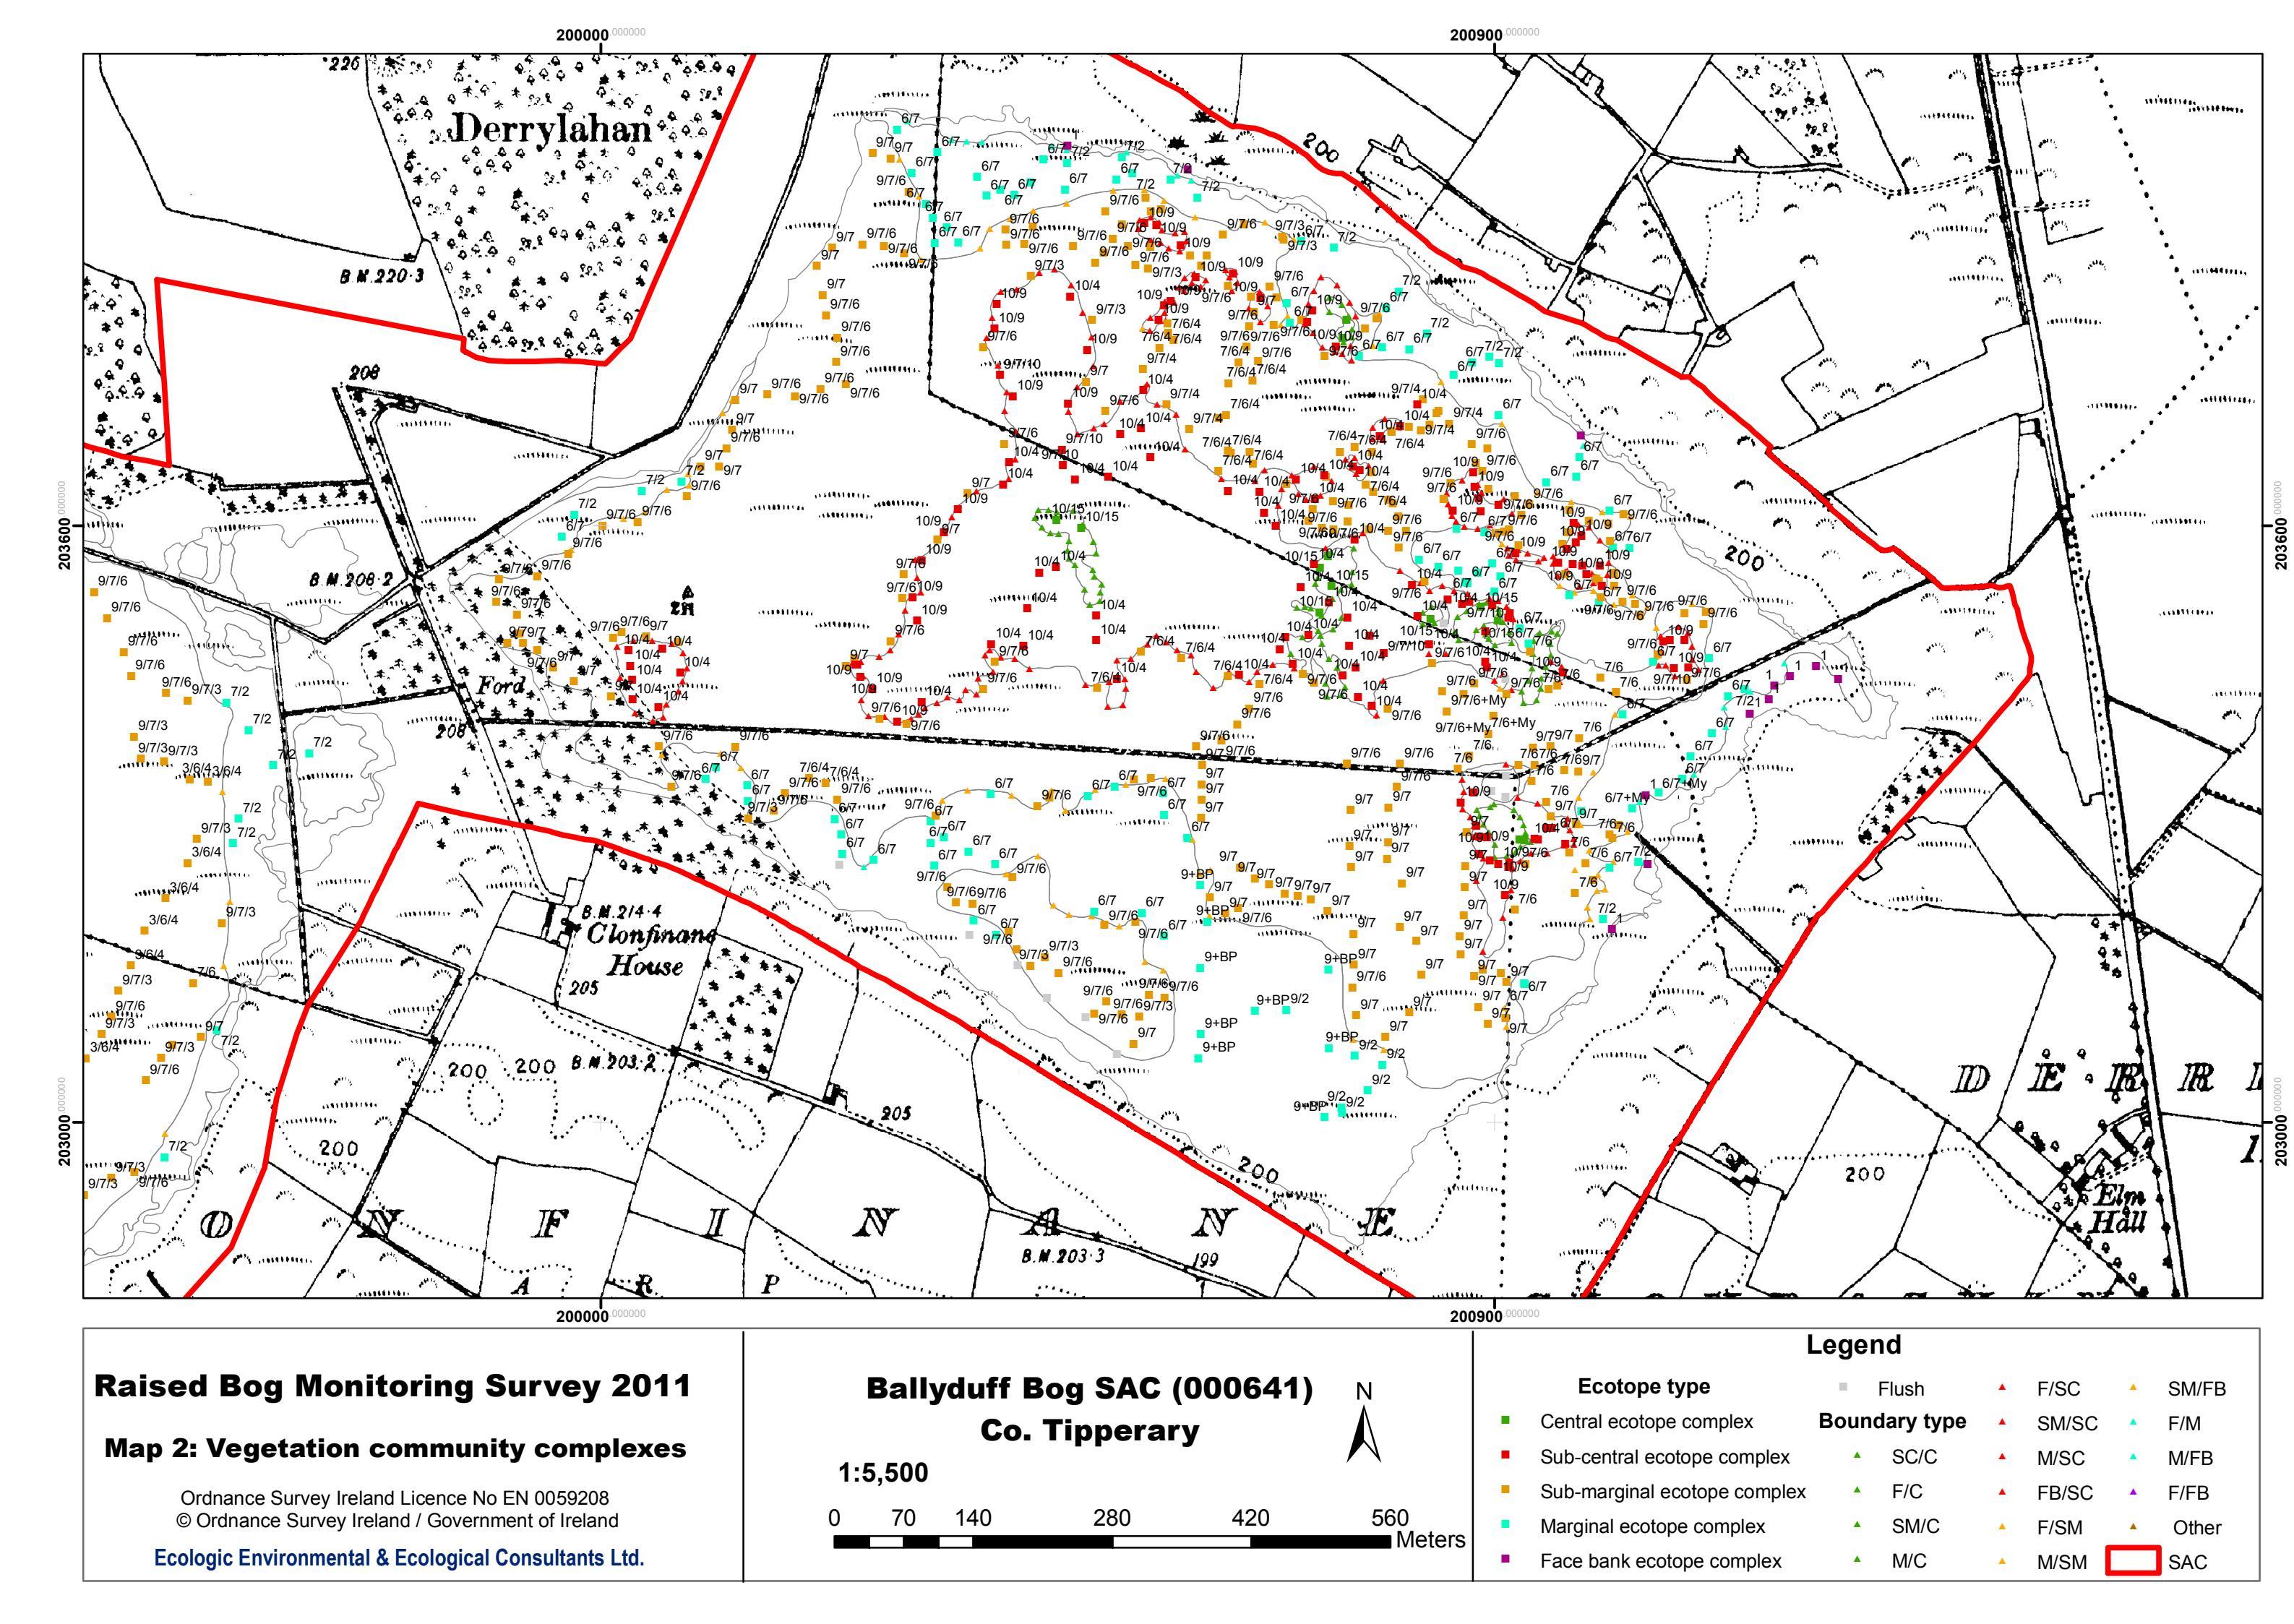
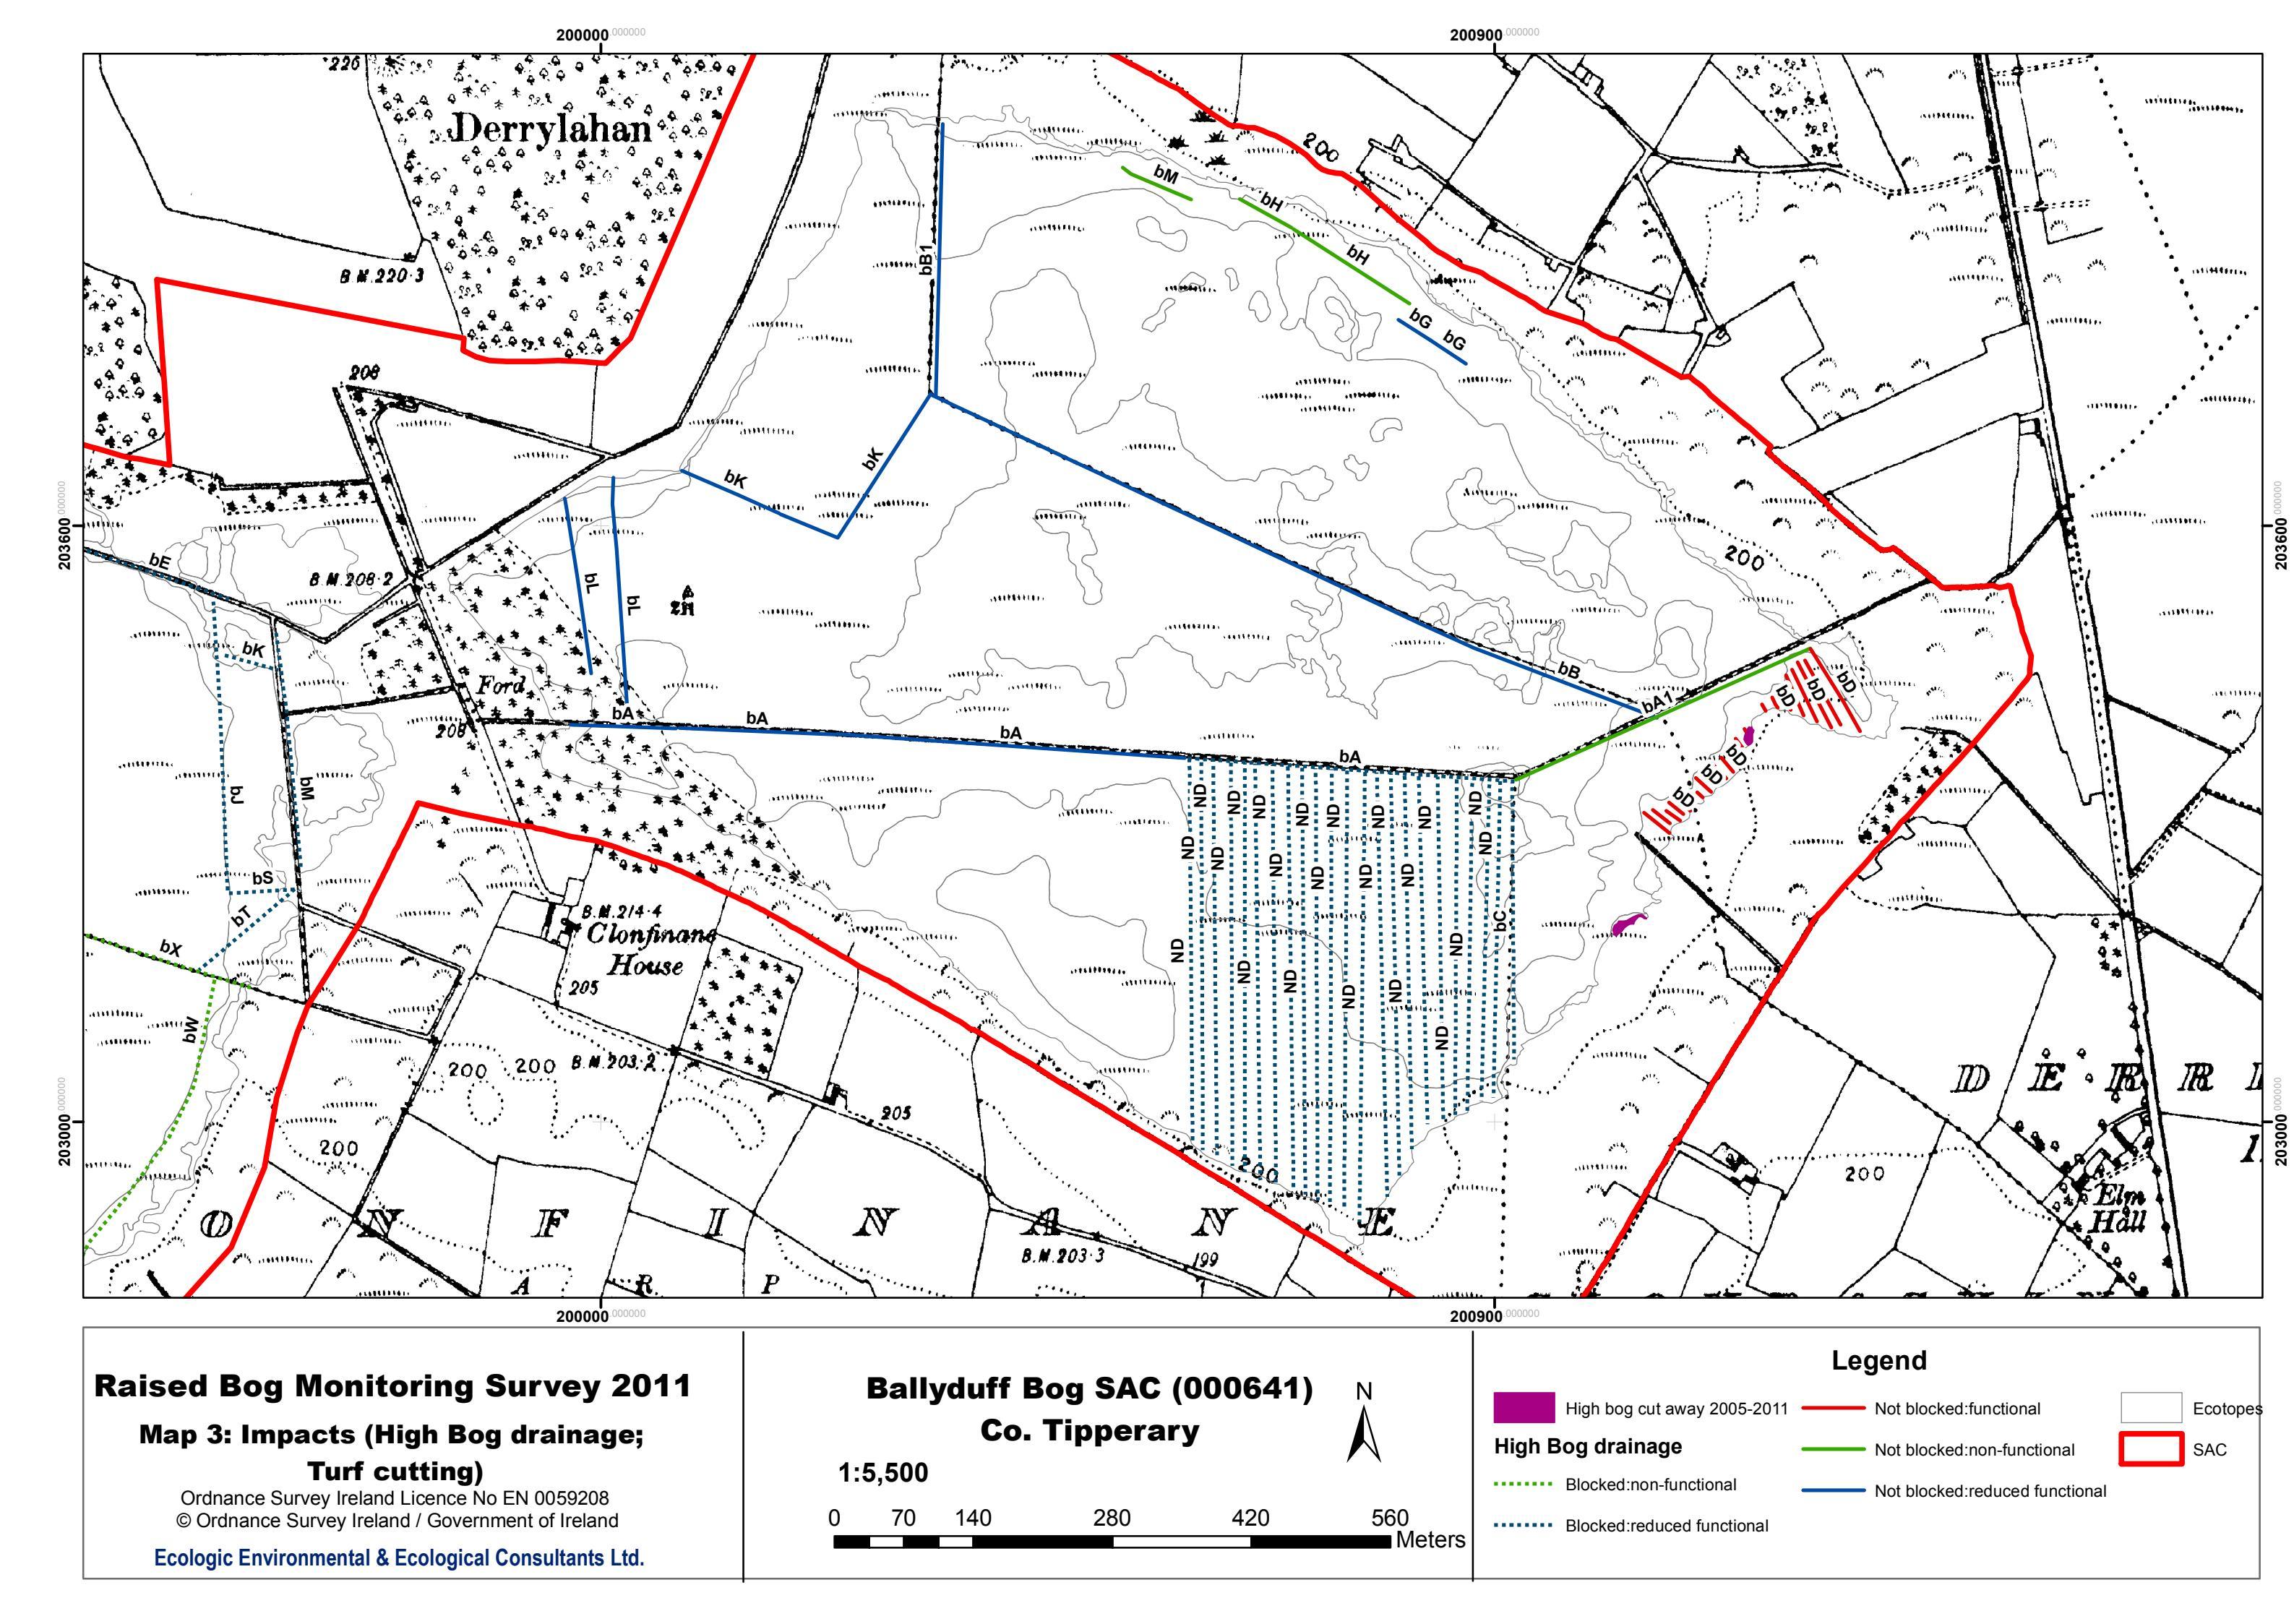
Appendix IV Survey maps

Central ecotope was found in Ballyduff Bog at six locations (C1 – C6) and sub-central ecotope at eight locations (Sc1 to Sc8) (see Appendix IV, Map 1). The highest quality Active Raised Bog sections consist of central ecotope (vegetation community complex 10/15) in depressed areas featuring hummocks, lawns, and inter-connecting pools (11-25%). *Sphagnum* cover is generally >90%, but is lower (75-90%) in places, and consists of *Sphagnum capillifolium*, *S. subnitens*, and active *S. austinii* hummocks, *S. magellanicum* and *S. papillosum* in lawns and low hummocks and *S. cuspidatum* in pools along with *Drosera anglica* and *Menyanthes trifoliata*.
