Cloonfelliv Bog (SAC 002110), Co. Galway/Roscommon

Executive Summary

Site identification

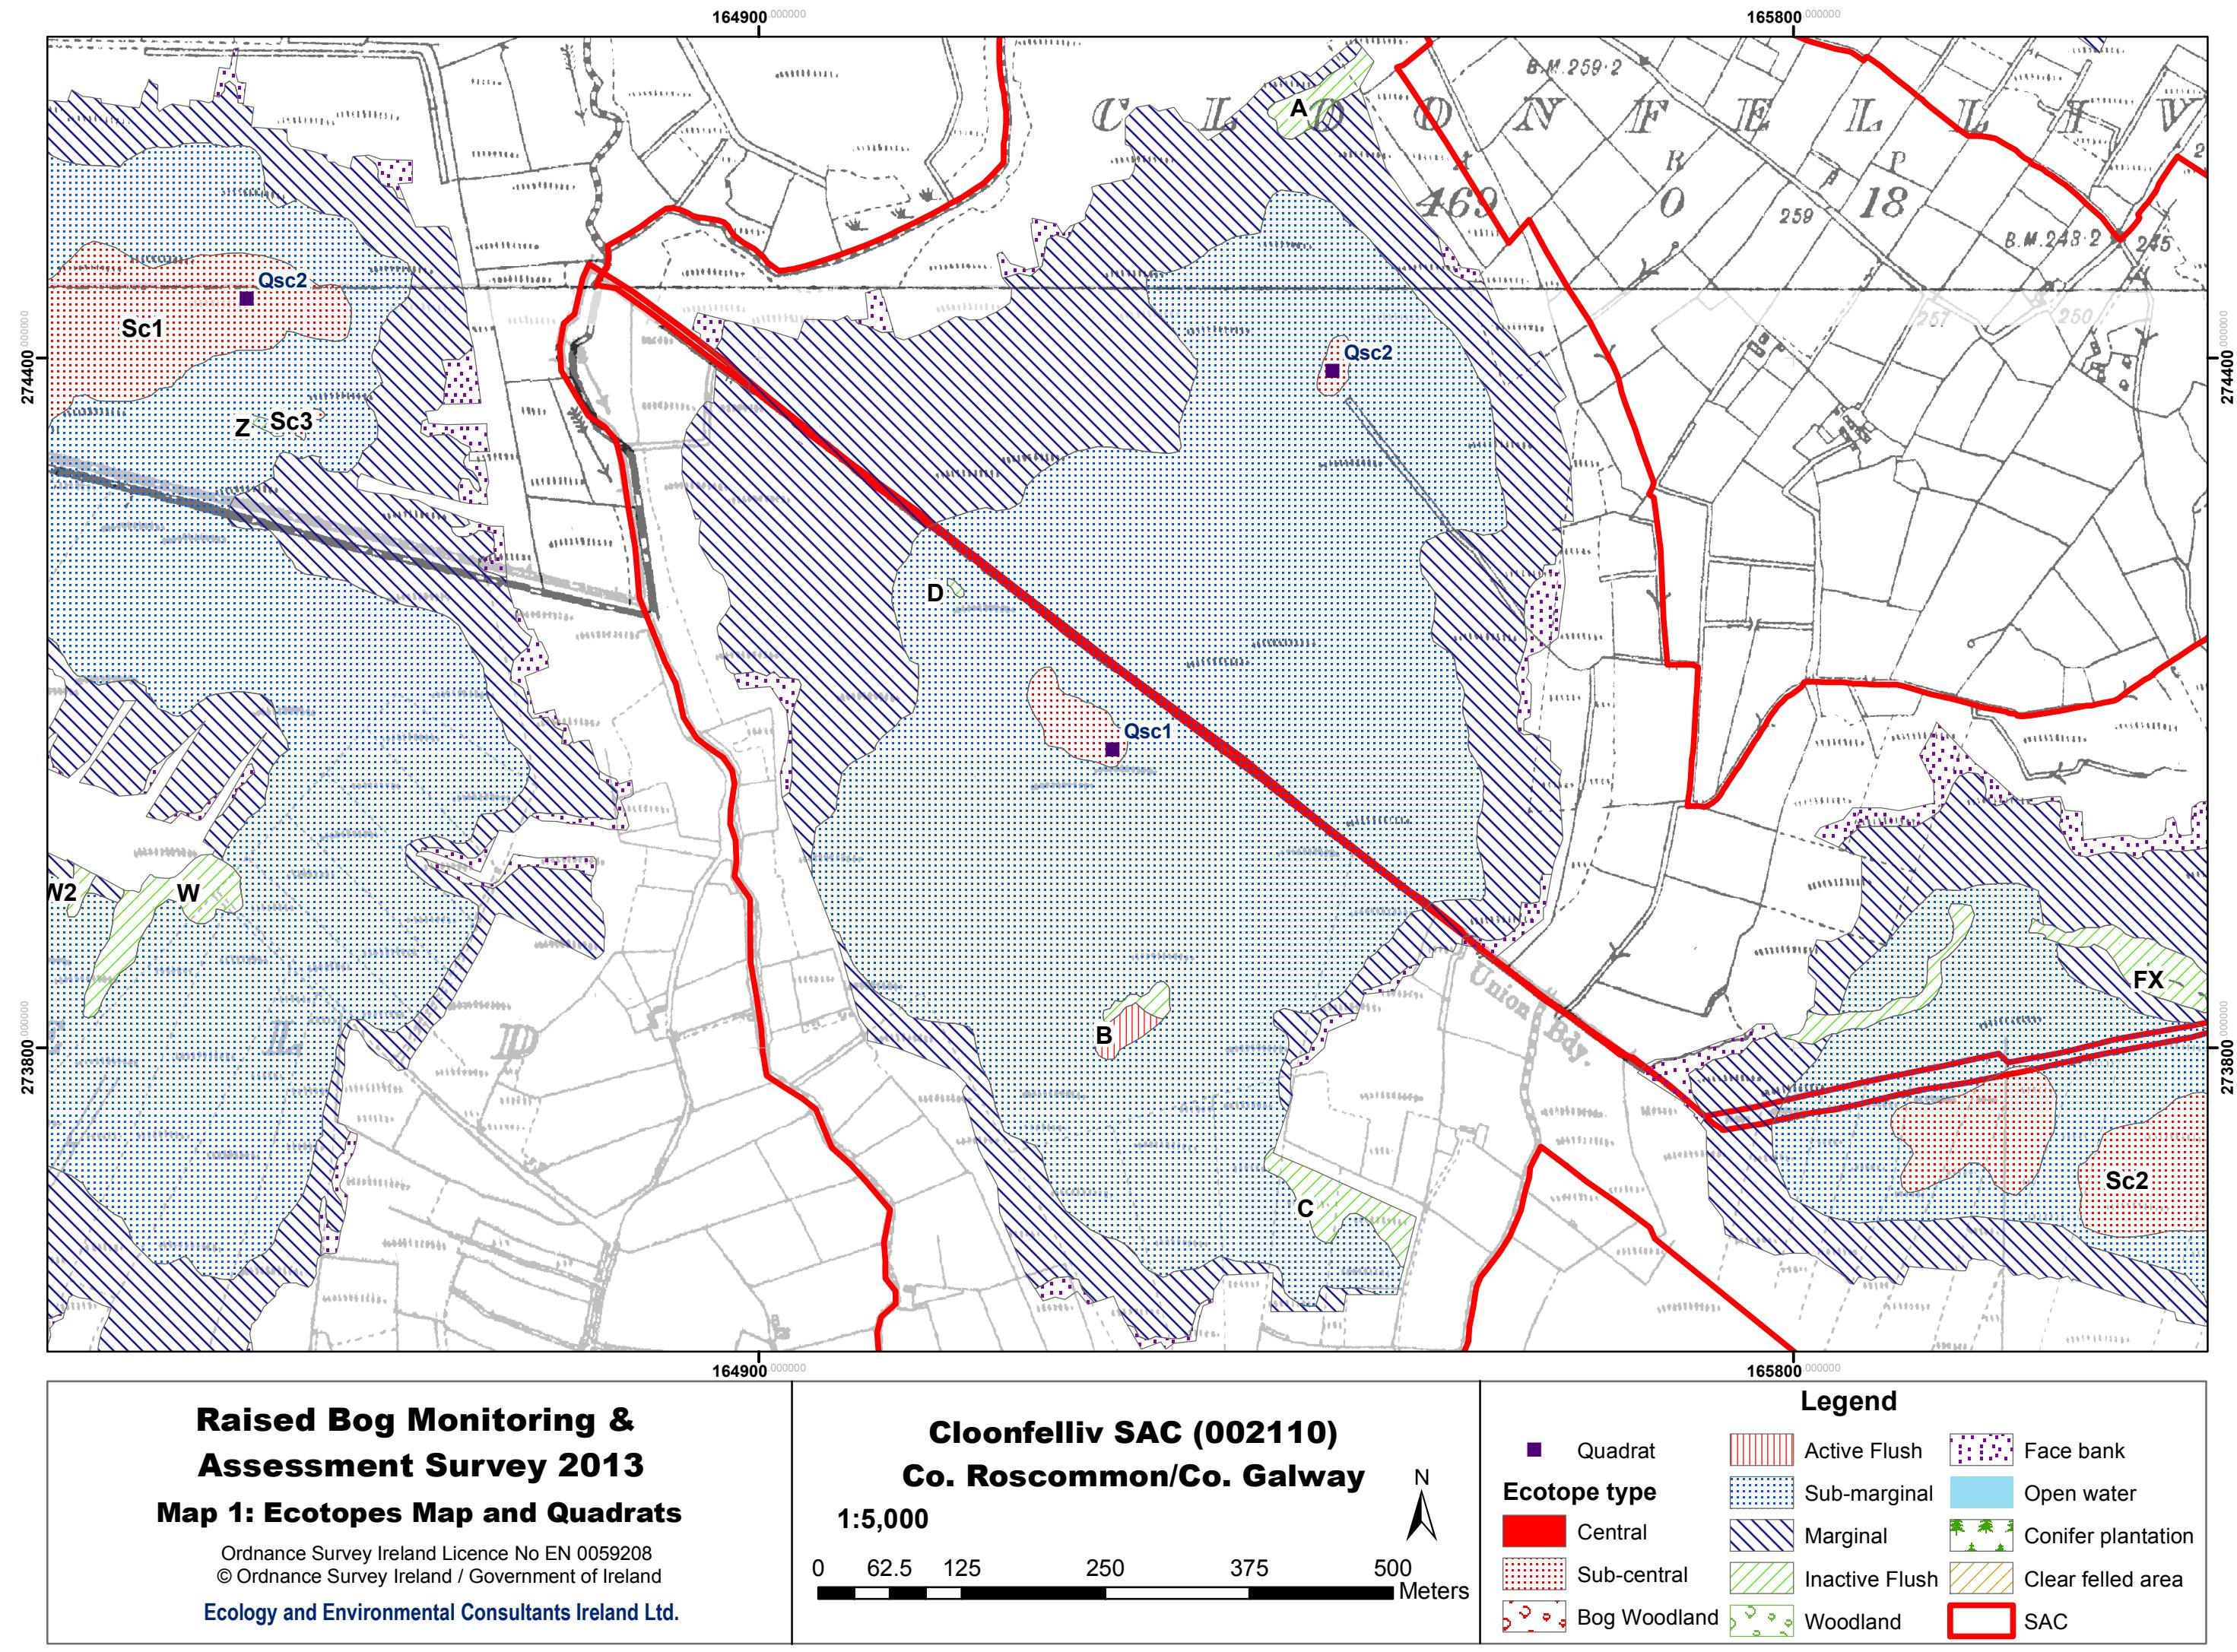
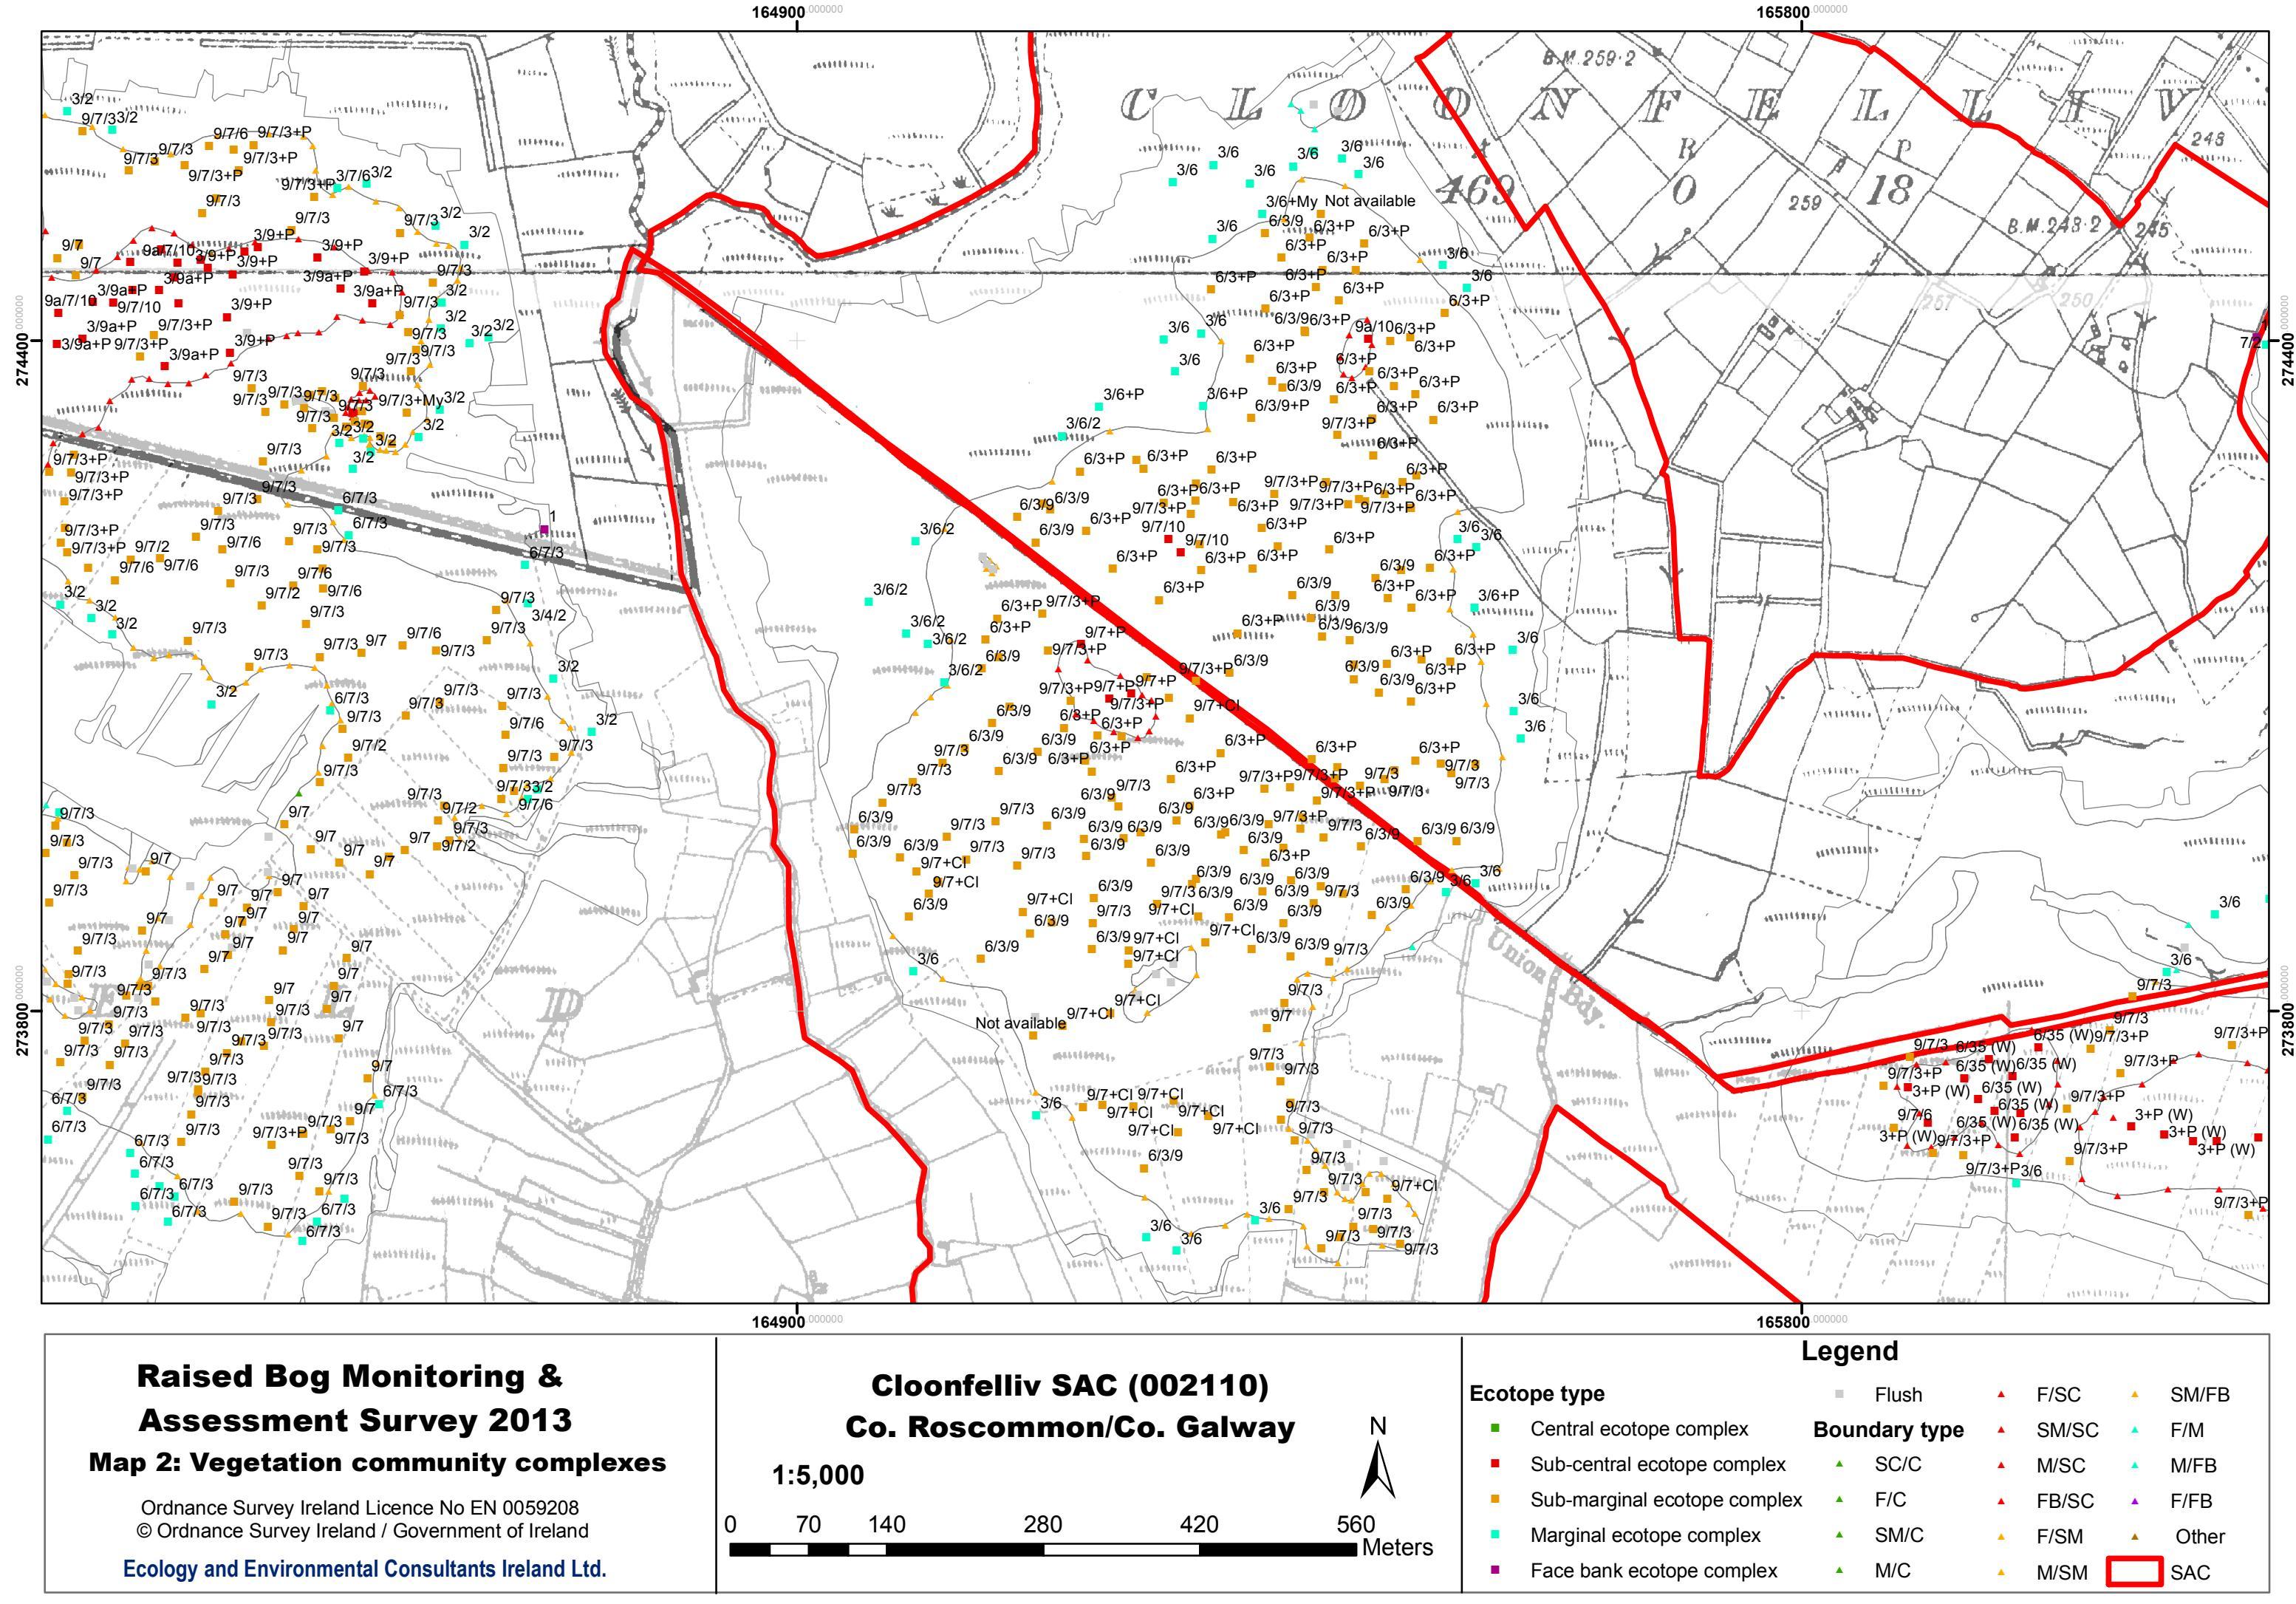
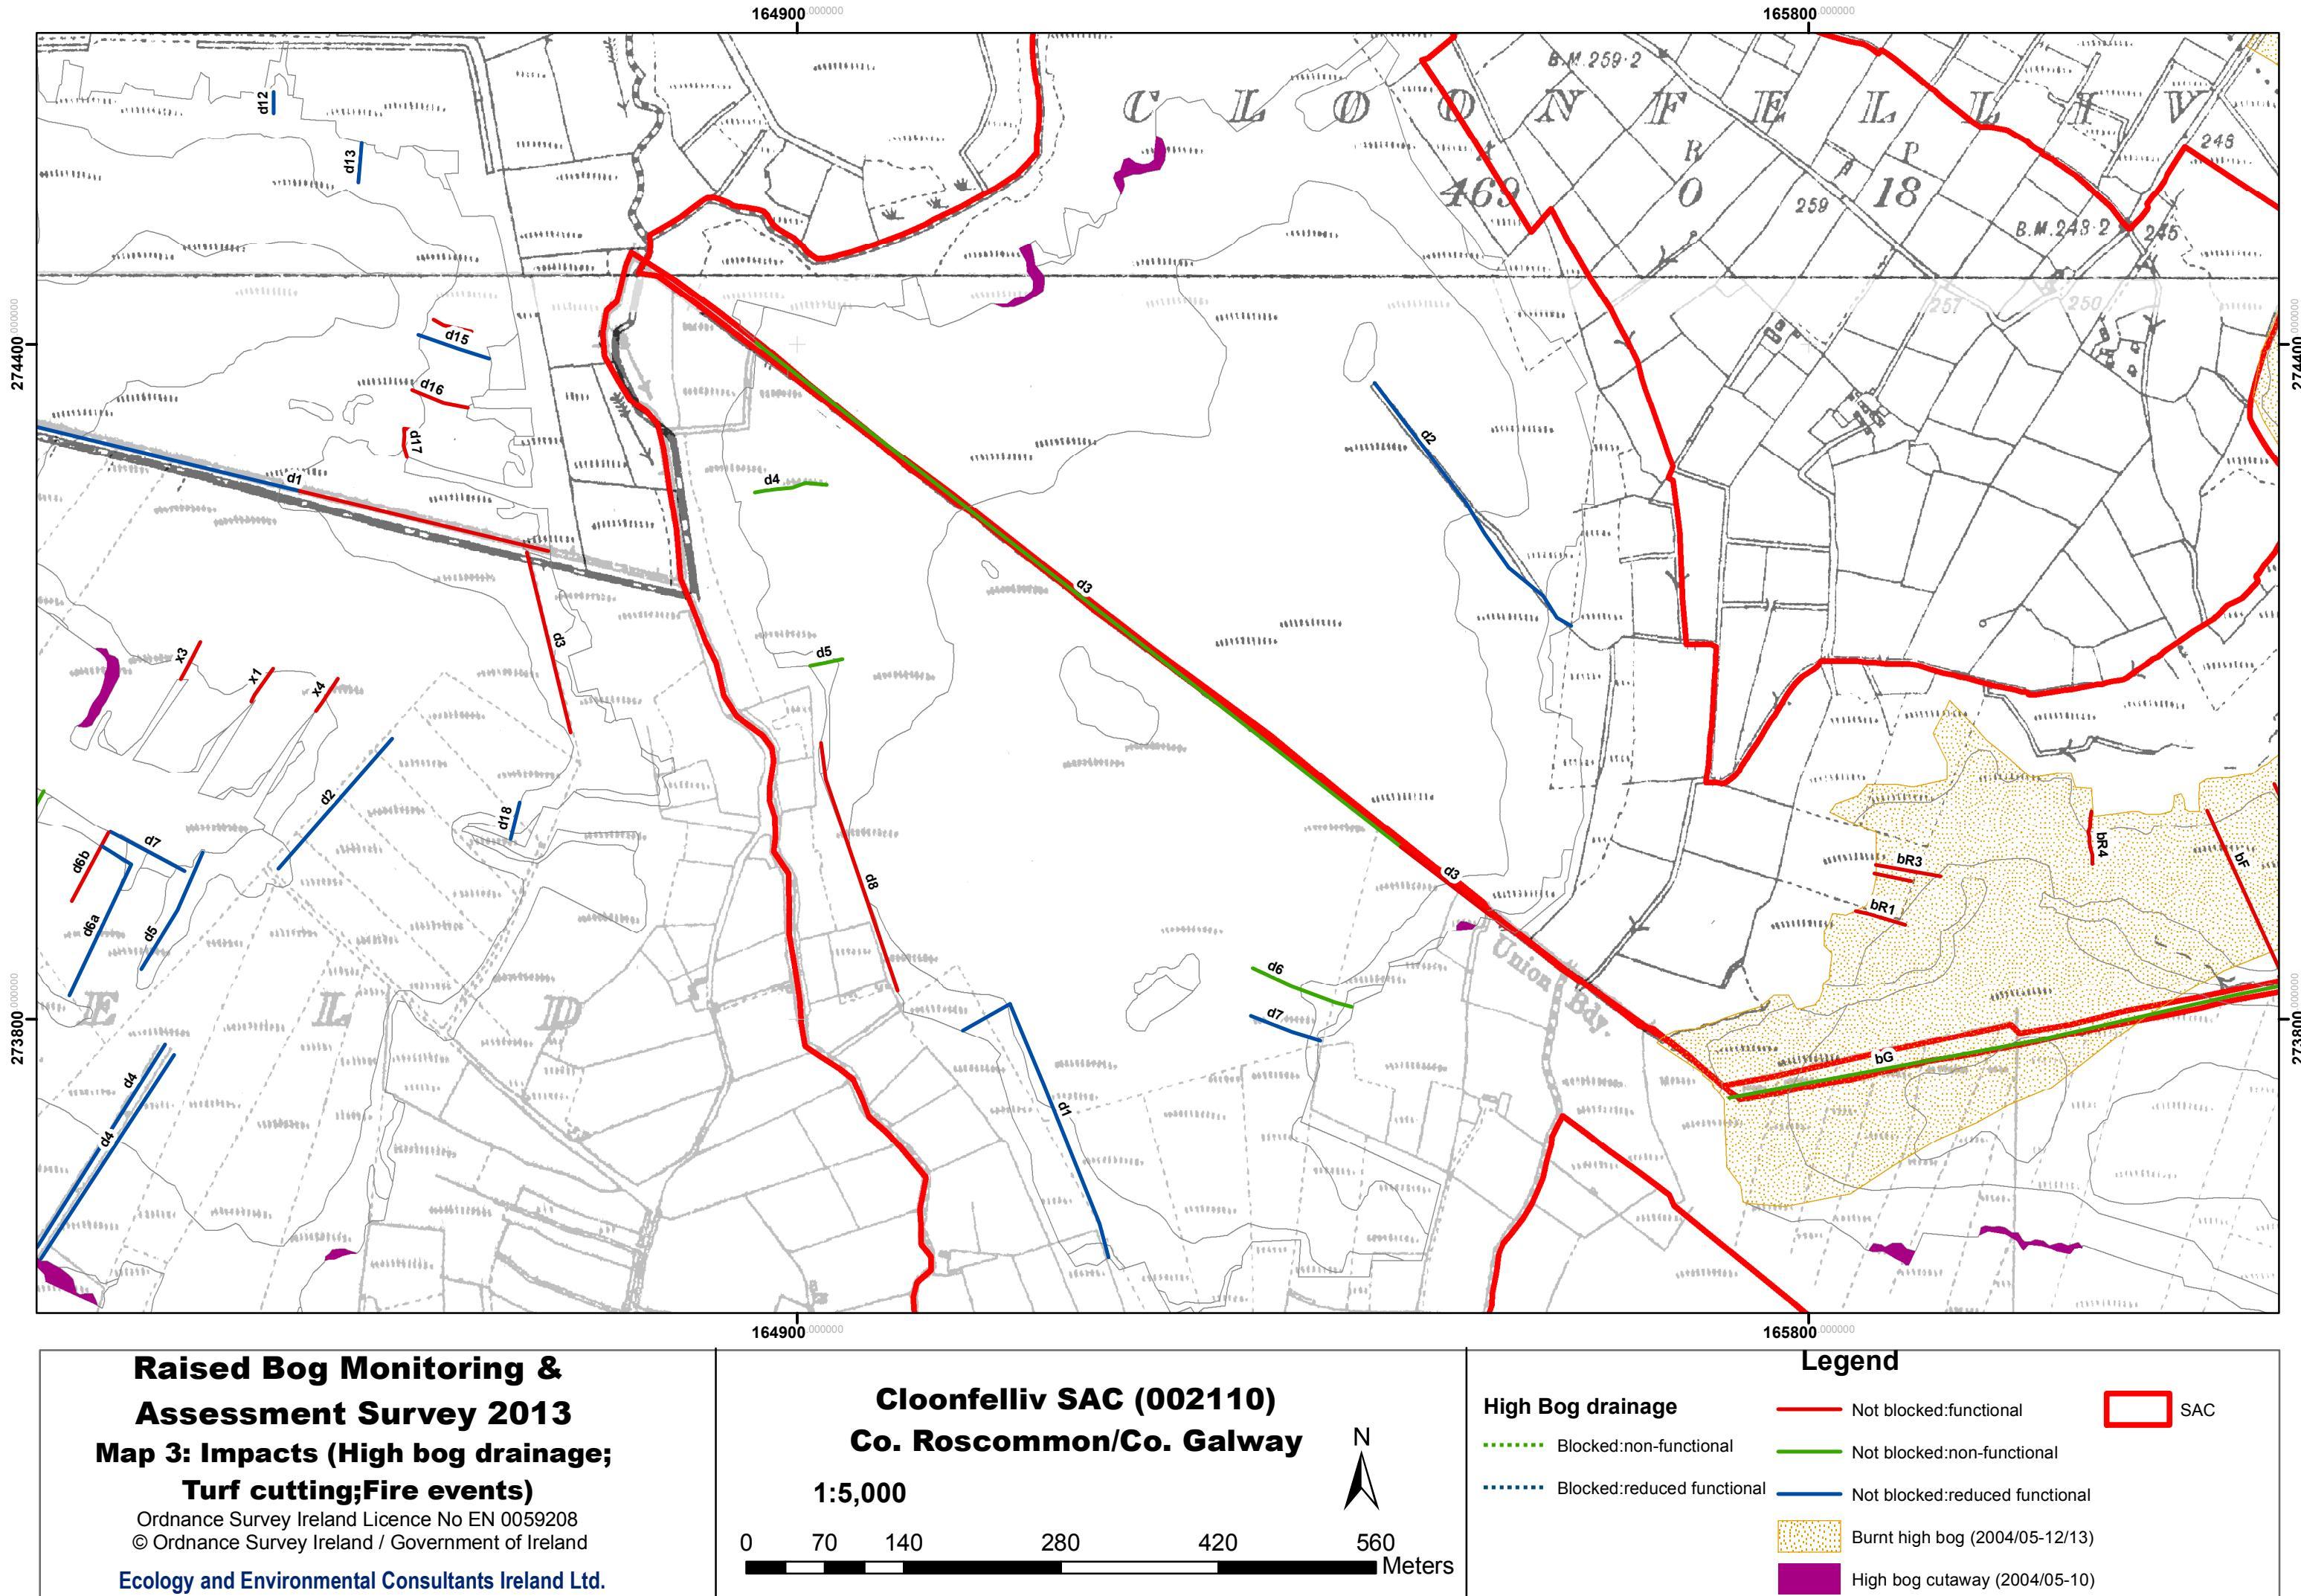
Appendix IV Survey maps

A digital vector format ecotope vegetation map was produced based on the spatial data collected during the survey using ArcGIS 9.3 and 2010 aerial photography. The Irish National Grid was used as the co-ordinate reference system. Vegetation complex and ecotope maps are given in Appendix IV.

Sub-central ecotope was found at two locations (**Sc1** & **Sc2**) (see Appendix IV, Map 1). Only two community complex types were recorded. Complex 9A/10 in Sc1 towards the north of the high bog is essentially a large pool (ca. 15m x 7m) full of *Sphagnum cuspidatum* with lawns and low hummocks of other *Sphagna* such as *S. papillosum*, *S. palustre* and *S. capillifolium* growing in, but mostly at the edge of, the pool. The *Sphagnum* cover approaches 100% and *Eriophorum angustifolium* is the most dominant vascular plant. Complex 9/7 + P in **Sc2** towards the centre of the high bog is a much poorer quality area of sub-central ecotope. The *Sphagnum* cover here ranges from 34-50% and is composed mostly of hummocks of *Sphagnum capillifolium* and *S. papillosum* with a patchy cover of *S. cuspidatum* in the pools. *Calluna vulgaris* and *Eriophorum vaginatum* are the most dominant vascular plants while evidence of flushing is also indicated by the presence of *Aulacomnium palustre* and *Polytrichum strictum*.
