# National Survey of Upland Habitats

Site Report No. 7: Mount Brandon cSAC (000375), Co. Kerry (Revision)

Philip M. Perrin, Jenni R. Roche, Simon J. Barron and Orla H. Daly January 2014

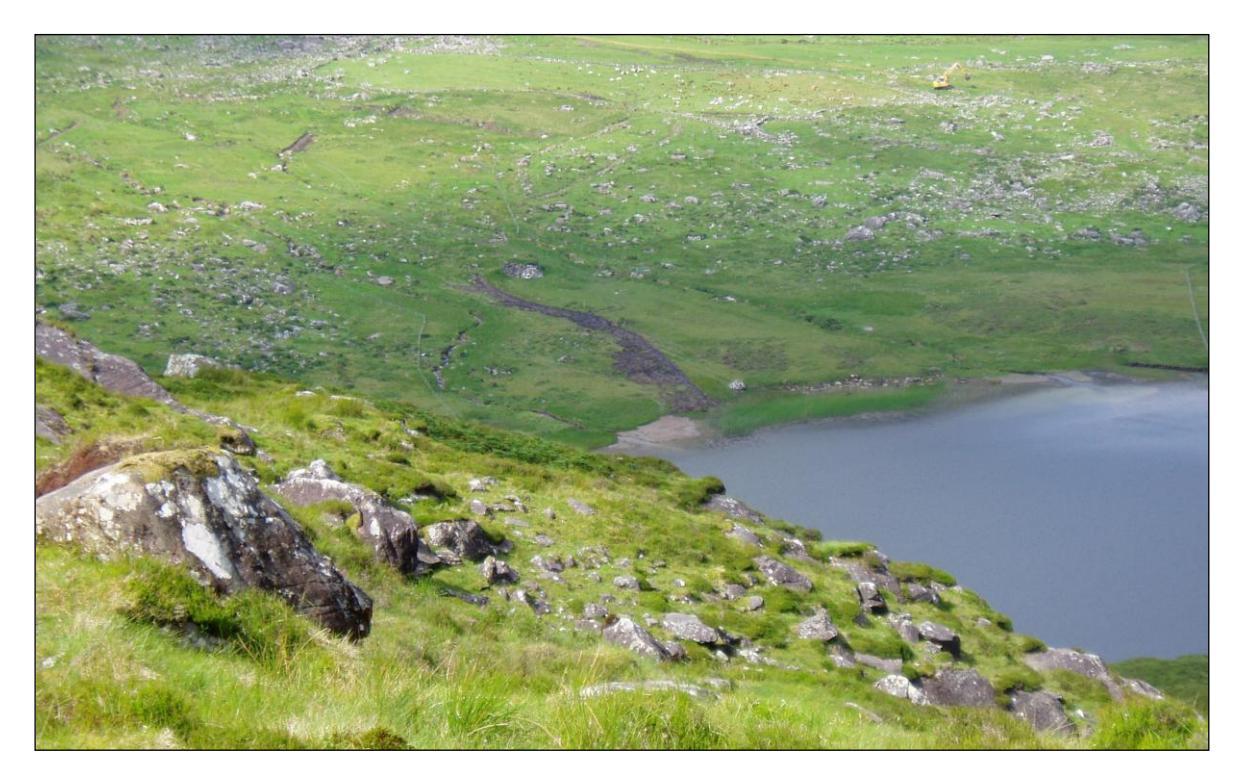
- 3.36 Some of these drains dug at Mullaghveal emptied directly into An Loch Dubh (Plate 1), a lake classified as **3110 Lowland oligotrophic lakes**. This lake is part of the Owenmore River catchment, which contains a population of the freshwater pearl mussel (*Margaritifera margaritifera*), a species listed on Annex II of the Habitats Directive. This declining and critically endangered species is highly sensitive to siltation as a result of drainage and these operations represent a significant threat to its conservation status.

Plate 1: Drainage works in a mosaic of 4010 Wet heath, GS4 Wet grassland and PF2 Poor fen and flush, draining directly into An Loch Dubh near Mullaghveal. The excavator is visible in the top right (Photo: BEC Consultants).

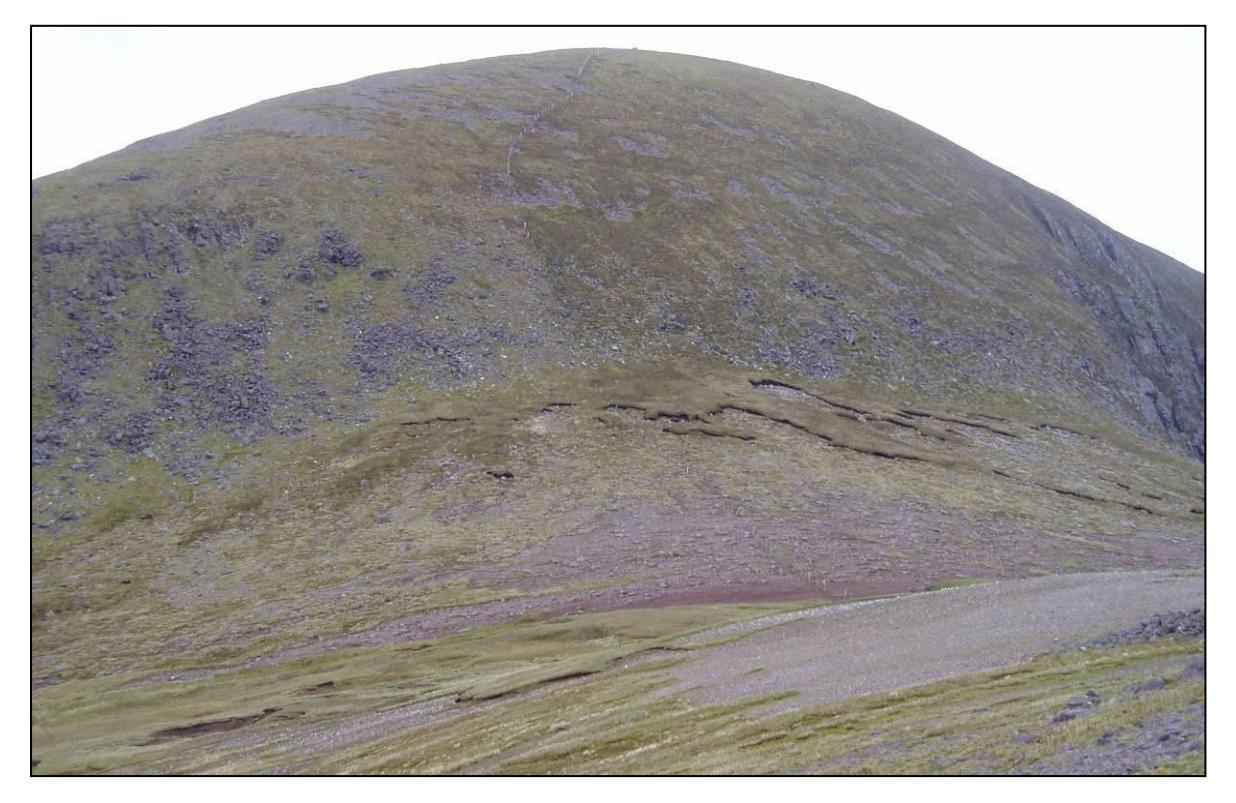
Plate 2: 4060 Alpine and Boreal heath on the southern slope of Masatiompan, showing greater heather cover to the right of the fence (running vertically up the centre of the mountain) (Photo: Jenni Roche).

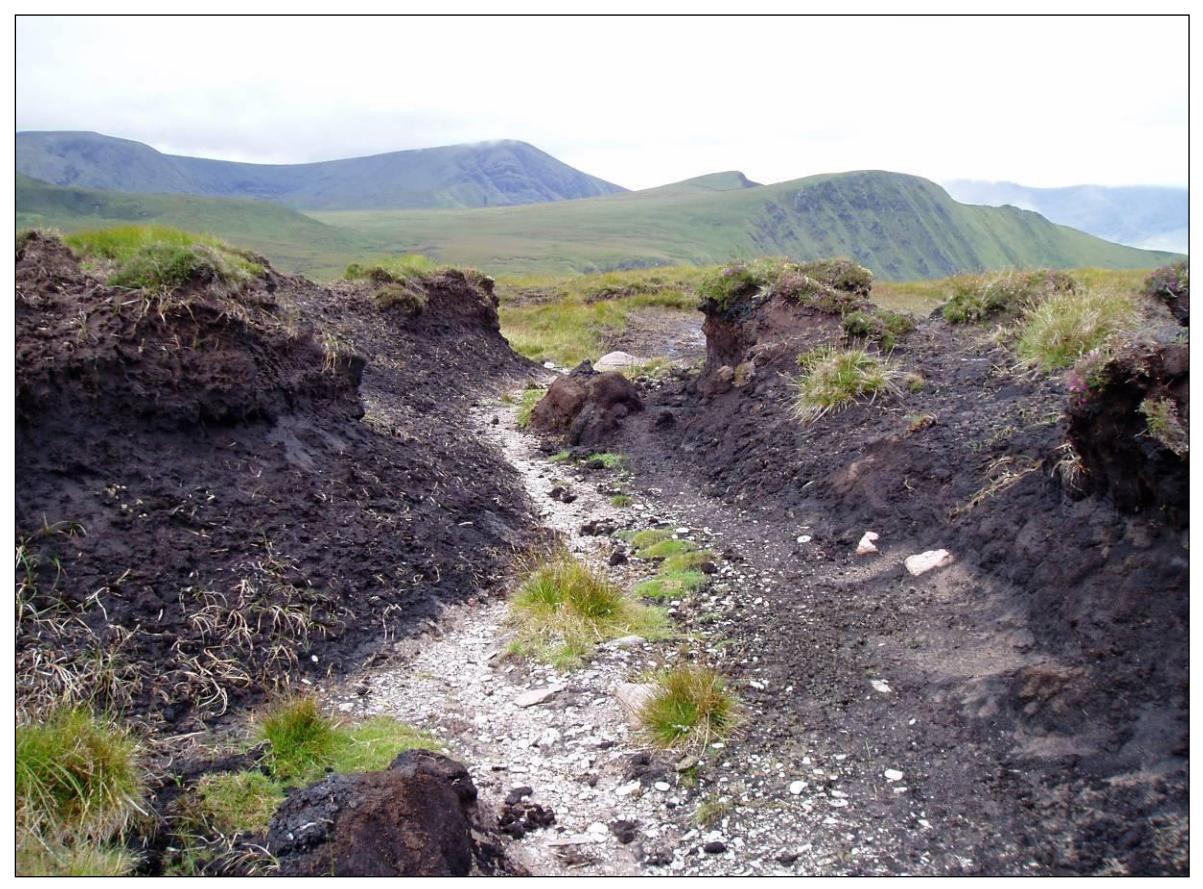
Plate 3: PB5 Eroding blanket bog southwest of Beenoskee (Photo: Jenni Roche).

3.106 This survey has found that erosion of blanket peat is a major issue for several areas of **\*7130/7130 Blanket bog** within the site. The assessment of structure and functions recorded unfavourably high levels of erosion in **PB2 Upland blanket bog** on Cnoc Mhaoilionáin, Slievanea and Fallaghnamara and particularly around Slieveglass. Severe hagging was also

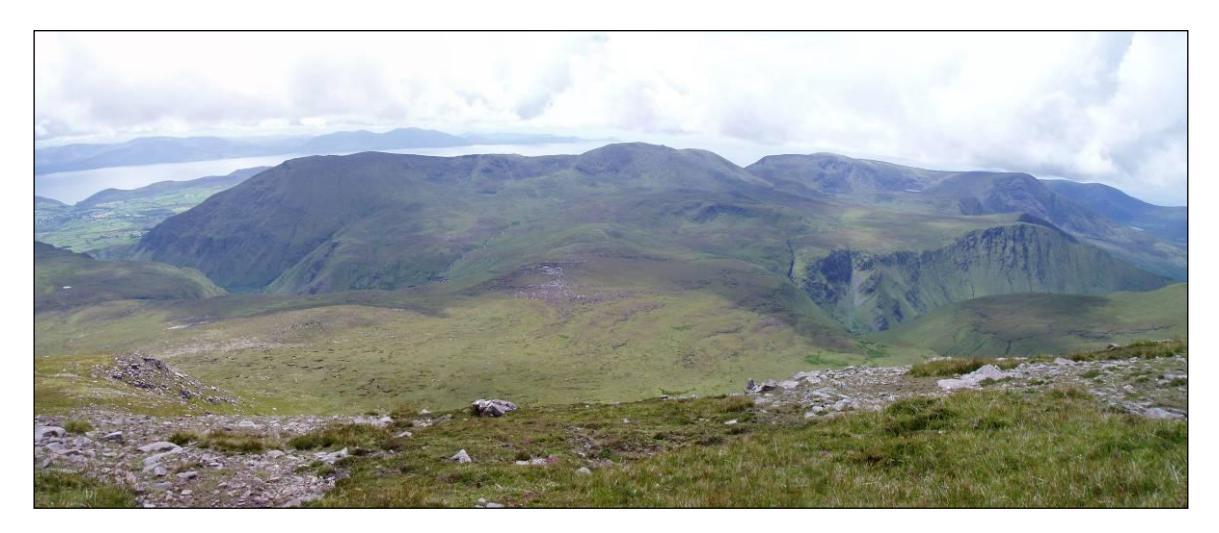
Plate A13: View from Beenoskee over eroding upland blanket bog to Cnoc Mhaoilionáin and An Cnapán Mór (Photo: Jenni Roche).

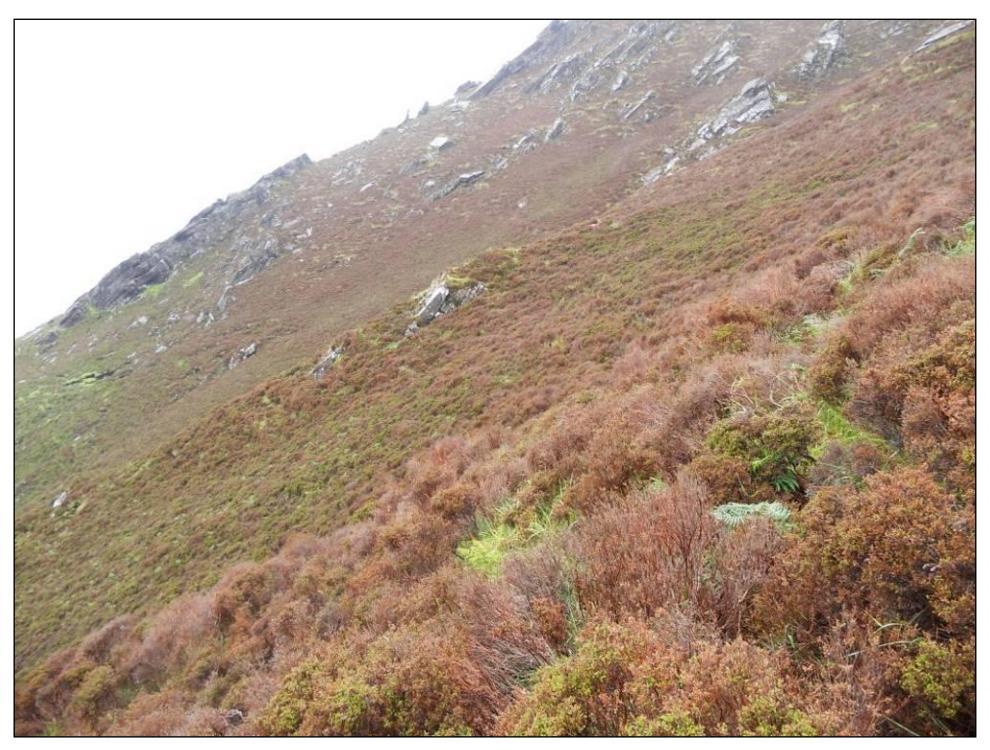
Plate A15: Die-back of *Calluna vulgaris* on the northwestern slopes of Masatiompan (Photo: Philip Perrin).

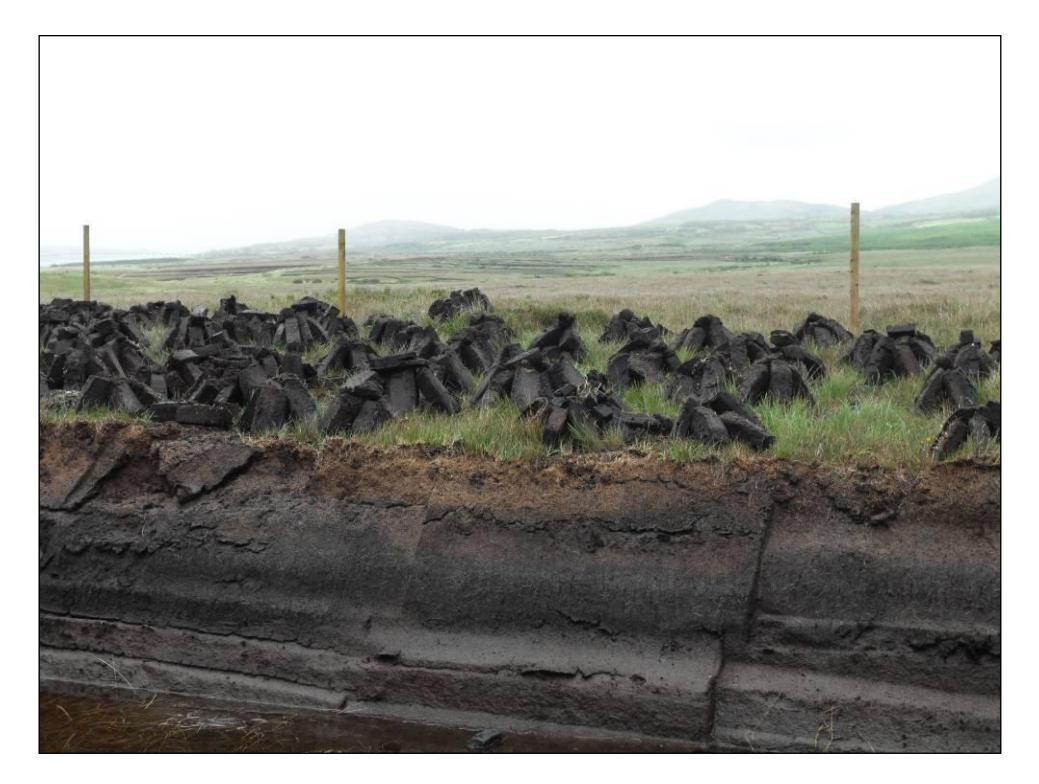
Plate A16: Active peat cutting, Cloichearaí (Photo: BEC Consultants).

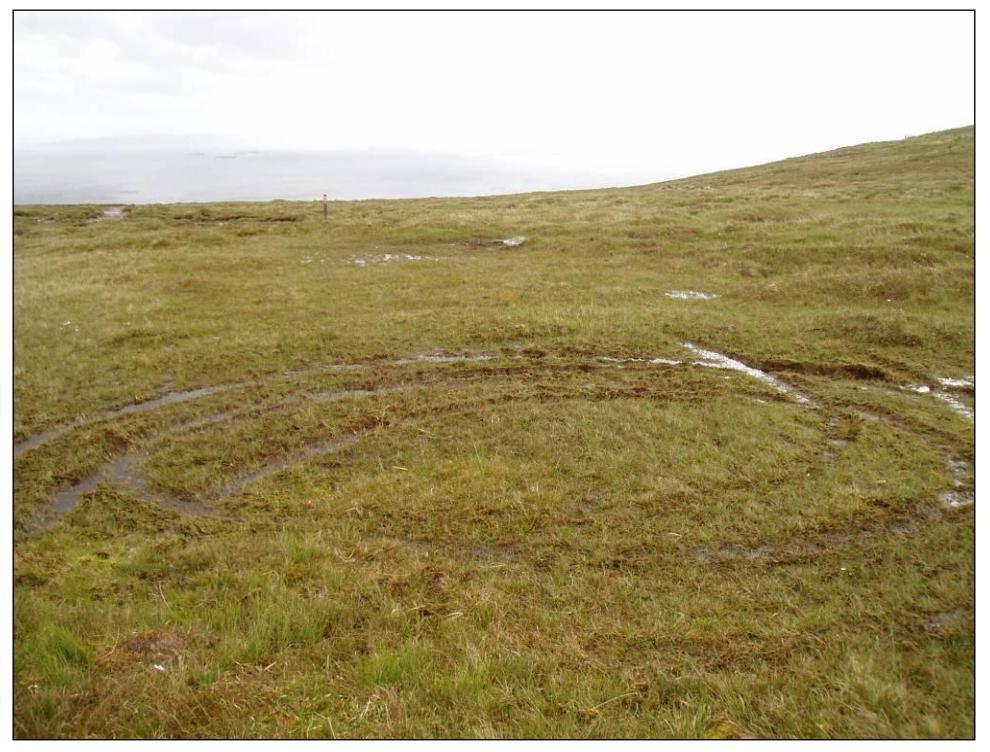
Plate A17: Damage to \*7130 Active blanket bog due to quad biking, near Brandon Point (Photo: BEC Consultants).

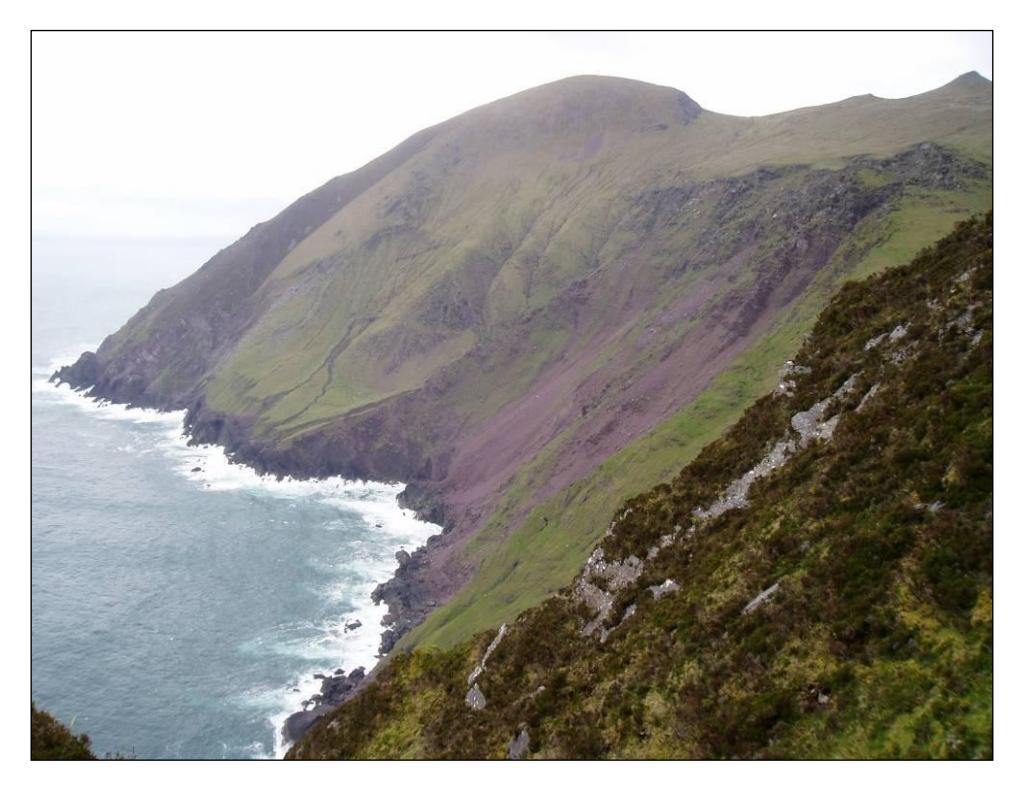
Plate A18: Land slippage, Beennaman (Photo: Jenni Roche).
